CHIRP FEEDBACK

Issue No: 11

A Maritime Safety Newsletter

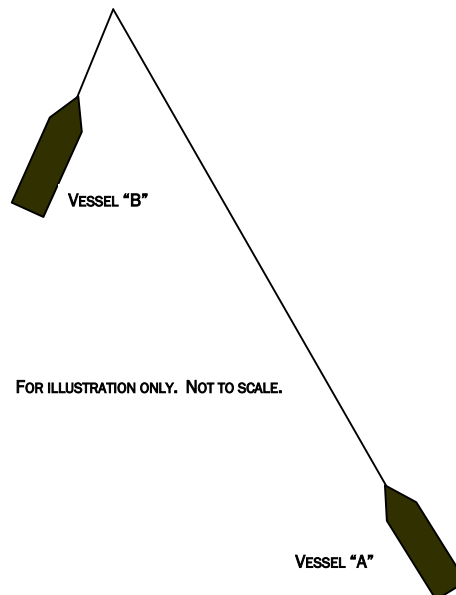
OVERTAKING 2

CHIRP Comment: This report contained insufficient detail to plot accurately, but the following diagram may be of assistance:

Report Text: The incident occurred in the afternoon in the Irish Sea. The weather was NW 5/6 with good visibility. Vessel "A" was on a NW'y course, ahead and to port was vessel "B" on a NNE'y course. Vessel "A" appeared to be the overtaking vessel coming up on the starboard quarter of "B" at a speed of about 20 kts. As they closed "A" called the "B" on #16, then onto #6 and the following conversation took place (this is not a word for word recollection of the conversation):

Without wishing to seem cynical, but there appeared to be a total lack of understanding of the "basics" of the collision regs in this incident and it gives me reason to be concerned.

CHIRP Comment: The Maritime Advisory Board noted this incident bore many similarities with the collision between the Hyundai Dominion and Sky Hope, where the vessels were debating the Rules almost up to the point of collision! Rule 13 (c) states:

"When a vessel is in any doubt as to whether she is overtaking another, she shall assume that this is the case and act accordingly. "

There is clearly a language issue in this incident and whilst the English language used in this exchange may not be considered difficult; the use of Standard Marine Communication Phrases is recommended when dealing with an OOW (Officer of the Watch) whose first language is not English.
