CHIRP FEEDBACK

Issue No: 12

3/2006

A Maritime Safety Newsletter

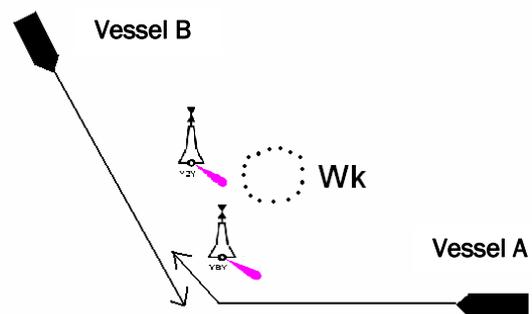
Illustration only. Not to scale.

0650 "Vessel B" called on VHF requesting our intention.

I advised him that I would come to stbd. when my vessel was clear of the buoys. He said he would maintain his course and speed. At the time I did not have him plotted on my radar and did not appreciate how close he would pass the buoys.

In the event, he passed only about 1/2 a mile from the buoy, so I ended passing about 2 cables from the "Vessel B" and the buoy.

Afterwards VTS called "Vessel B" advising him that he exercised very poor seamanship; he should have passed the buoy at a greater distance to give my vessel more room.

I would class this as a near-miss.

CHIRP Comment: This report was forwarded to the operator of Vessel B, who disagreed with the analysis of Vessel A and the VTS; believing Vessel A was most at fault as the give way vessel for not appreciating the risk of collision earlier and acting accordingly.

The bridge team on Vessel A should have been monitoring the movement of other vessels irrespective of any other activities being undertaken. The VHF communication from Vessel B indicates the bridge team had been monitoring and were aware of the developing situation, but both bridge teams should also have been aware that the planned manoeuvre would occur close to the buoys.

Slowing down could have resolved this situation, but as with many other incidents reported in these pages, it does not appear to have been considered.

The Maritime Advisory Board considered that in this situation it would have been appropriate and seamanlike in these special circumstances for Vessel B to have altered to starboard to allow more room for Vessel A's intended manoeuvre.
