# CHIRP FEEDBACK

Issue No: 13

4/2006

A Maritime Safety Newsletter

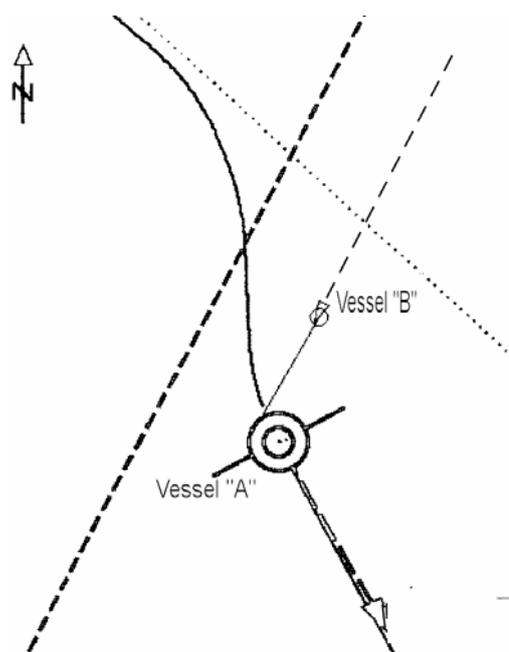
**COLLISION AVOIDANCE - CROSSING**

**Report Text:** Vessel "A" on passage in the North Sea in position 52 34N 002 55E, approaching the DW Route a big vessel ("B") to port on a collision course.

The vessel did NOT show three vertical red lights!!

I asked him his intentions and that it was his duty to keep clear of me. He answered something like "Why should I..., and I cannot reduce speed"!!

All the time he kept his course and speed. All the time we had a sufficient CPA, so we have never been in real danger!!

1. Vessel "B" was proceeding, in laden condition at a mean draught of 13.82 m when the incident occurred.
2. Vessel "B" was in the DW (Deep Water) channel with a course of 207 sailing at a speed of 13.2 kts, and was the give-way vessel, whilst Vessel "A" was on a course of 140 sailing at a speed of abt 21.5 kts.

4. As per data submitted by both vessels at 02:50 GMT the 2 vessels were abt 2 nm apart. Had the 2 vessels maintained their course and speed Vessel "A" would have passed from the bow of the Vessel "B" at a CPA (Closest point of Approach) of 0.3 nm.

6. Clearly the root cause was Lack of Compliance with Company procedures.
7. As per company's QMS, and as a result of the near miss in caption, the OOW in question should have undergone additional training upon signing-off. However, in this case the OOW, has retired after his scheduled signing-off at next port.

8. As means of preventive action to avoid reoccurrence across the fleet and, according to company's QMS, an information circular will be distributed to the fleet. Same as per QMS procedures, will be discussed during each vessel's Safety Committee Meeting.
