CHIRP FEEDBACK

Issue No: 14

1/2007

A Maritime Safety Newsletter

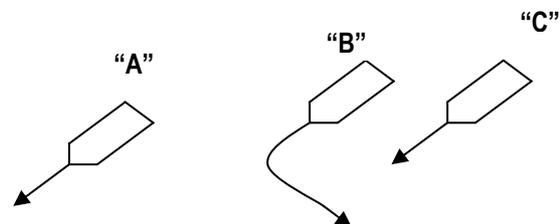
First “B” cuts across bows of “C”.

“C” has to alter 360° to avoid collision with “B” cutting across bows. No warning given. Near-collision. Appalling seamanship.

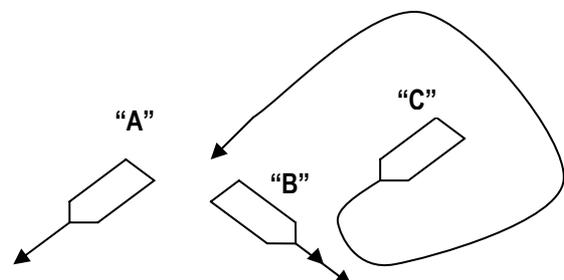
“B” now on collision course with Vessel D, who calls her up and she has to stay on course for three miles

before altering to port. Very open water, no traffic to worry about!

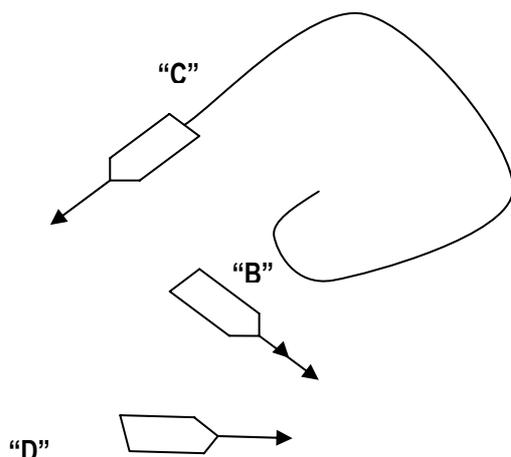
"B" has absolutely no idea or conception of traffic rules or seamanship and is an accident waiting to happen.

Eventually "B" is persuaded to alter course to port towards her destination and away from Vessel "D". The "Navigating" officer has obviously been instructed to blindly follow the red line on the radar without deviation.
