MARITIME FEEDBACK

Issue No: 16

Autumn 2007

A Maritime Safety Newsletter

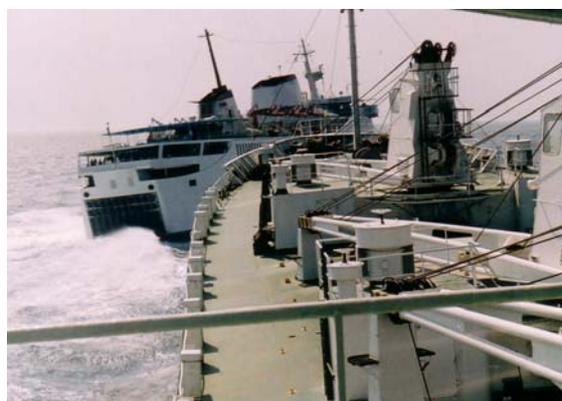
The ferry - boat "#####" approached us on our port side. Then, for about 10 minutes we were sailing in the same direction with the same speed (16knots). The ferry boat's navigator then decided to increase the speed a bit, and then they crossed our bow very, very close to our vessel.

CHIRP Comment: The reporter has sent **CHIRP** this report 12 years after the event. Therefore it is not possible to follow it up. Nevertheless, it is a breath-

taking illustration of the risk involved in such an unnecessary an ill-considered manoeuvre.
