MARITIME FEEDBACK

Issue No: 22

Spring 2009

A Maritime Safety Newsletter

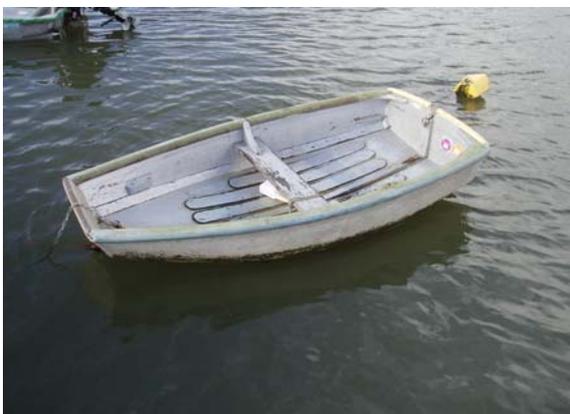
The three men were commercial fishermen who had been crossing the river in their small tender when it capsized. They had no lights and were not wearing lifejackets.

The photo shows the small tender after it was recovered.

Lessons Learned: Wear a life jacket. Don't overload. Have lights.

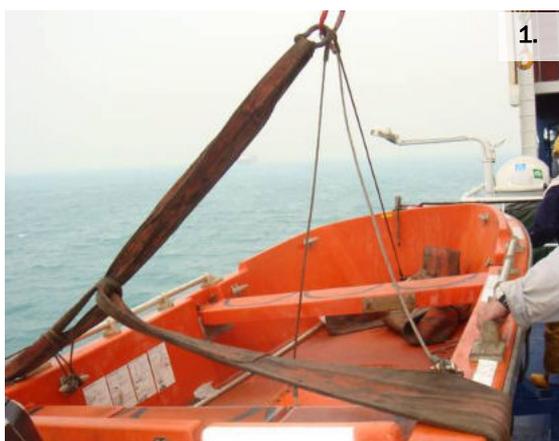
Report Text: A large cargo vessel was at anchor. The opportunity was taken to carry out a drill of launching the vessel's rescue boat. The boat is an open dory, made of glass reinforced plastic. For lifting, it has three eye-plates, one forward, and one each side at the after end. Each eye-plate is bolted to the hull with four bolts. The heads of the bolts are visible but not the shanks or nuts. The boat is lifted by a single arm davit, with a three-part wire bridle, with one part to each of the eye-plates.

The boat's crew of four were wearing boiler suit, safety boots, helmet and life jacket. The boat was swung out with the four crew members on board. As lowering commenced, the eye-plate on the port side aft suddenly detached from the hull. The boat was left hanging starboard side up. Three of the boat's crew plummeted into the sea, a distance of approximately 12 metres. The officer in charge of the boat was left hanging on. Having ascertained that this officer was able to remain secure, the boat was lowered to the water and the three crew members were recovered, fortunately without long-term injury.

Photo1: The rescue boat after it had been recovered back on board. The large webbing strap had been rigged whilst the boat was in the water to replace the third part of the bridle which is hanging loose.

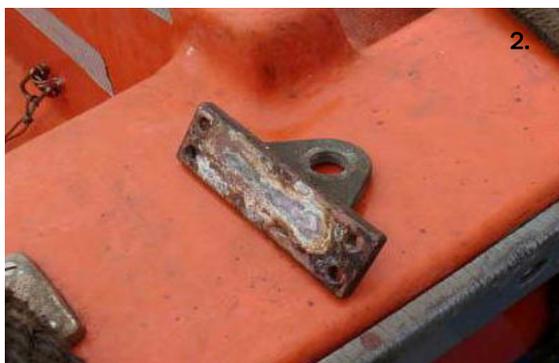
Photo 2: The detached eye-plate.

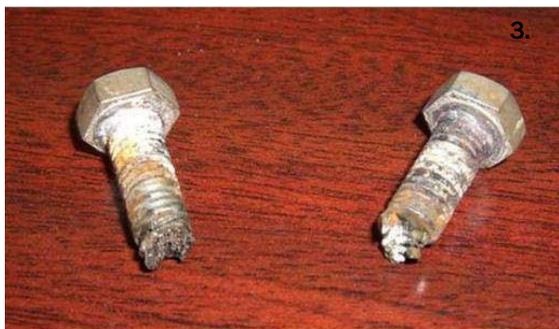
Subsequent examination showed that all four stainless steel bolts had failed.

Photo 3. Two of the failed bolts. The other two had similarly failed.

The ship's manager arranged an urgent survey with the boat manufacturer on two vessels with the same rescue-boats of similar age. The bolts and eye-plates were found to be in satisfactory condition. At the time of publication of this newsletter, the manufacturer is analysing the broken bolts to determine the cause of the failure. Possibilities include a production error with these bolts or galvanic action.
