CHIRP FEEDBACK

Issue No: 24

Autumn 2009

A Maritime Safety Newsletter

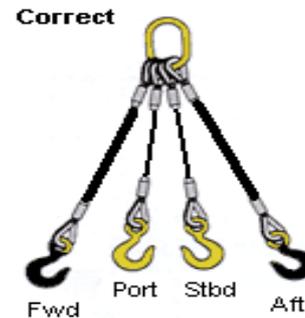
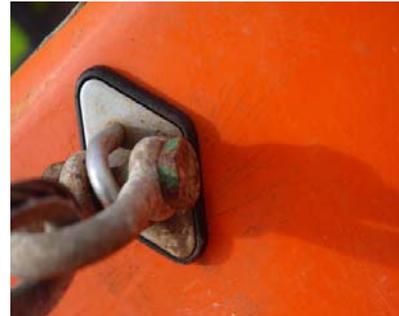
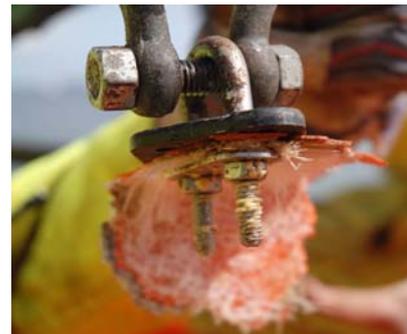
Report Text: A vessel was lifting the six-man glass-reinforced-plastic rescue boat aboard as part of a routine training exercise, with two persons aboard, when one of the eyes for the four leg lifting bridle pulled out of the hull of the boat which was suspended approx 0.5m above the water. The boat was quickly returned to the water and to an upright position afloat. Although shaken by the experience, no staff were injured or fell out of the boat.

The bridle is designed so that two larger legs are attached fore and aft and take most of the weight, with two smaller legs to stabilize port and starboard.

A contributory cause to the failure, in addition to poor boat design, was found to be that the lifting bridle was attached to the davit incorrectly. Consequently the larger/longer fore and aft legs being the outer pair mounted on the master link, the shorter port and starboard stabilizing legs were outside the fore and aft legs making them shorter still and then taking extra strain for which they were not designed. It is important that, when using multiple leg lifting bridle, it is attached correctly.

The company has subsequently replaced these grp rescue boats.

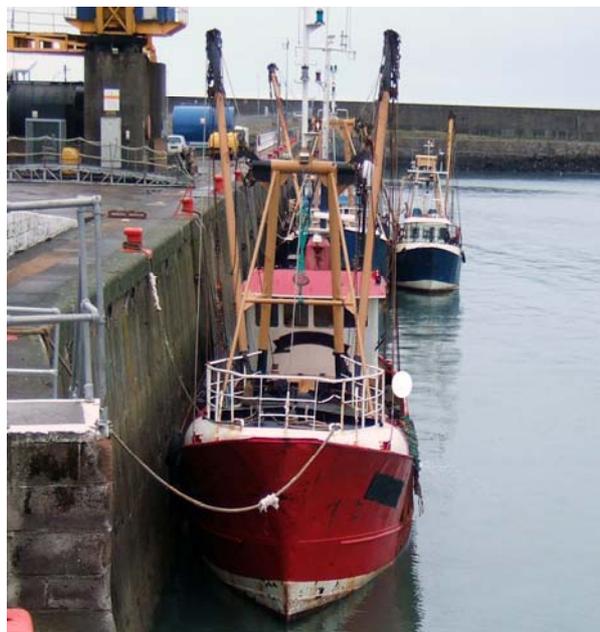
A recent report by the MAIB described a tragic fatality in which a deckhand on board a scallop dredger fell overboard as he was emptying a dredge bag. He had been standing on the dredge beam, which was suspended and almost level with the gunwale, when the dredge bag lifting becket parted.

Despite the quick reactions of the skipper and crew, the deckhand sank below the sea surface. He was not wearing a lifejacket..

The MAIB investigation identified a number of safety issues including:

- Operation of fishing gear.
- The practice of not wearing a lifejacket or safety harness.
- A lack of understanding of risk assessments.
