# CHIRP FEEDBACK

Issue No: 25

New Year 2010

A Maritime Safety Newsletter

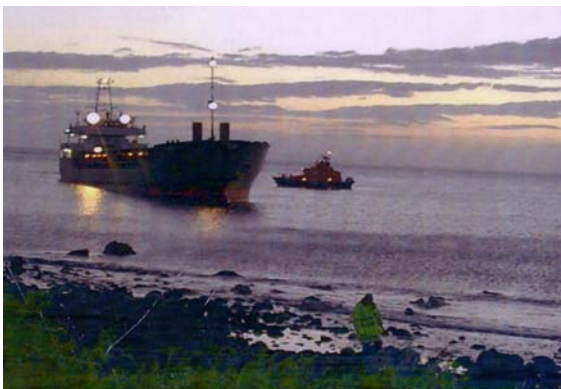
The possible consequences of fatigue were well illustrated in a presentation by the Marine Accident Investigation Branch. This described the grounding of a general cargo vessel on the shore of Northern Ireland in 2008. The officer of the watch (OOW) had fallen asleep shortly after taking over the watch at midnight. With no-one awake on the bridge, the ship ran aground three hours later. The OOW (the chief officer) had been working a 6 hours on / 6 hours off watch-keeping regime with the master. Such a routine on vessels engaged in near coastal trade poses a serious risk of cumulative fatigue. Additional safety measures which could have helped mitigate the risk were not used. There was no lookout on the bridge throughout the night and the watch alarm was not switched on. The company's Safety Management System (SMS) audits had failed to pick up that these important safety requirements were routinely not being applied. The full report can be found on the MAIB website.

*Asleep then aground!*

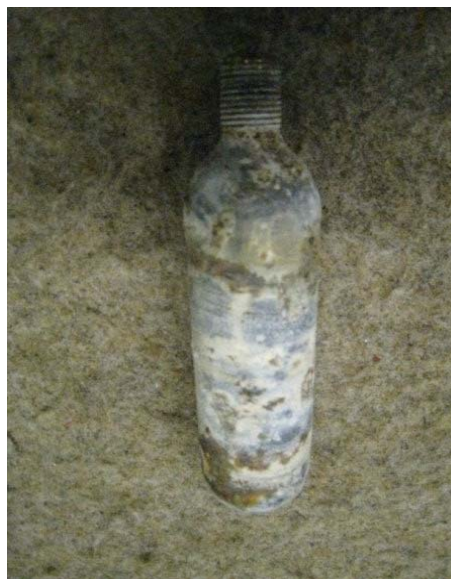
It is important that lifejackets are inspected by a competent inspector in accordance with the manufacturer's recommendation. The inspection will include examination and weighing of the gas bottle. The severely corroded bottle shown in the photograph was from a lifejacket that had been in service up to the time of the inspection.

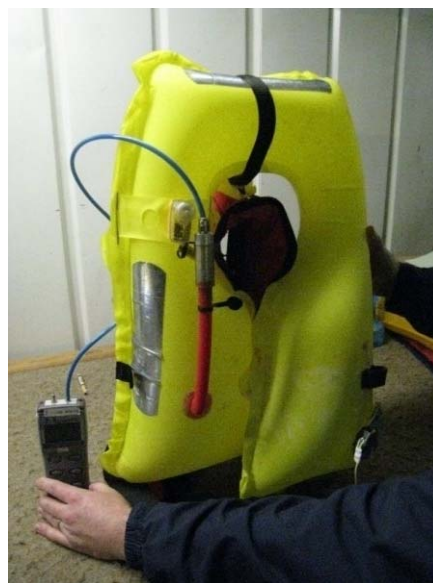
The inspector will inflate the lifejacket from a gas supply to a prescribed pressure. It will subsequently be checked to make sure that the pressure has not fallen below a prescribed allowance, taking into account any change in temperature during the test.

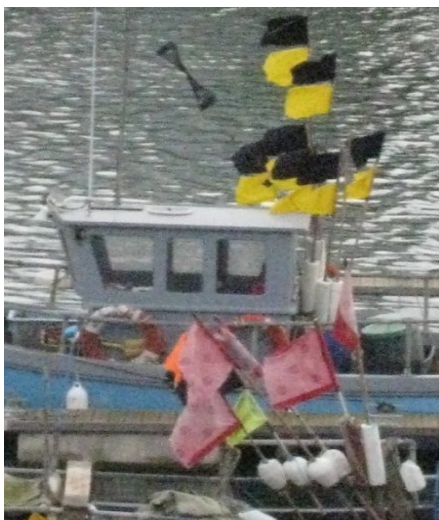
In contrast to the improperly marked gear noted in this report, it was pleasing to see a commercial fishing boat with buoys that were conspicuously marked. However, we would observe that if the fishing signal (two cones with apexes together in a line one above the other) were to be attached to the masthead by a halyard rather than a fixed lashing, this would allow the signal to be lowered easily when not fishing.

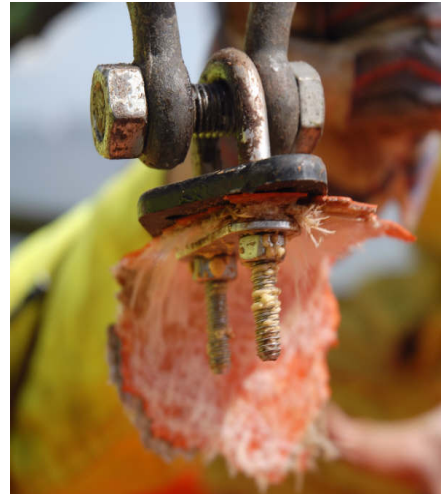
Although the proximate cause of the incident would appear to have been correctly ascertained examination of the photographs would seem to show the following additional factors that should be checked on all similar boat attachments:

- 1) The shackle pin would appear to have been replaced with a fully threaded stainless steel bolt, as well as not being a snug fit in the holes in the shackle bow there would be a risk of vibration causing the threads of the bolt to wear the lifting eye. There also remains the question of if the bolt would be as strong in shear as the correct shackle pin, certainly if this is an unauthorised substitution it would render the shackle outside it's original certification.
- 2) I believe that the doubling plate under the detached eye is too small, I would expect it to have an area of at least 4 times that of the top plate.
- 3) I was surprised that the fibreglass does not appear to have been locally thickened in this region.

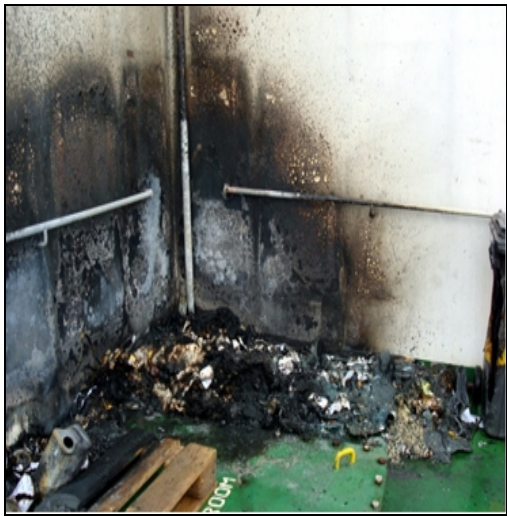
Seven of the vessel's eight garbage bins stored on the starboard side of the poop deck caught fire causing complete destruction of the seven bins and damage to both sides of the two adjacent bulkheads of the adjoining spaces (the engine room and deck store) and also caused scorching to the deckhead of the engine room workshop. The bins were of the plastic wheelie bin type of 200 litre capacity each.

The fire was started by linseed oil soaked rags after a can of linseed oil had been mistaken for varnish remover. The oil soaked rags had been placed in a garbage bin on the poop deck and had started a fire by spontaneous combustion.

Stores in the adjacent deck store were scorched and smoking and close to ignition. The fire was rapidly extinguished by the use of 3 portable fire extinguishers

An audit to be carried out across the company's fleet of the construction of all the garbage receptacles on ships in use for the reception of oily rags.

The company's initial outfit standard for new vessels to include the supply of receptacles in compliance with the garbage management plan for the storage of oily rags internally and on external decks.

Develop guidance highlighting the hazards of spontaneous combustion in linseed and other vegetable oils and bio fuels.

Carry out a review of the Garbage Management Plan with special regard for the management of oily rags.
