# CHIRP FEEDBACK

Issue No: 26

Summer 2010

A Maritime Safety Newsletter

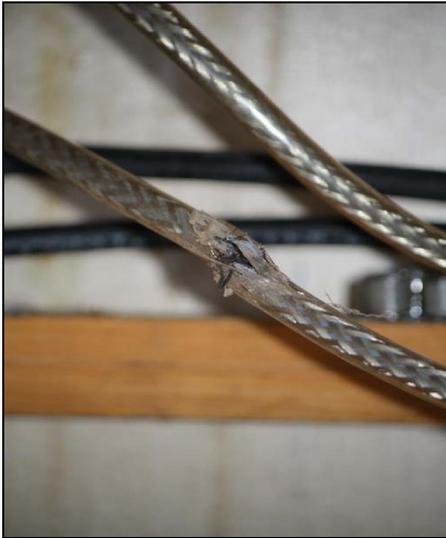
Accident - Because the cables were too long, slack had been left behind the chart shelf. Unfortunately the slack had not been secured and, during many years of the shelf being moved in and out, a shearing force had been applied to the 12 volt cables. This finally resulted in a short circuit which burnt the cable before the fuse went, as shown in the photograph:

Further investigation disclosed another cable from the radar installation being partly damaged in the same way by the same shelf. This was the 220 volt power supply. A short circuit on this cable could have led to an electrical fire on the bridge, causing major damage to the vessel.

**CHIRP Comment:** As the reporter has correctly identified, the incorrect installation of the cables could have resulted in a major fire. This highlights the importance of having and implementing a good procedure in the ship's Safety Management System regarding changes to the vessel's equipment and systems. This should include, risk assessment, planning of the work and supervision.

Remedial action: After the wiring had been repaired, the following countermeasures were applied:

- 1) All radar wiring was checked for any kind of damage.
- 2) Slack in the cables has been picked up and the cables have been secured by cable ties.
- 3) Other bridge equipment has been checked for slack cables and signs of wearing.

Lessons learned: The work of service teams must be checked. It is strongly advised that service engineers carrying out such installations should be accompanied by an appropriate member of the ship personnel.

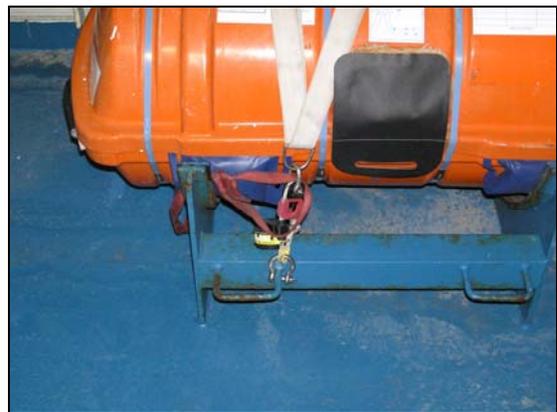
**Report Text:** Whilst travelling as a passenger on a vessel, I noted that the hydrostatic release unit (HRU) on a life-raft valise had been incorrectly fitted. In the event of the vessel sinking (albeit unlikely) the liferaft would probably have been pulled down with the ship. I sent a message to the company. They promptly thanked me for having advised them and advised that the non-conformance had been rectified. They also advised that the valise contained a Means of Rescue rather than a liferaft. I attach a photograph of the incorrectly fitted HRU.

**CHIRP Comment:** The HRU had indeed been incorrectly rigged. As shown in the photograph, the painter had been lead through the shackle connected to the webbing securing the valise. Therefore, if the HRU had been activated, the painter would have remained connected to the webbing strap and thus to the ship.

There is a general lesson that the HRU was visible to the ship's staff but nobody had previously noticed that it

was rigged incorrectly. It is useful for members of the ship's safety team to carry out walk-around checks of the vessel so that such aberrations are spotted and corrected.
