CHIRP FEEDBACK

Issue No: 27

Autumn 2010

A Maritime Safety Newsletter

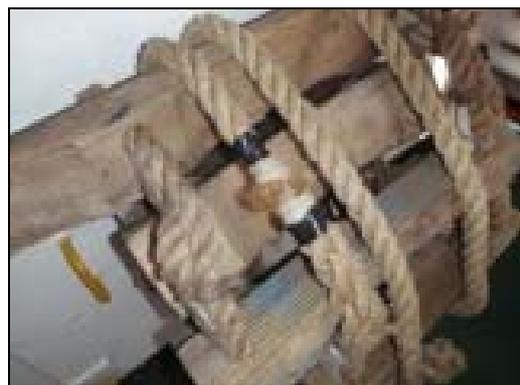
Report Text Whilst attending vessels, I have found pilot ladders with plastic tape wrapped around the manila rope of the pilot ladders. This is deadly. When the rope becomes wet, the plastic tape will inhibit the drying process and the rope will start to rot. There will be no visual indication as the rotting rope is hidden by the tape.

In a hot climate this process may be very quick, a week or less. The writer is aware of an incident in which a pilot fell into the water due to such failure of a ladder.

I have also seen manila rope used for lifeboat painters similarly wrapped with plastic tape.

When I pointed out the hazard, the ships' staff took prompt action to replace the ropes.

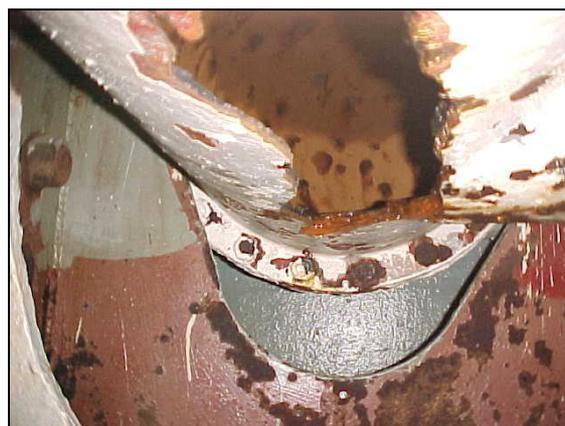
On completion of educting operations, the ballast main was filled directly from No. 1 ballast tank (forward from most tanks) which contained water to a depth of between 10 -15 metres. Line filling was achieved by opening the butterfly valves that have no positioning function, i.e., can only be 100% open or 100% closed. The vessel was trimmed by the stern at this point.

The opening of No. 1 ballast tank valves resulted in water quickly entering the ballast pipe work. When the quickly moving body of water 'hit' the first closed line block valve, a pressure surge (water hammer) occurred that damaged an adjacent section of Engine Room pipe work. The bottom section of a T-piece was forcefully ejected from the pipe work and resulted in an opening approximately 800m x 300mm.

The Engine Room flooded to a depth of 1.1m in approximately 10 minutes. The engineering team promptly manned the Engine Room and efficiently implemented emergency procedures. Emergency bilge injections were immediately brought into action using two separate pumps and water levels reduced to a safe depth.

- Operating procedures are to be reviewed to ensure reference is made to the care needed when filling ballast pipelines. If necessary, procedures should be amended in accordance with the change management procedures appropriate to the Fleet Group in question.
- Handover requirements have been revised for personnel new to the class of vessel concerned.
- The cargo-handling manual will be updated to give clear and concise guidance on how to refill evacuated ballast lines.
