CHIRP FEEDBACK

Issue No: 28

New Year 2011

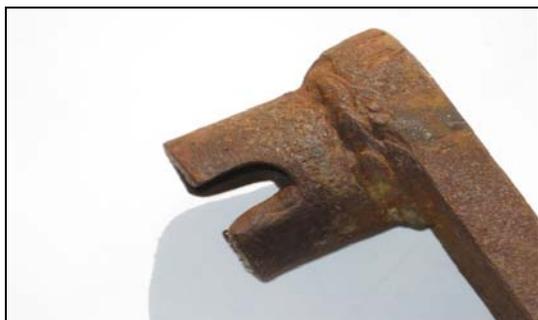
STRUCK BY CRANK HANDLE

Apparent cause of accident. On inspection of the starting handle after the accident, it is clear this was not the correct approved starting handle for this engine but appears to be an extremely poorly fabricated handle with origins unknown and totally unsuitable for the job.

When starting the engine the correct handle is manufactured in such a way that a clutch pin (pawl) engages with a keyway on the starting shaft. This stops the handle slipping off the shaft. The starting procedures and precautions as laid out in the manufacturer's manual, and the Life Saving Appliances manual, clearly states to use only the correct starting handle, and not to use the handle if it is damaged in anyway. The handle was not inspected before use. The correct handle which was also in the boat was not used.

Actions taken to prevent re-occurrence. Incorrect handle removed, to be disposed of. All crew informed of this accident at a drill/meeting where safety precautions & procedures in starting the engine refreshed again. Copy of starting procedures placed inside the engine compartment. The accident also used to highlight importance of risk assessment at a shipboard toolbox talk, where all crew members were involved in formulating a risk assessment for this procedure.
