CHIRP MARITIME FEEDBACK

Issue No: 30

3/2011

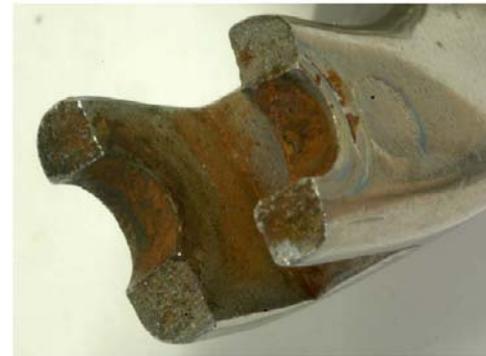
Report Text: This is a large yacht where the rescue boat is stowed inside the hull via a shell door. The accident occurred during recovery of the rescue boat. Just as the rescue boat was being slewed into the tender bay, the port aft snap shackle of the lifting arrangement failed. The snap shackle attached the third leg of the lifting arrangement to the deck of the rescue boat. When this happened, the rescue boat swung downwards and to port, being held by the forward and starboard slings. Two deckhands had been seated in the rescue boat for hoisting and they fell into the water as the shackle failed. Each suffered minor injuries. Both wearing inflatable lifejackets remained conscious throughout and were recovered by other crew members. The cause was found to be failure of the snap shackle secured to the lifting point in the rescue boat. The yacht and its fittings were about 2 years old. The lifting gear was certificated for the load and had not been subjected to any severe loads since new. Regular inspections had been carried out as part of maintenance.

The lifting bridle snap shackles. Note that both the forward and port shackles have failed.

The manager advises that his company has replaced snap shackles in the lifting bridles of rescue boats with conventional shackles.

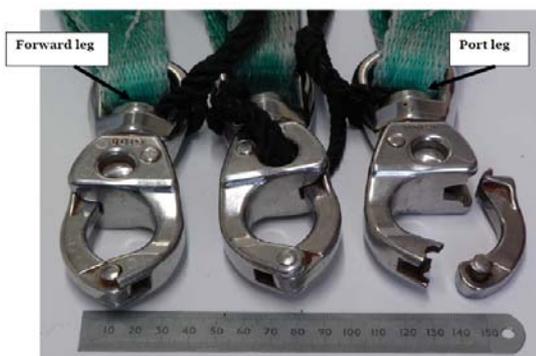
Fracture surfaces on port shackle. Note the corrosion especially in the bore of the holes for the pin.

CHIRP Comment: The manager has subsequently sent us a report of a metallurgical investigation of the failure of the shackle. The report noted that there was corrosion present on the surface of the material that had fractured. The features on the fracture surface indicate that they failed by a fatigue mechanism, cracks initiating at the bore of the hole for the pin.
