# CHIRP MARITIME FEEDBACK

Issue No: 31

Autumn 2012

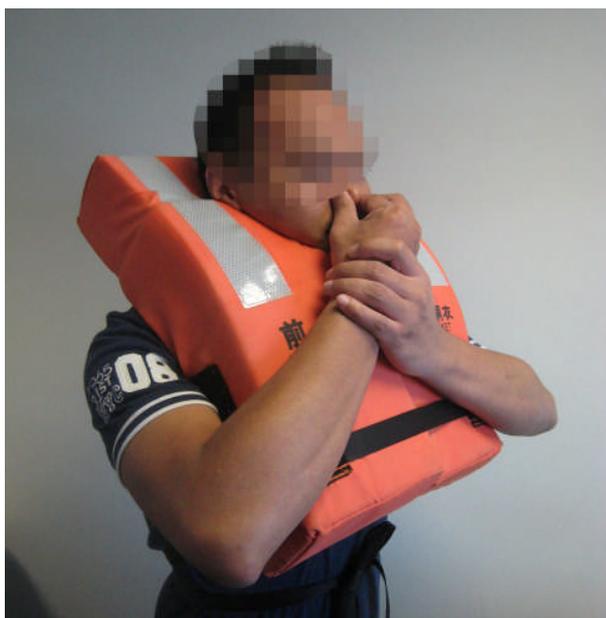
1. The lifejacket is very tight around the neck. If jumping into the water wearing the lifejacket, there would be a high risk of injuring one's neck.
2. The lifejacket is cumbersome in which to work. It is difficult to work in a lifeboat or to climb down a boarding ladder whilst wearing the lifejacket.

**CHIRP Comment:** The lifejacket bears the Wheelmark symbol which denotes that it conforms to the European Marine Equipment Directive. CHIRP contacted the European organisation under whose authority the Wheelmark had been granted. They advised us to contact the manufacturer in Asia for details of the testing that had been carried out. This we did.

The manufacturer sent us details, including photographs, of the tests that had carried out in accordance with international regulations. These included thirteen persons jumping into the water from a height of 4.5 metres, with arms clasped over the lifejacket. None of the test subjects suffered adverse effect from the jump.

We have also obtained general advice from industry experts. They advise that a revised international standard for lifejackets came into effect in 2010. This requires the in-water performance to be measured against a "reference test device". This features a tight neck aperture, as a tight fit around the neck and body ensures that the lifejacket is less likely to move, thus minimising physical stress. The 2010 standard does have higher requirements in respect of clearance of the mouth from the sea surface and turning performance. These requirements have tended to increase the bulk of the lifejackets. This makes them really suitable only for abandonment situations, rather than for regular use whilst working.

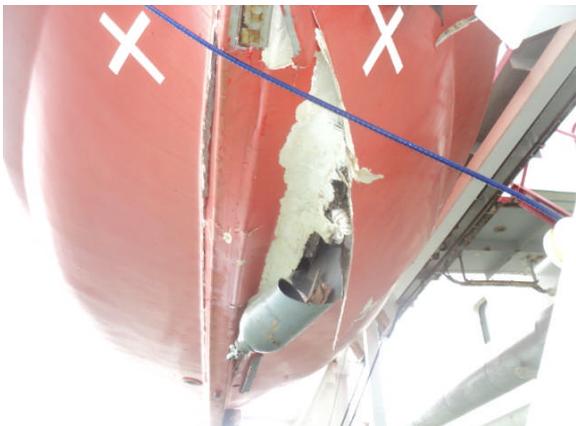
**Report Text:** Approximately one month after a survey and five-yearly overhaul of Life Saving Appliances, a fully charged air cylinder exploded just above the keel moulding of the TEMPSC (Totally Enclosed Motor Propelled Survival Craft), causing considerable damage. Fortunately, no personnel were injured. Once the vessel arrived in port, an independent lifeboat service company was requested to investigate the incident and assess the damage with a view to carrying out repairs.

**Damage to the survival craft, showing the exploded air bottle.**

**CHIRP Comment:** This report illustrates the importance of regular inspection and survey of all parts, including hidden areas, of bottles containing pressurised gas or air. Fortunately in this case, no-one was nearby or working in the lifeboat, otherwise there could have been serious harm. As it was, the lifeboat was clearly out of action for the remainder of the voyage.

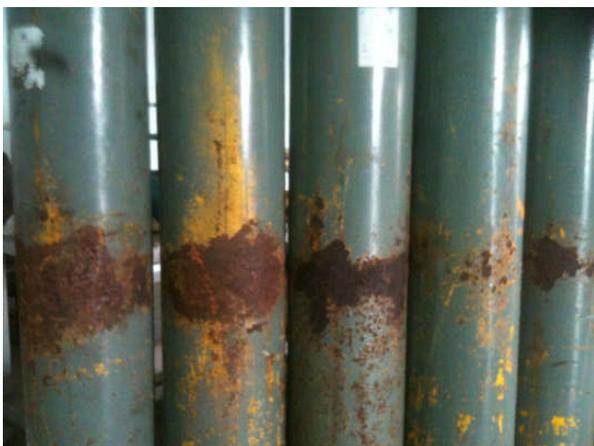
The remaining air cylinders were removed and a close scrutiny was undertaken. From evidence in the form of a date stamped into one of the cylinders, it was ascertained that a hydro-test of cylinders last took place more than five years ago. Further inspection of the remaining cylinders showed quite clearly material wastage through corrosion of approximately 50% of the cylinder walls' original thickness.

**The remaining air bottles, showing the corrosion in the area where the retaining strap had been fitted.**

As there was no more recent date stamp, it can be assumed that these particular cylinders were not hydro-

tested in the recent survey. Indeed, judging from the cylinder wall corrosion that can be observed, it appears possible that they were not removed from the boat during the survey.

After assessment, the TEMPSC was deemed to be beyond economical repair and was scrapped. A replacement lifeboat had to be obtained.
