# CHIRP MARITIME FEEDBACK

Issue No: 33

Autumn 2013

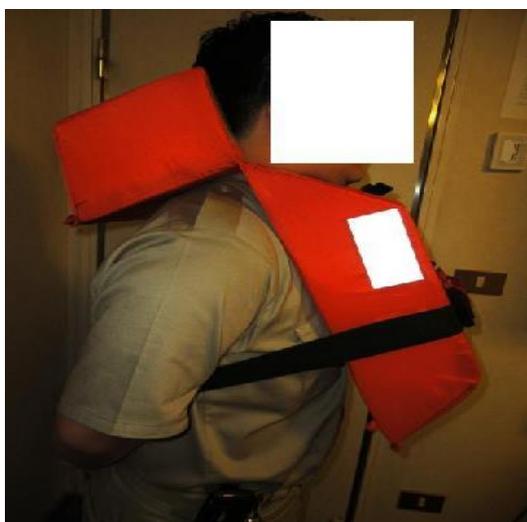
**Report Text:** I am writing to you in regards to the Issue No.31 and specifically about the Lifejacket Design article. I am a mariner onboard a cruise ship. We have been supplied with additional lifejackets that compared to the old type are quite bulky and VERY tight around the neck. These are made by a major manufacturer.

I totally agree with the concerns raised by our fellow mariner: this kind of lifejacket is really tight around the neck to the point that during drills, crew members wearing it felt uncomfortable in them and experienced a feeling of suffocation. In addition to that it makes it quite difficult to perform basic safety related jobs i.e. preparing the lifeboats at embarkation deck, climbing up and down ladders and descending an MES chute.

Clearly these lifejackets passed the latest stringent tests required by SOLAS and have far better life saving capabilities. However they were not designed keeping in mind ease of wearing which is essential for those who work at sea.

**CHIRP Comment:** We have drawn this to the attention of the manufacturer of this lifejacket.
