# CHIRP MARITIME FEEDBACK

Issue No: 35

02/2014

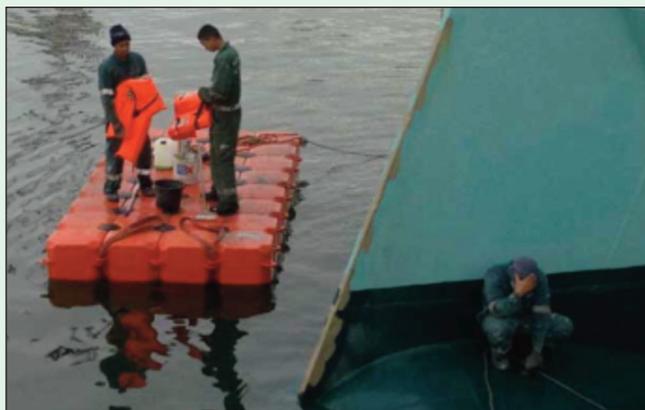
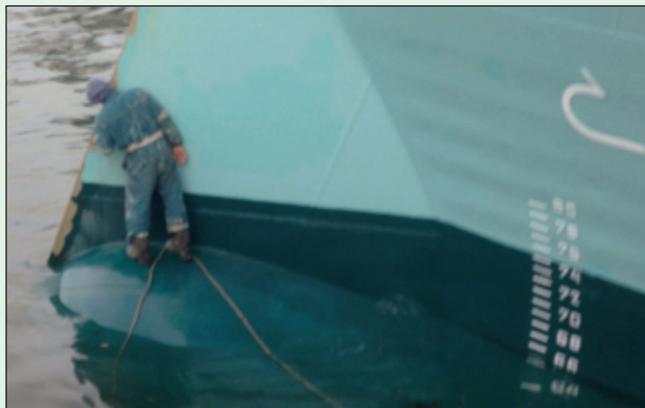
The port supervisor arrived on the quay and noted the punt in the water. Also on the inboard side and out of view of the pilot cutter was a crewman perched on the bulb of the bulbous bow of the ship. At the same time an officer from the ship arrived on the quayside to enquire what was going on.

Our port supervisor pointed to the operation that was happening and highlighted the fact that none of the three men (two on the punt and one on the bow) were wearing any buoyancy aid. The officer seemed unconcerned stating that his crew can swim. Buoyancy Aids (Life Jackets) were supplied and the work on the punt continued and the man on the bow came ashore.

The use of the lifejacket should be questioned as they are for lifesaving purposes and not for this type of work.

There should really be proper work wear buoyancy aids.

Harbour Authority – Lessons learned: The Harbour Board Staff are encouraged to note safety concerns and intervene when necessary.

The report illustrates a poor application of the SMS and the need for the use of risk assessment and a permit to work when working over side. Charterers using their own company branding on Owner/Master controlled ships operating in commercial pools should consider the need for compliance with the Charterer's stated QHSE policies and in particular have an equivalent SMS, whether or not they provide the crew doing the work.

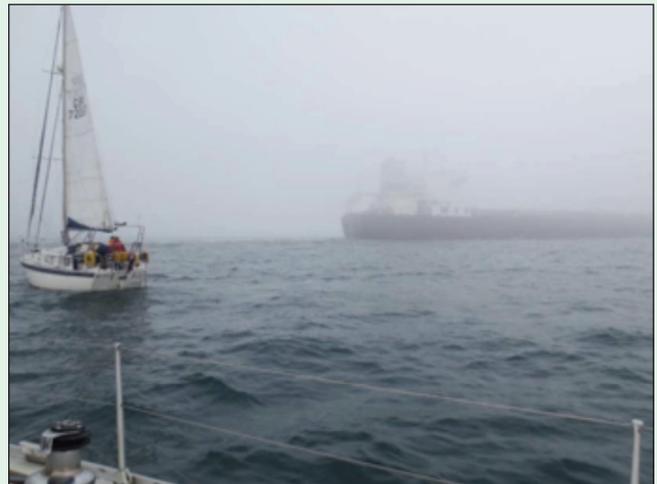
CL's radar was set with course up (not the more convenient north up) and so when we altered course all the tracks of radar contacts changed and in the next few minutes it was not clear if the true courses of any of the contacts had changed. However we felt confident that from the previous plot we should be safe. We then suddenly saw a large indistinct visual contact on our port beam at a range of two to three cables. At first we thought this was a ship heading west but after a few moments we saw a bow wave and realised it was a large ship heading straight for us. Seconds later the helmsman saw that we were very fine on the ship's starboard bow and altered course violently to port reversing our course from east to west, D following. A large, Chinese registered bulk carrier (BC) just passed us at a distance of less than 100 yards (see photo attached, taken from D). This was too close for comfort.

**Overview:** We had altered course from north to east to avoid the BC, which we had plotted as steering west. However as we came into close quarters she was steering south so she had clearly altered course. Our radar plotting on CL was not accurate enough to have seen this although on D they had just noticed this but did not have time to notify CL. It seems clear that BC had altered course to port and to a course of south at the same time as we had altered to a course of east. We had both altered from one set of converging courses to another at the same time!
