# CHIRP MARITIME FEEDBACK

Issue No: 36

03/2014

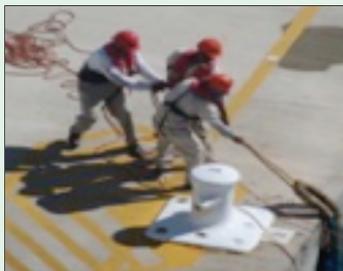
**Report Text:** I was a passenger on a cruise liner and whilst docking it was good to see that the linesmen were wearing PPE. However, they appeared to be unaware of the danger of standing in a bight.

**Lessons Learned:** Routine operations such as this should be included in safety briefings to operators and in the scope of safety audits.

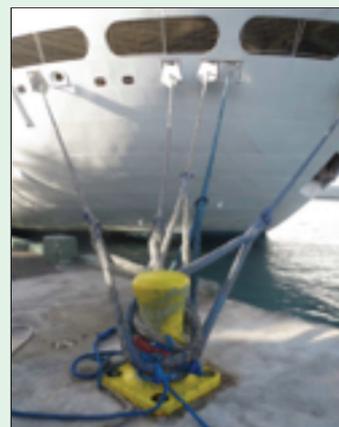
**Report text:** Whilst at Nassau I took this photo of another vessel where five of the ship's aft mooring lines were secured to one bollard. I do not know the breaking strain of the mooring ropes or that of the bollard, but I suspect that the combined strength of the ropes may have exceeded that of the bollard. However, I do not recall reading of any incident in which a shore bollard has been pulled from the ground.

**CHIRP Comment:** It is the terminal operator that is contractually responsible for providing a safe berth. Mooring bollards should have a determined SWL rather than having to rely on assurances that they are strong enough. It is not possible for a Ship's Master to verify the capability of each mooring bollard. The Master should also be aware; the ship's own mooring layout capability will impact the loads on the bollard.

Ship owners should check with their agents to verify the moorings bollards on the assigned berth are adequate for the size of ship nominated to the port. Best practice can be found in the LNG shipping industry where computer programmes are used to verify mooring capabilities of a berth before a ship visit.

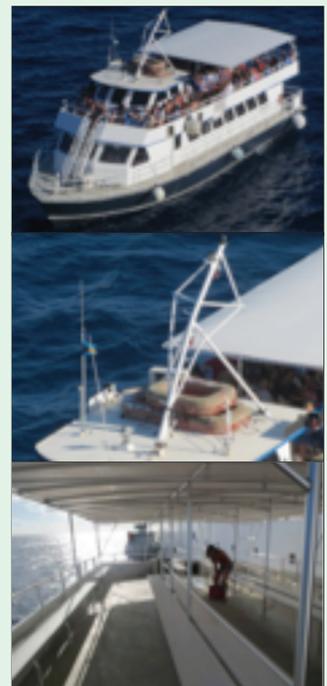
No safety announcement was made but I noted life-jackets stowed on shelves and in two piles at the after end. On the return journey in the afternoon, I was on the same tender, but this time on the upper deck. Again there was no safety announcement. I noted that, whereas there were life-jackets in the main cabin, there were none on the upper deck. For passengers on the upper deck, they would have to rely on life-jackets being passed up from the main cabin. As there were only two doors to the main cabin, one forward and one aft, it seemed to me unlikely that this would

happen if the vessel were to founder. There were two rafts on top of the wheelhouse but these would probably not have floated free as they were carried between the legs of a tripod mast and they appeared to be tied loosely to the mast. I estimate that "Tender X", had over 100 passengers

on the upper deck. I had heard that the total number of passengers on each tender was 250.

**CHIRP** contacted the cruise liner company and was advised the company has made enhancements to the tender’s safety briefing and the raft secured on the top deck was now correctly stowed. Whilst the life jackets were found to be in compliance with the safety certificate, **CHIRP** commented that if a full risk assessment was undertaken, it would reveal there are no readily accessible lifejackets for those people on the top deck, they will be reliant on people on the deck below

passing lifejackets to them. In the event of an emergency, doing this with frightened and untrained passengers may not achieve the desired outcome within the short period of time available to them. It was suggested the placement of the lifejackets on the tender should follow that employed by other tenders at the same location where lifejackets are clearly visible on their top decks.

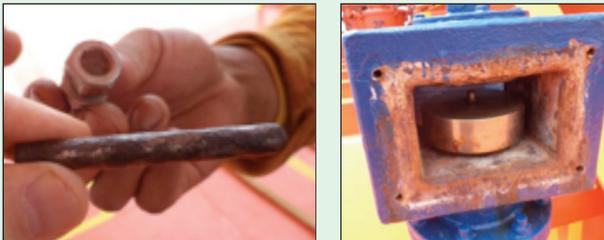
- d) A ballast water tank vent had a broken steel shaft on the vent float. The shaft had broken when the float was clogged and became stuck inside the vent cowling.

The device is “an automatic closing device” as required by the International Load Line Convention Reg 20 (3). When it is dry it remains open; in the event of the deck flooding to the height of the closing device, the float rises up the spindle and prevents water entering the ballast/fuel tank during heavy weather. The cargo, fuel and ballast tank vent systems should be included in the Planned Maintenance System; the date and frequency of any inspections, with any changes recorded and retained on file.

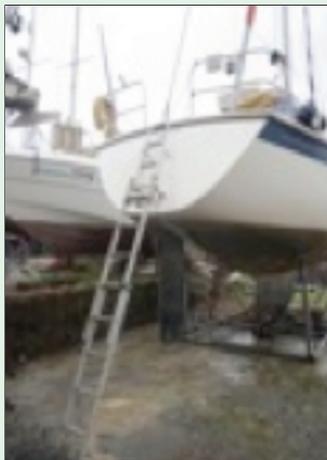
**Report text:** I was hoping to visit a friend whose yacht was ashore in a boat yard. He was not there so I decided to go on board to leave him a note. The deck of the yacht was about 3 metres above the ground. Access was via a short extension ladder, approximately 2.5 metres long, lashed to the boarding ladder fitted to the transom. When I was near the top of the extension ladder, the locking mechanism failed, the ladder retracted, the lashing failed, and the ladder fell away.

Fortunately at the time I was holding onto the transom ladder with both hands. I was left dangling without being sure how high off the ground and without being able to see whether the ladder was on the ground directly underneath me. There was no one around to assist so I had no choice but to drop to the ground. Fortunately the ladder had fallen clear and I came to no harm. I realised however that had I fallen onto the ladder on the ground, I could have broken an ankle.

The failure of the locking mechanism on the ladder was not obvious. However, I should have paid more attention to the security of the lashing. In general, slips and falls represent a significant proportion of accidents on vessels. I nearly added to the statistics!

Boat yards used by owners of recreational craft should be aware of their exposure to this risk and their responsibility in the eyes of the law. Owners of such craft have a basic responsibility not to use equipment when they are unsure of its condition and if concerned they should report their concerns to the shipyard.
