CHIRP MARITIME FEEDBACK

Issue No: 39

02/2015

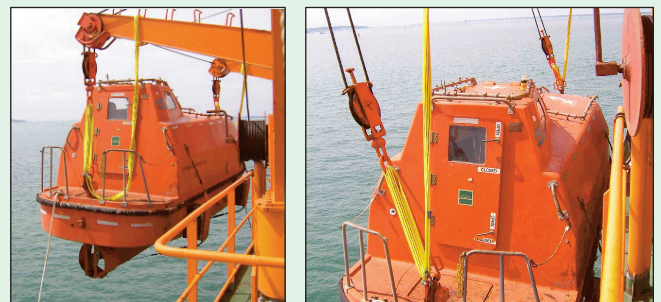
It is important that FPDs are made of resilient material that can absorb shock. In the photo the same principle has also been applied to the hanging-off pennant. This ensures any failure of the hooks would not induce a large shock loading, which in a wire or chain could cause the latter to sequentially fail as the materials have limited resilience. Furthermore, as can often be found in incident reports, corrosion in wires can be present and could cause weakening of wire strops.

disruptive loads can occur they too can be by-passed by hanging-off or maintenance pennants that attach the boat directly to the davits (see photo). There have been some notable accidents recently in which falls parted and many seafarers paid with their lives (7 lives in 3 accidents!). We will discuss this in more detail in a future edition of Maritime FEEDBACK.

The Industry Lifeboat Group (ILG) continues to apply pressure where it can promoting good practice such as the use of Fall Preventer Devices (FPD) and hanging off pennants used to by-pass the hook. Photographs below show FPDs (between hanging-off lug and fall) and Hanging-off pennants (between hanging-off lug and davit arm) rigged for use.

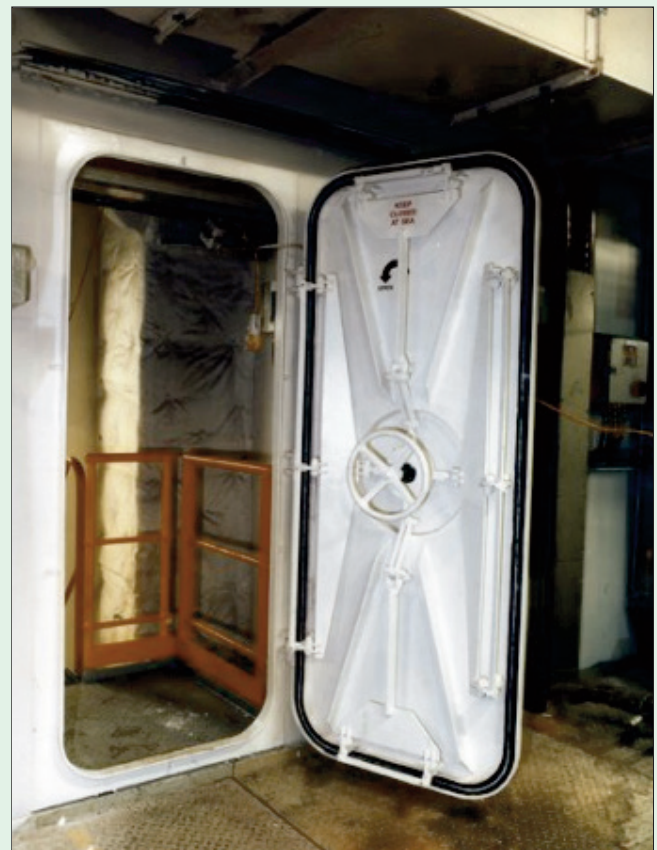
Report Text: A watertight door left open and unsecured on main deck. This created potential injury to limbs. Causal factors: Failure to follow procedures and an inadequate securing system.

CHIRP Comment: Leaving these doors permanently open at sea increases the risk of progressive flooding and loss of stability. International Convention for the Safety of Life at Sea (SOLAS) describes how watertight doors should be used, including how and when these doors can be left open and when they need to be closed. Vessel management teams are encouraged to ensure that all personnel are aware of the risks and that watertight doors are kept closed and to use all of the dogs.

If regulations will allow, consider installing a door closure device designed to aid door control and stability.
