CHIRP MARITIME FEEDBACK

Issue No: 40

03/2015

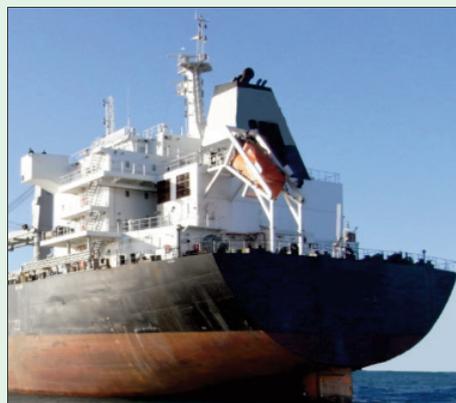
Report Text: During an abandon ship drill we encountered difficulty in releasing the free fall lifeboat from its stowed position due to the moveable parts being stuck in the stowed position. The procedure for performing the simulation test was missing on board the vessel.

Causal factors: Failure to follow planned maintenance inspections resulted in inadequate maintenance due to guidelines not being followed.

Picture shows the stowage of a shipboard Freefall lifeboat.

Preventative action: The matter was discussed on board. The frequency of testing the release mechanism is important as it clearly detected a fault at the time of the simulation test. The ship managers agreed with the vessel's comments that the release mechanism should be tried out frequently, i.e. checked once a month and the parts well greased to prevent corrosion of any touching parts that can cause the jamming of the release system.
