# CHIRP MARITIME FEEDBACK

Issue No: 41

04/2015

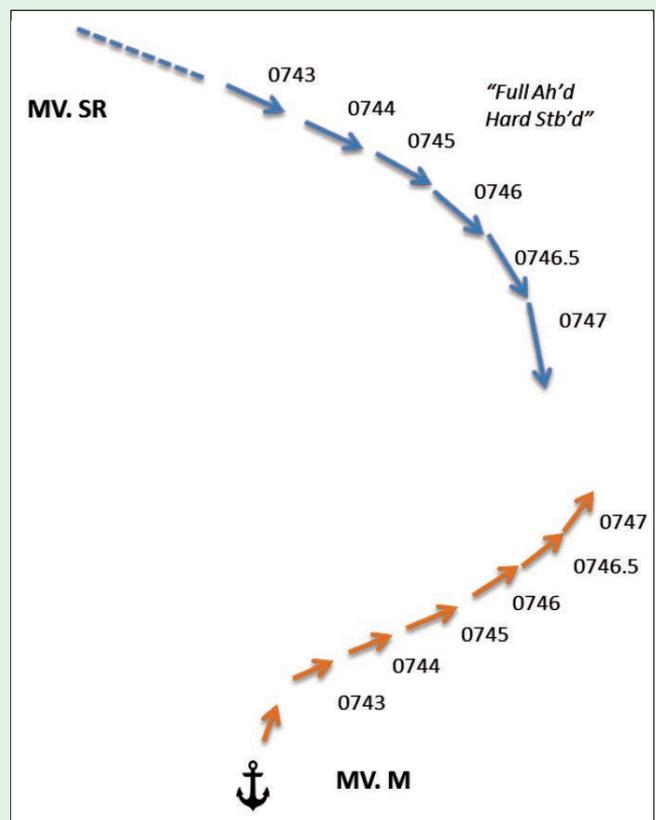
"MV SR had permission from Luanda port control to proceed to the inner bay anchorage for port clearance: We passed through the inbound road proceeding to the inner bay with a speed of about 7 knots. At that time, MV M was anchored at West of Ilha do Cabo island. At about 0723, I observed MV M move in a direction NNE with speed about 2 knots and it appeared she wanted to cross the road to the North. After 5 minutes, I observed the compass bearing of MV M was increasing and at 0732, the compass bearing with MV M was still increasing: I thought she will passing across my stern. At 0740, our speed

was 7.1 knots heading 120°, MV M's speed was 4.0kts heading 074° and on VHF we communicated with each other. I told MV M that: "I am inbound vessel proceeding inner bay to drop anchor, I want to pass across your bow then alter course to starboard, can you alter your course to port side to passing my stern?" MV M answered: "You want to pass my bow, OK, copy that." At 0743, I observed that MV M altered course to port side not obviously, her speed 4.0 knots heading 071°, so I called her again on VHF asking them to alter course to port side more quickly, she answered: "I am altering slowly."

In that situation, it is impossible for me to reduce speed or to alter course to port side, so I increase our main engine to full ahead, and at 0745, I ordered steer "hard to starboard" and alter course in order to pass the bow of MV M with Closest Point of Approach (CPA) 0.19 nm.

**CHIRP** believes the captain of MV SR provided a very comprehensive reply to the report with a remedial action plan that was soon completed. **CHIRP** used the information taken from MV SR's Voyage Data Recorder to create a schematic view of the vessels' tracks.

**In conclusion:** I should apologize that I was not fully compliant with the COLREGs and the cause for this close-quarters situation. First, I should proceed at safe speed. Second, I should take early action to avoid the risk of collision. Third, I should take action as the give-way vessel and avoid crossing ahead of the other vessel in a crossing situation, even if have a communication with other vessel in advance. And I promise that in the future, I will organize the OOW with me to study the COLREG and full comply with the COLREG."

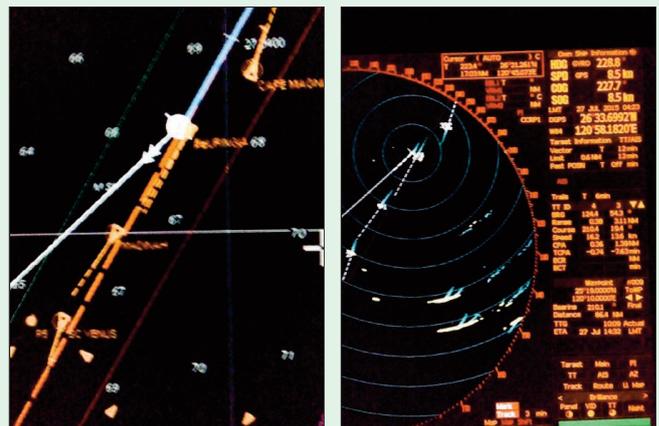
**Report Text:** As Chief Officer I had taken over the 0400-0800 morning watch from the second officer. I had observed a vessel astern overtaking us showing a low CPA of 0.3nm, overtaking on the port side. As the overtaking vessel was still 2 miles astern I assumed he would alter to pass at a safer distance. As I continued monitoring the vessel he approached closer than 1nm, I signalled with Aldis lamp and called on VHF. There was no response or action from the other vessel. As the CPA was now still showing less than 0.3nm and range to the other vessel was now 0.5nm astern, it was clear the other vessel was not taking appropriate action under COLREGs Rule 13. I altered course 30 degrees to starboard to increase the CPA and reduce the risks from a close quarter's situation. The other vessel finally passed on my port side at a range of 0.36nm. The other vessel at no point altered its heading and ignored repeated attempts at VHF communication/warnings.

This is a perfect example of the increasing number (and size) of vessels who simply do not give way under any circumstances. It is frustrating to say the least that increasingly to pass other vessels in a safe manner you are ALWAYS the give way vessel. Although I am relating only this example, I have numerous similar experiences with large vessels approaching up to 400M in length, from large well-known companies who will overtake at 3 or 4 cables in open sea. When two such vessels meet each other in unfavourable circumstances an accident is inevitable sooner or later. Please see attached screen shots during the incident

**CHIRP Comment:** COLREGs Rule 13 governs overtaking situations and states that, “any vessel overtaking any other shall keep out of the way of the vessel being overtaken.” This rule applies to all vessels and is unusual in that it firmly puts the onus on one vessel to take all necessary action, in order that a collision might be avoided. The third party ship managers have taken appropriate action by their work with the current officers to help to prevent reoccurrence.

1. Briefed the Master.
2. Asked him to conduct a bridge team meeting and discuss the feedback in detail.
3. Conduct a Navigation Audit and ensure compliance with procedures and Collision Regulations.

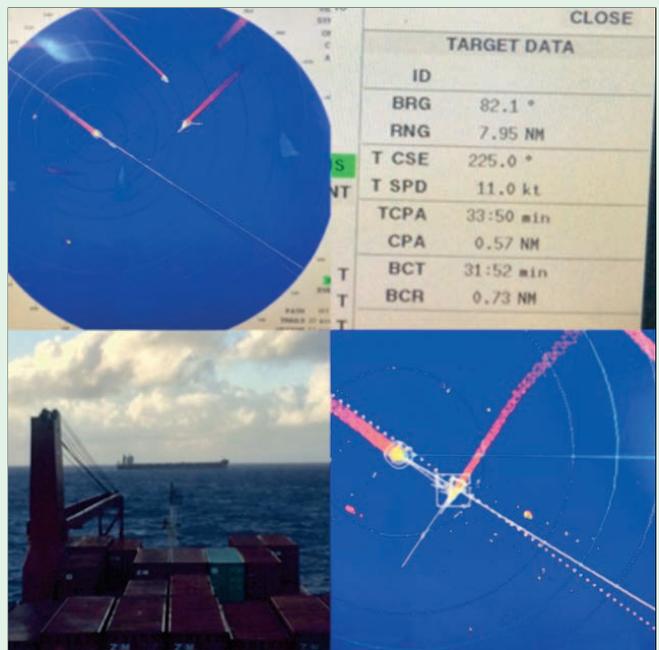
**Report Text:** Container ship 'A', on passage from Kingston Jamaica was heading towards Willemstad Curacao on a course 127° at 7.7 Knots. The Master was monitoring traffic and observed Vessel 'B' from far away. With a small CPA and with the intention of not to cross the bow of Vessel 'B', the Master of the container ship 'A' reduced the ship's speed a small amount, believing to be acting under Rule 8(e) and giving himself more time to assess the situation, he then contacted the Officer of the Watch (OOW) on Vessel 'B'. When asked about the intentions of Vessel 'B', their OOW replied that container ship 'A' should pass his stern and B' would alter course more to his port side. The Master of container ship 'A' did not agree and replied that Vessel 'B' should follow COLREGS Rule 15, Unfortunately the OOW on 'B' just said 'thank you' and changed VHF channel without acknowledgement. The Master on container ship 'A' tried to call Vessel 'B' again on VHF but got no reply.

The pictures of the Automatic Radar Plotting Aid (ARPA) screen show 2 miles range rings showing the crossing ahead was 1.7 miles with CPA 0.57 miles.

However this action was in breach of Rule 15 as the Vessel 'A' course should have altered to starboard in order to comply with COLREGs Rule 15.

The Maritime Advisory Board raised concern over the actions of the OOW on both vessels. The Master of containership 'A' was correct when advising the OOW on Vessel 'B' that his actions did not comply with COLREGs Rule 15. However the Master of containership 'A', by making only a small alteration in speed, took action which was unlikely to be detected by the other ship and therefore was at risk of not being in compliance with Rule 17 (a)(i). Rule 17 has three stages and you must identify and assess each of them:

- a) Refresh training on COLREGs and Rule 15 in particular.
- b) Extraordinary Navigational audit..
- c) In addition the case was discussed during an extraordinary Safety Committee meeting with all Deck officers participating.
