Editorial

It is a pleasure to offer this 42nd issue of CHIRP Maritime Feedback as its new editor. My predecessor in this role, John Rose, has done an enormous amount to extend the publication's reach; I hope I can continue in the same vein.

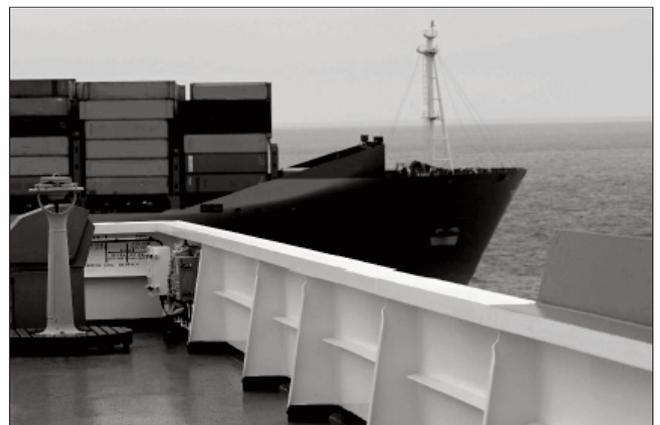
OVERTAKING IN A TSS. A VLCC heading north-east in the Sandettie TSS was overtaken at very close quarters (1-2 cables) by a container ship. This manoeuvre necessitated her passing F1 buoy, marking the separation line at a distance of about 50 metres. The manoeuvre took place at the entrance to the NE lane, where the VLCC and to an extent the overtaking vessel were heavily constrained by their draught. The container ship did not comply with guidance on the relevant chart and in BA5550 advising against use of the Deep Water Route (DWR) by vessels under 16 metres in draught, and to the dangers of overtaking.

It is the obligation of the overtaking vessel to “keep out of the way of the vessel being overtaken ... until finally past and clear”. The distance at which the container ship, at speed, passed the VLCC (see photograph) was far too close. There was no spare room. Though we do not have tidal information (height or stream) which may have influenced decisions, it is clear that the VLCC judged he had little or no space to starboard. The OVERTAKING manoeuvre should not have taken place. Moreover, interaction will almost certainly have been present; this can cause loss of heading control or – at the least – unpredictable rudder requirements to maintain course (dependent on ships’ sizes and speeds, and the depth of water in which they were navigating). Though not in itself a factor in the rights and wrongs of collision avoidance, it is a fact that a collision where this manoeuvre took place could have closed the strait to deep draught vessels bound NE, or at the very least obstructed the route, with major consequences.

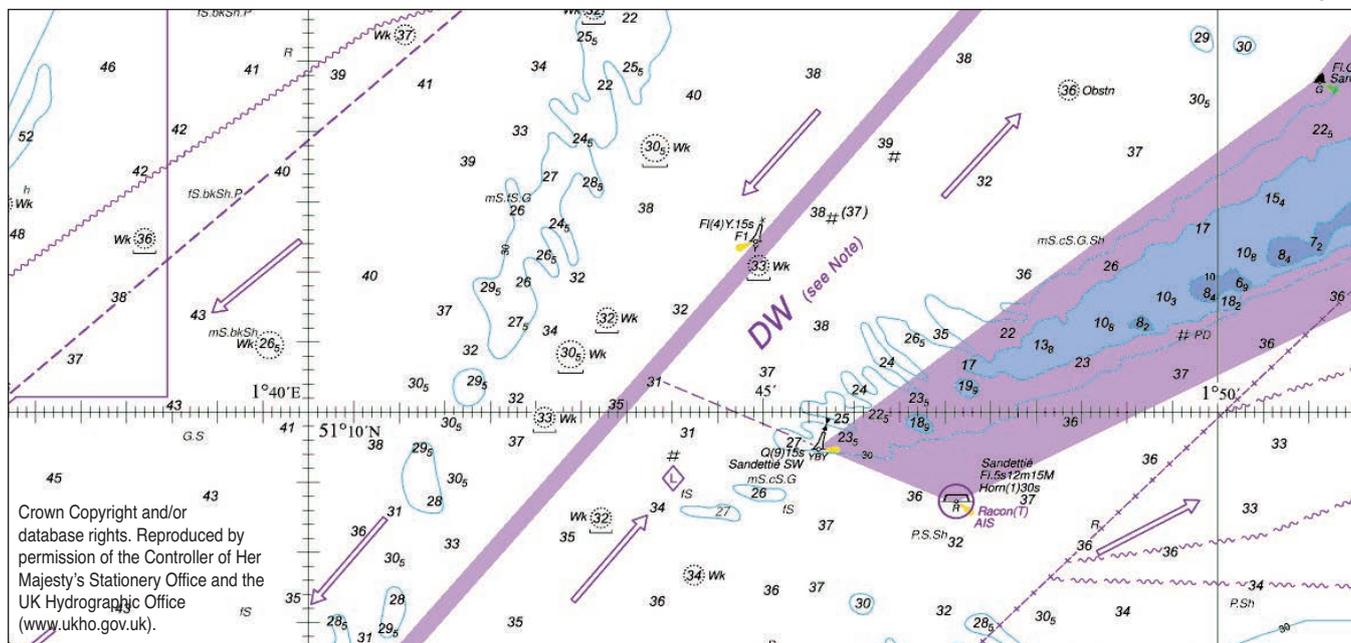
A very narrow entrance to the NE-Bound Sandettié DWR – note the position of F1 buoy. (Not to be used for navigation).

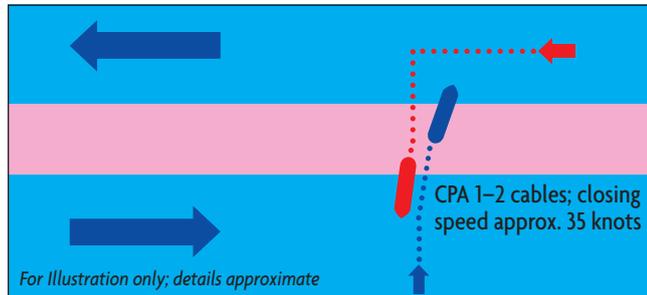
Ships crossing a TSS pass nearly head-on at very close quarters (about 1 cable) at an approximate closing speed of 35 knots. See the reporter's comments below. The actual location is not revealed in order to preserve anonymity. We do not have an exact track chart, but the reporter's reconstruction shows the following:

Extracts from the information reported to CHIRP. The reporter commented: [Our ship] 'was crossing the TSS. Approx midway through the crossing the [other ship] left the far lane' (shown westbound in the diagram) 'to cross the near lane' (shown eastbound in the diagram). 'The [other ship]' steadied up on a course that led to her and the [reporter's ship] passing ... extremely close. The OOW on the [reporter's ship] had not plotted the [other ship] and failed to notice that she had altered until it was very late. Instead of taking action he called the [other ship] and use valuable time before the two V/L's passed less than a cable apart!'

Extreme care is required when crossing a TSS. The red ship has positioned herself close to the separation zone to minimise any crossing risk with the other ships in her own lane, and correctly lines up at 90 degrees to the general direction of traffic flow. We do not have details of other shipping. However the effect of her turn is to place her nearly head on with the reporters. The closing speed is 35 knots. The range closes rapidly. The blue ship's bridge team only notice the situation at the last minute, and then uses up valuable time on VHF radio with every chance of more, not less, confusion being created; the red ship was also very slow to react. Factors here may include overload on the bridges of both ships causing failure to appreciate the head on situation, and the choice by the red ship of the location for her crossing turn (for example if in the vicinity of a busy ferry route); this choice is at least a major, often the major decision when crossing a TSS.

Passage planning and thinking ahead. It is wise to plan a crossing manoeuvre where there is no reason to expect a higher than average number of other crossing vessels (for example at a known ferry crossing point). A good method is to identify a 'crossing window', marked on the chart in advance, within which the crossing should be conducted.

Execution. When preparing to cross a TSS, think well ahead. Assess traffic in the lanes, and choose – if you can – a moment to cross where a gap is likely to open or where you are unlikely to create crossing situations with more than one ship at a time. **Throughout use the Mark 1 eyeball**, combined with compass assessments of bearing movement if

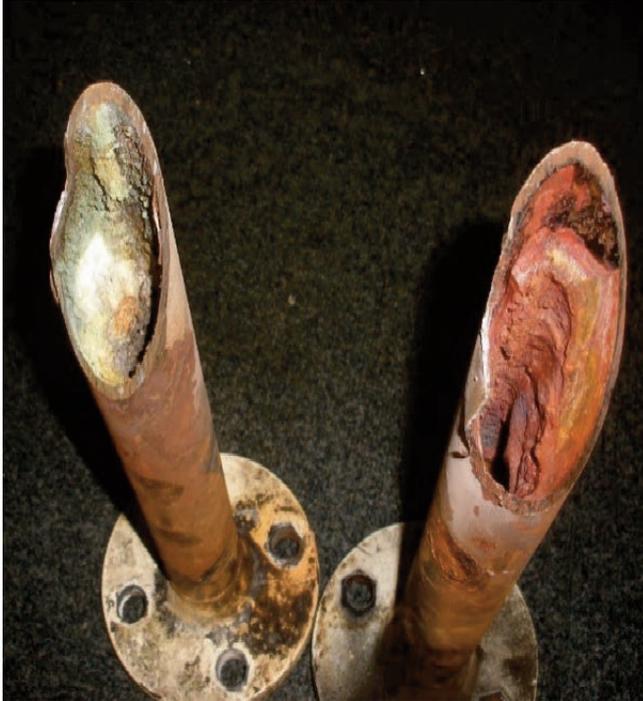
In the course of work to fit exhaust gas scrubbers in a large ferry, pipes serving the exhaust gas heater fire suppressant system had to be cut; pipes/nozzles were found to be nearly blocked and thinned. This would have prevented the system from working as designed in event of fire. The cause was probably leakage past isolation valves allowing seawater to enter the 'supply lines'. Salt then crystallized in the heat. The comprehensive report outlines remedial action.

Extracts from the information passed to CHIRP. 'Given the condition of the pipes and nozzles – had we had a fire in the exhaust gas heaters, it would have been very unlikely that the fire suppression system would have had any effect. The reason for the blocking of the nozzles is that it is suspected that the isolating valves on the fire main have been leaking past, allowing sea water to fill the supply lines and when reaching the hot environs of the exhaust gas heaters, the water has rapidly evaporated, leaving a build up of hard salts in the nozzles.

Heavily obstructed pipes – Ferry Fire Suppression System

We are proposing some modifications to the fire suppression system: The nozzles and pipe-work will be like for like, but with a different routing to allow easier access for inspection in the future. Pipes and nozzles will be galvanised. New valves will be fitted to the fire main at the branch off of the supply lines. The original valves are 'globe' valves, we intend to change these for stainless steel ball valves.

Immediately after the isolating ball valves, we will fit stub pipes with a further ball valve fitted on each line. This valve will serve two purposes:

- (1) to check for any water leaking past the isolating valves and
- (2) to connect an air hose and blow air up through the supply lines and nozzles to prove clear. This will be put into the Planned Maintenance System as a routine (probably monthly) job. These ball valves will have plugs fitted in the outlets at all times when not in use. The valves will be fitted with clear signage as to their purpose.
