Editorial

REPORTS ...

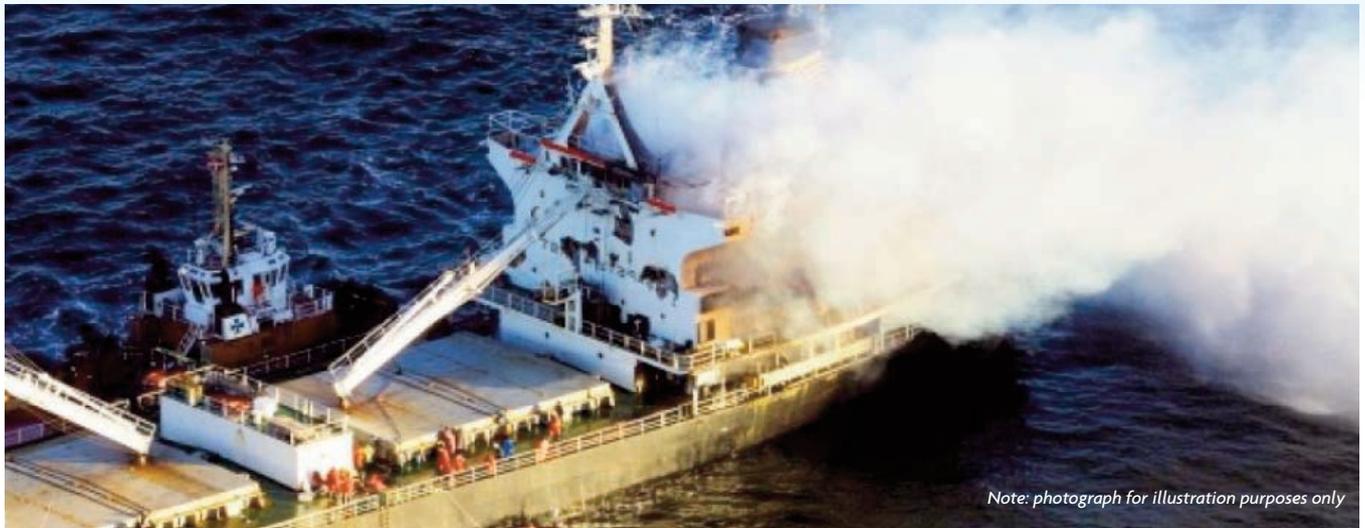
During welding operations, a fire broke out on the outside of a ship's superstructure. Within two minutes the entire after side of the superstructure

was on fire. Contributing factors are reported to have been the dozen layers of paint found to have been applied, and flammable components between the paint layers arising from allowance of inadequate time between the paint applications.

The welding was conducted on the outside of the superstructure on a deck panel. Sparks dropped into a pile of rubbish which ignited; the fire quickly spread. There was no fire watch set by either ship's staff or the repair yard. An attempt to extinguish the fire with a 'high pressure cleaner' did not work; the fire was later successfully put out.

Of particular interest is the speed and spread of the fire, apparently caused by trapped flammable products igniting within the multiple paint layers. Several of the layers were presumably not recently applied, but all or some must have retained combustible products.

Take hot work seriously. It should never happen without the ship's (and, if appropriate, the yard's) leadership and management knowing about and owning the activity and associated precautions. **Never treat it as routine.** Follow a **comprehensive check-off list** every time, based on the UKCOSWP 2015 or equivalent guidance. **Authorise and supervise** the work properly, know what is flammable, remember **adjacent compartments, remove everything flammable** before work, be alert to the **properties of paints** in the vicinity, and ensure **repeated follow-up checks**.

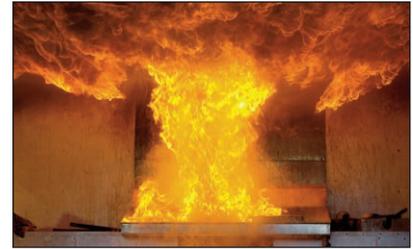
A casserole containing oil was left unattended in the oven or on the range; oil leaked through small holes at the side.

This case is a classic near-miss. Fire did not break out, but it could easily have done so.

In this case an unattended leaking casserole represented a long term hazard, indicating a poor sense of hygiene and awareness of risk.

Maintain **particular vigilance in galleys**, and invariably include them in rounds routines by day and night.

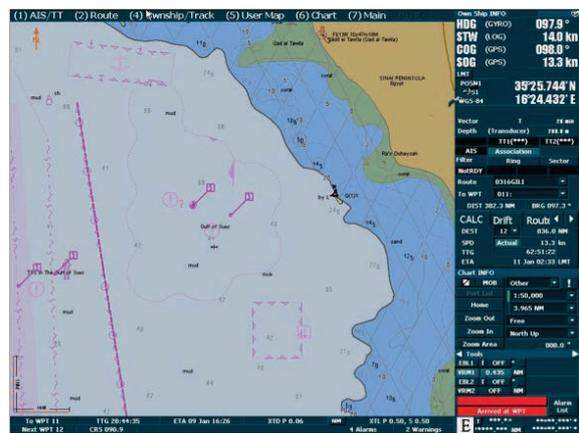
One supplier’s chart

During preparation of a passage plan for a forthcoming voyage, it was observed that one chart did not show all the information that had been seen when passing through the Suez Canal previously. There emerged considerable confusion on the source, date and identity of the right chart within the ship’s system. Space prevents detailed coverage. Eventually the correct electronic chart was identified by the ship’s provider, and supplied.

CHIRP suggests that **training, familiarisation and practice** are crucial. Take time to **read and understand instructions and advice** (see some of the sources listed above). **Know your equipment.** ECDIS displays don't necessarily have to have a GPS input; they can be used exactly as paper charts have been, if necessary. **The principles of safe navigation haven't changed;** just the means by which some of our information is displayed. **Don't trust automated displays, without a healthy instinct to cross-check.** Remember the age old, gilt-edged, adage: **"use all sources, and double check everything". Keep on top of your configuration control.**
