Editorial

CHIRP MARITIME

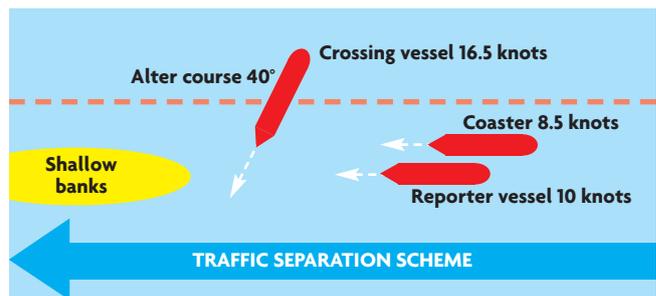
Own vessel was proceeding in a lane of a Traffic Separation Scheme that was in close vicinity to a bank. A ferry was observed leaving Port A bound for Port B. Initially the closest position of approach (CPA) was 1.5 mile astern of me. At a range of about 4 miles he altered course 40 degrees to starboard, resulting in a CPA and bow crossing range of 0.2 miles. By the time the range was 3 miles, no attempt had been made to call me by VHF radio to advise his intentions. I called to ask for clarification of his intentions and was told he had altered course 40 degrees to starboard and wanted to pass ahead of me and that I was the give way vessel. I advised him that I could not alter to starboard as I was overtaking a small coaster doing about 8.5 knots and just 6 cables away on my starboard quarter; with no room to pass on the other side of the ferry due to the proximity of other vessels and transiting at a relatively slow speed.

He told me that I was the give way vessel, which is absolutely correct, and that I should slow down to let him pass ahead of me. This was at a range of 3 miles and he had made it into a close quarters situation by altering to starboard in the first place. Fortunately we were proceeding at slow speed around 10 knots and I was able to slow our ship down fairly quickly to allow a CPA and bow crossing range of 1mile.

The reporter said, "Expect the unexpected!" This was an ill-advised manoeuvre at very close range, creating a close quarters situation when it was totally unnecessary. If he had maintained his initial course then a close quarters situation would have been avoided. This is a passenger ferry making a very dangerous and late manoeuvre.

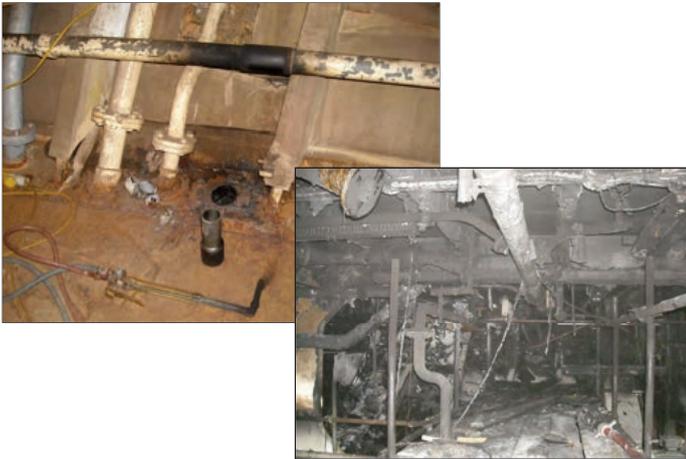
Further to the latest report in Maritime FEEDBACK 44, a reporter has shared with us an investigation into an incident several years ago, in which a spark from burning equipment landed on pipework lagging and the paint on top of that lagging caught fire. The lagging had been stripped to an extent but had not been stripped completely. The build-up of paint on the deckhead covering the insulation is believed to be the main accelerant to the fire spreading across the space. This was subsequently confirmed in a separate test that created a similar situation.

Prior to the incident the pipe fitter supervisor had checked the area and shown the two pipe fitters the work and location that they had to complete the task. A burner and firewatcher were called in order to assist with the penetrations. The firewatcher signed out a 'damping' extinguisher in order to dampen the area directly below any penetrations, which were pop marked to show the

exact location. He used this equipment for damping down all three penetrations. The Permit to work was followed and the local area cleared before work started.

The fire watch in the compartment below noticed black smoke and used the extinguisher in the vicinity of the smoke but the fire spread rapidly overhead. Consequently the fire alarm was sounded and the ship was evacuated.

What started out as routine work soon became a major fire – the message for all is, plan for the unexpected! The use of a fire blanket to cordon off areas where sparks can ignite adjacent areas is also a prudent precaution to take.

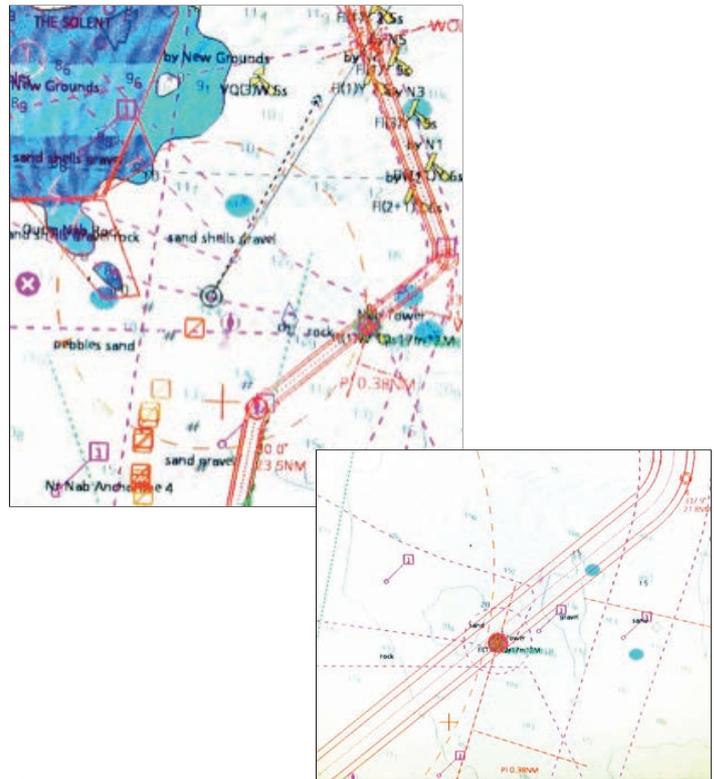
When the pilot boarded the 200 metres long crude oil carrier, which was inward bound into the Eastern Solent waters, he was more than a little surprised that the passage plan approved by the Master (and clear to see on ECDIS) showed the course passing directly over the Nab Tower, which is clearly marked on the chart.

There was an apparent failure of the Safety Management System and its implementation on board. Every passage plan should be checked, agreed by the master and then signed off by all of the navigation officers. In this case this clearly did not happen.

This is a good example of why some ports have compulsory pilotage and shows the benefits of agreeing the passage plan between the pilot and the master.
