CHIRP FEEDBACK

Issue No: 6

A Maritime Safety Newsletter

from **CHIRP** the Confidential Hazardous Incident Reporting Programme

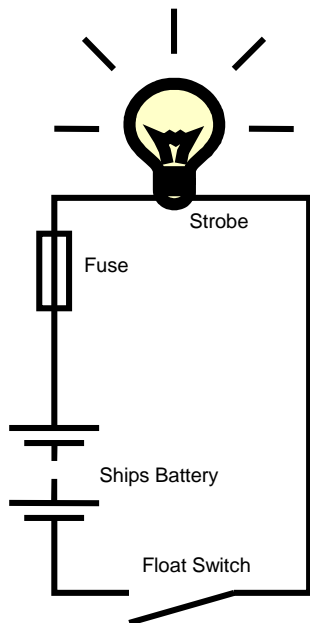
Report Text: A trawler recently changed hands and a high level alarm conforming to the attached schematic was ordered to be fitted before the vessel sailed.

The new owner agreed and put the job in hand, but unfortunately the vessel sprang a leak whilst alongside the quay and flooded the engine room causing considerable damage before the installation was completed. The leak was caused by localised corrosion where pig iron ballast was in contact with the hull.

CHIRP Comment: Flooding that goes undetected regularly leads to loss of the vessel with serious risk to life. The schematic below is referred to in the report and intended as a secondary alarm, directly wiring the ship's batteries to a strobe on the wheelhouse deck-head via a float switch.

Simple and cheap for any size of vessel; below shaft level, high enough to test easily and less likely to generate annoying false alarms, but allowing adequate time to sort out most problems and always on; even in port.

It is a common sense solution, but also the law; the 15-24m Code states that ships must have either an independent secondary alarm or a "fail safe" primary system.
