MARITIME SAFETY

Where the fault really lies

Why aren't the frequent flag state investigations into lifeboat and rescue boat accidents leading to a significant fall in seafarer deaths and injuries? **Capt JOHN ROSE** of the Confidential Human Incident Reporting Programme (CHIRP) thinks he knows the answer...

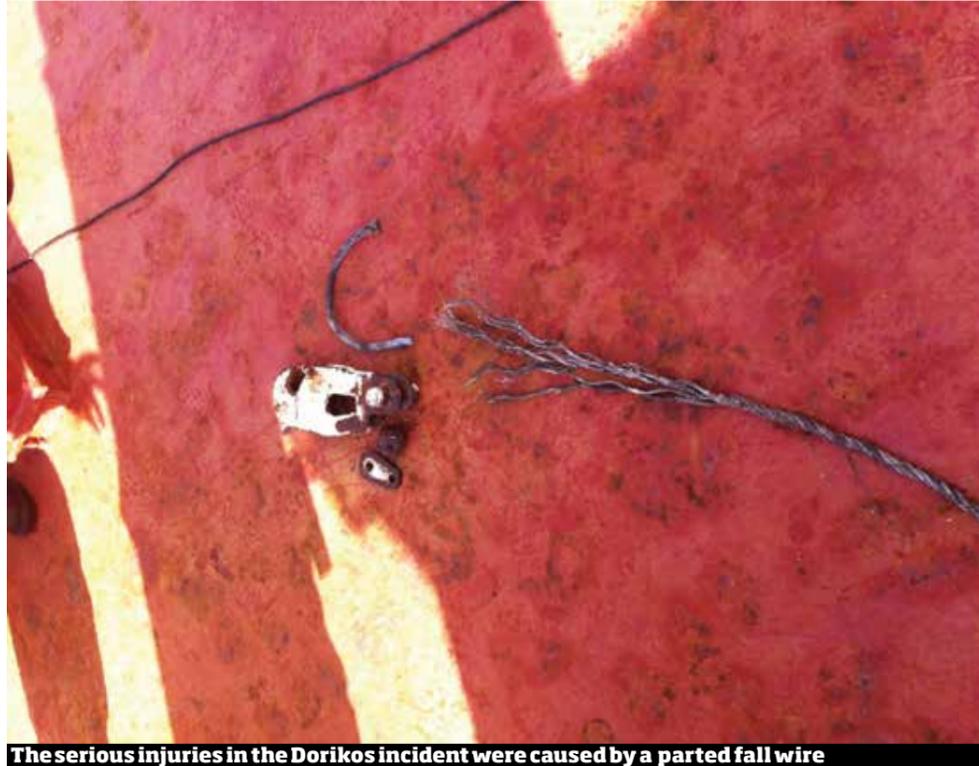
The galvanised wire rope onboard Dorikos was only seven months old, but it had been

incorrectly assembled within the housing of the hook. This caused the wire to bend sharply at two locations, resulting in mechanical damage to the wire surface at the bending positions.

The serious injuries in the Dorikos incident were caused by a parted fall wire

In the Dorikos report there is no consideration of the fact that the root cause was in the design of the equipment. The method to change out the wire was not 'fail safe'. Once again, when offering advice, the regulators have not looked beyond the ship's rail. Be warned: this tragedy could so easily happen on another ship, as a piece of paper on the Dorikos will not help other vessels with similar equipment onboard.

same error happening in a similar fashion on another ship. Therefore, I suggest that any supplier of equipment should ensure the manufacturer's design makes full allowance for the competence and capability of the seafarer, rather than requiring the crew member to be trained to operate it. A poor design encourages mistakes that no amount of training or management intervention can completely mitigate.

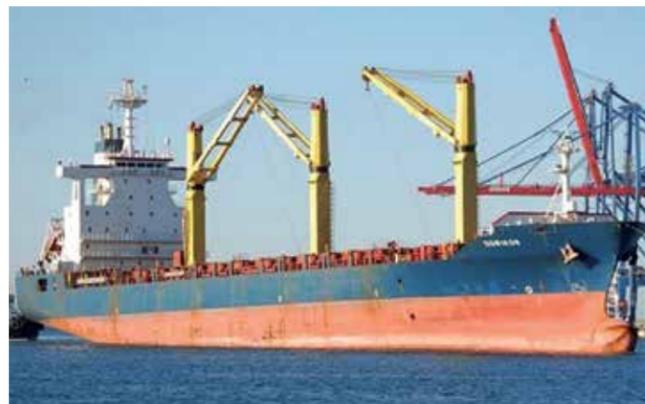
During a routine drill to launch the rescue boat onboard the container-ship Dorikos, with three crew members inside the boat, the fall wire parted — causing the boat and crew members to fall 7m into the sea. All three crew were badly injured, so it was with interest that I awaited the publication of the report by the Cypriot flag state authority.

The Cyprus-flagged containership Dorikos, where three crew members were badly injured during a rescue boat drill
