Editorial

Reports

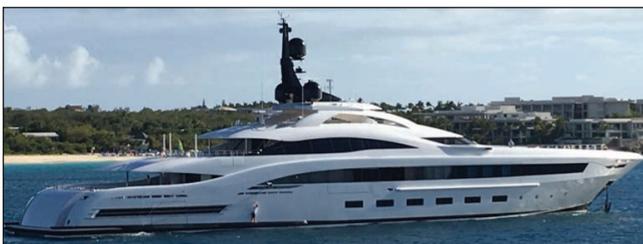
A crew member was seen on the starboard side standing on a ledge just above the waterline with no lifejacket or safety harness visible; he was hanging on to a single line from above. He balanced there for some time, before jumping into the sea and swimming up to the bow. He then climbed onto the anchor. The foredeck crew then continued raising the anchor whilst the man was busily working to clear the fouled rope.

Once he had cleared the anchor, he jumped back into the sea, drifting back down the starboard side of the yacht which was underway at slow speed. He was then recovered on board; the vessel departed.

Note man on starboard quarter platform

The hazards are clear. A particularly serious one is entanglement in the fouled line while the man was attempting to clear it from the anchor to which he himself was clinging. It is not obvious whether the line was under tension or whether it was light or heavy. However a sudden increase or release in tension could have had the man trapped under water or potentially towed astern near the propellers. The vessel was operating propulsion at the time. It is not clear whether the man on the anchor was continuously supervised or not. He certainly should have been; it is very unlikely that he was visible from the bridge. He was not wearing a life jacket and did not have a lifeline/harness other than the line onto which it is reported he was hanging. These are severe safety lapses.

Maintain professional standards; this depends on **safety culture** which itself in turn depends on the lead given by the Master and officers. Carry out a **risk assessment** and briefing before taking action in unusual circumstances; these may be short and crisp if need be, provided they are considered and conducted against a check-list (see above). **Guard against cutting corners** when the atmosphere is relaxed. **Remember key safety principles:** for example the wearing of life jackets always in exposed places, life lines, provision of a safety boat and supervision of risky work. **Remember ubiquitous risks at sea:** for example lines under tension, drowning.

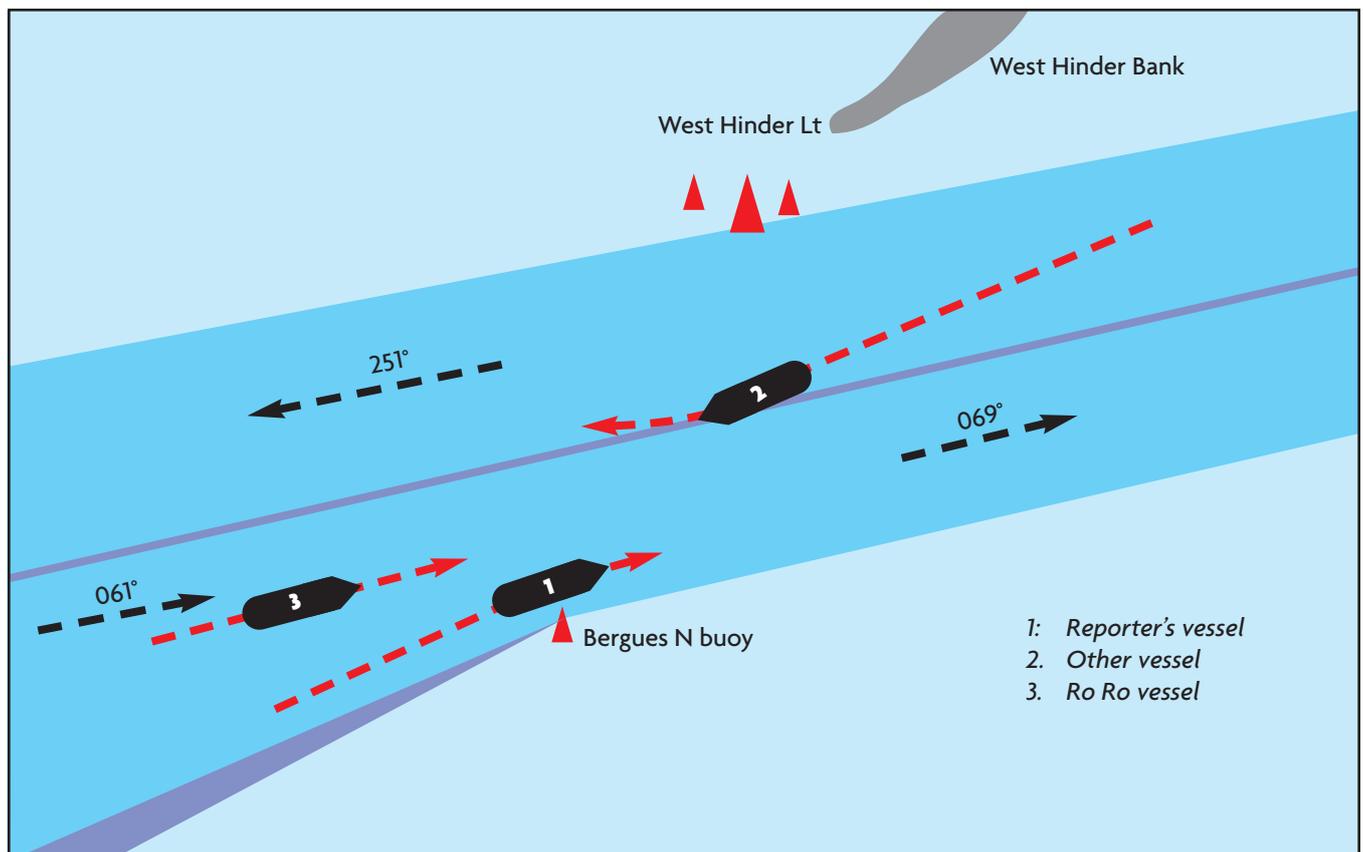
At approaches to Westhinder, ship 2 in the sketch was observed in the SW lane off Westhinder light tower. Own vessel was proceeding in the opposite direction in NE lane, passing close to Bergues North buoy, being overtaken by a ro-ro ship (ship 3 in the sketch) on port quarter. [ship 2] was then observed turning slowly to port and crossing the dividing line into the NE lane with a CPA of 3 cables to own vessel and collision course with [ship 3 in the reporter’s sketch]. I called on VHF 60, no answer ... eventually [place] approach contacted ship 2 on VHF16 asking what were his intentions and that VHF 60 must be monitored ... which then occurred, with [ship 2] turning back to starboard on the extreme edge of the separation scheme.

The reporter offered the view that ship 2 was not keeping a proper lookout, was not monitoring her position, and was in contravention of rule 10 (TSSs). She also failed to respond on the VTS channel for that sector and placed own vessel and another in a potentially dangerous situation. He noted that the standard of English was poor in VHF communication, that he (the reporter) was tightly constrained to starboard by the Bergues North buoy, and that visibility was good.

A highly dangerous situation arose; had ship 2 progressed any further before her alteration back to starboard into the south west lane, she would have been at very close quarters with ship 3, and quite possibly in collision. We see again how quickly such a situation can develop, especially in dense shipping and constrained waters. The danger is further exacerbated when the constriction of a TSS brings – in this case – three large vessels into close proximity with almost no sea room to spare: the “sandwich effect”.

Other COLREGS. She also failed to take ‘positive action in ample time’, and was probably failing to keep a proper lookout. These failures may well have been exacerbated by overload, tiredness, distraction, undermanning, and/or failure to look up and out. Obviating these risks must be part of the passage planning process and supervision at the time.

Overtaking in a highly constrained part of a TSS or approaching a corner can be dangerous and reduces options. In this case the reporter’s ship had no room to starboard as she approached the Bergues North buoy. Look and think ahead.

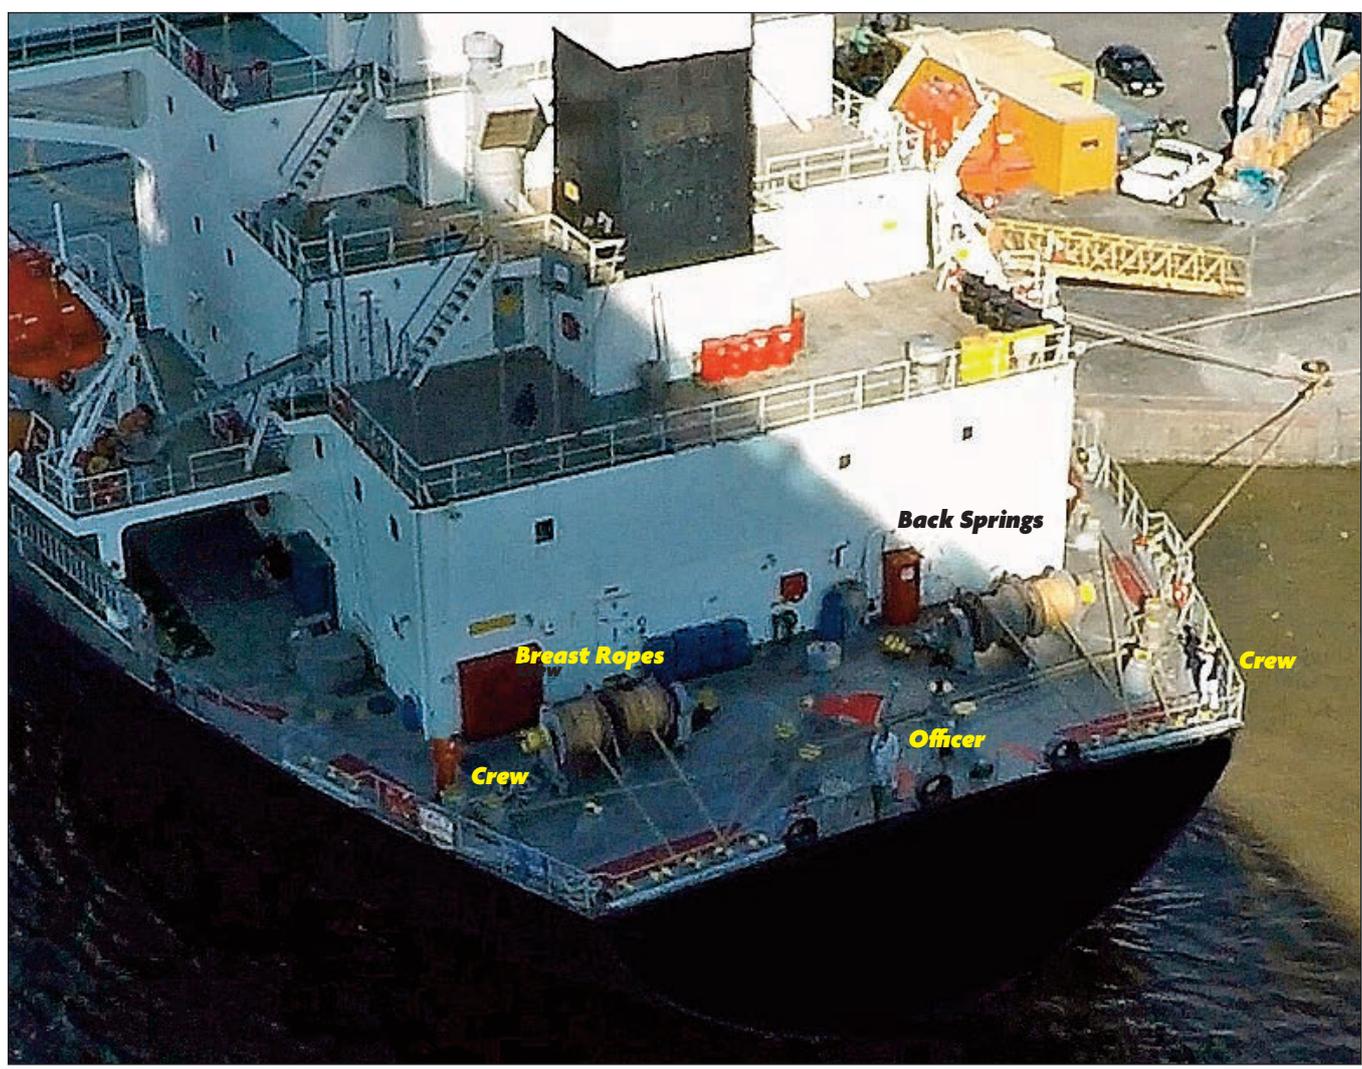
The moored vessel does not fit the berth since stern lines cannot be run and the back spring and breast lines have poor leads. This led to excessive strain being placed on the lines as the departing passenger vessels wake interacted with the moored vessel.

The design of the ship’s after mooring station appears poor; mooring lines may be at greater risk of parting due to the angled leads and the need to use roller leads across the deck. In this case the mooring bollards have not been employed.

There is an apparent lack of general awareness; the officer and crew members had placed themselves within the after mooring ropes snap back zone at a time when the mooring lines were likely to come under surge load.

This is a good example of an inappropriate berth in relation to the size of vessel; it could have been refused. Ships’ mooring arrangements are designed for conventional long leads forward and aft. The use of stern (and probably head) lines in reverse direction as shown greatly increases the stress on mooring arrangements, and encourages premature failure with obvious safety implications. In this case the passenger ship’s manoeuvres at very close quarters may – through interaction and surge - have amplified the danger of mooring failure.

The whole mooring deck in this case is a “snap back zone” especially in such a confined area with multiple unconventional leads. Consideration may be given to identifying and marking alternative “tension spots”. These carefully considered relatively safe points for mooring parties to stand and operate will limit exposure to snap back and discipline crew to remain in sheltered areas to the maximum extent possible. Mooring lines may be subject to surge at any time; **roaming and unauthorised movement on working decks should be forbidden**. Roaming ‘safe areas’ may well not be safe all of the time; snap back zones will vary according to leads and circumstances. For further information see Maritime FEEDBACK number 39, page 2; Code of Safe Working Practices for Merchant Seamen (COSWP) section 26.6; and the article on this subject published in the November 2015 edition of the ‘Safety at Sea’ magazine.

Safe “tension spots”, training and mooring discipline represent a safer way forward in mooring practice.

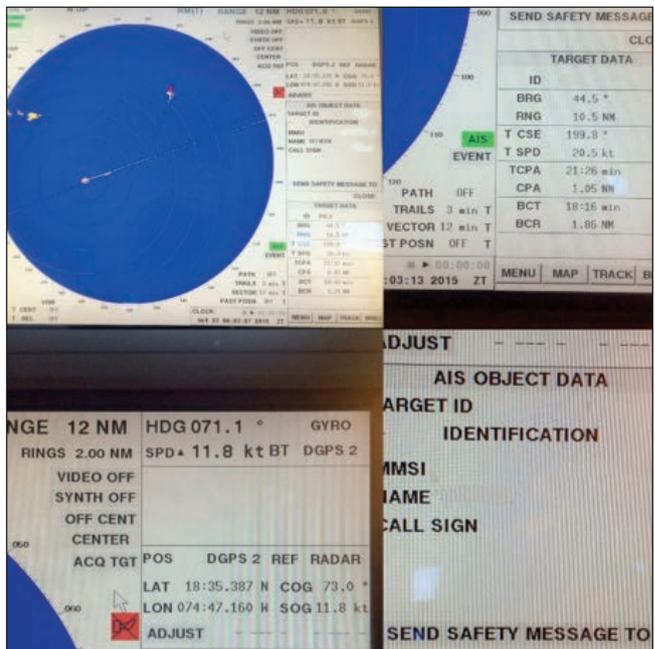
The reporter considered that the passenger ship’s crossing ahead distance (around 2 nautical miles (nm)) and CPA (around 1 nautical mile) were too small; this is shown on the automatic radar plotting aid (ARPA) screen shot below. It depicts true vectors in this case.

ARPA screen shot; true vectors

“If there is doubt, a risk of collision exists”. Thus it is incumbent on a ‘give-way’ vessel (and also a matter of good manners) in a crossing situation to alter if the stand-on vessel expresses concern. **Doubt is always accompanied by danger and risk of miscalculation.** Avoid use of VHF if possible; it can be a distraction from the correct actions when time is tight. Think from the point of view of the other ship; what may seem safe and reasonable to one may not from the other’s bridge. **Maintain the habit of constant ‘what-ifing’:** “what if my steering gear failed now”?
