Editorial

The hazards of Pilot boarding

Throughout 2016, the International Maritime Pilots' Association (IMPA) held a safety campaign focused upon the standard of pilot ladders and associated equipment. **CHIRP** supported this campaign and received many reports on the subject, several of which are highlighted below.

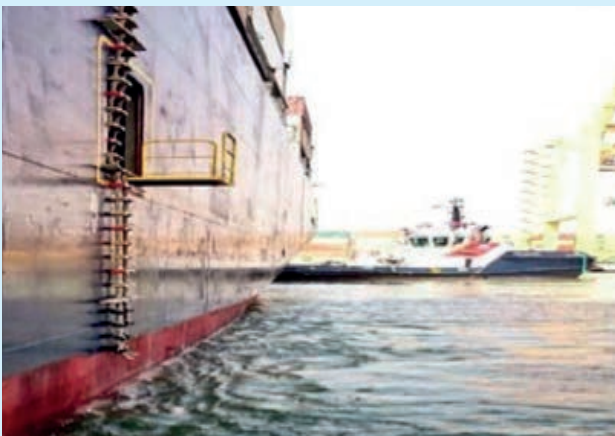
This vessel, like her sister ships, has a pilot boarding point located too far aft. Access is by means of a side door with a platform and pilot ladder. The position of the access point becomes dangerous at shallow drafts because it is directly over a non-parallel hull area on the aft quarter (see photograph below). This is particularly dangerous because it affects the safe performance of the pilot boat, especially in a swell, bad weather, or when the vessel is turning. Furthermore, the platform used in the arrangement also makes it dangerous at deeper drafts because its height is less than 5 metres above the water line. The danger is greater when the ladder is rigged FORWARD of the platform.

Retractable platform access – looking aft

We have therefore concentrated on improving the existing arrangement to ensure maximum safety for pilots and pilot boats and have issued instructions concerning the embarkation/disembarkation of pilots.

- the embarkation platform is foldable and is in fact used or not used in close collaboration between the vessel and pilot boat depending on the individual situation; the vessels use a table that shows the clearance of the pilot door and platform from the water line in relation to the vessel's draught, which allows the Master to inform the pilot boat precisely about the clearance available and eliminates "guestimates";
- in cases where the embarkation platform is folded away and not used, an additional removable handhold stanchion was fabricated and is used to allow the pilot a safe transfer from the ladder into the ship (see photograph below);
- vessels were instructed to carefully plan the pilot transfer in close collaboration with the pilot boat and not to alter course during pilot transfer or while the pilot boat is alongside the vessel;

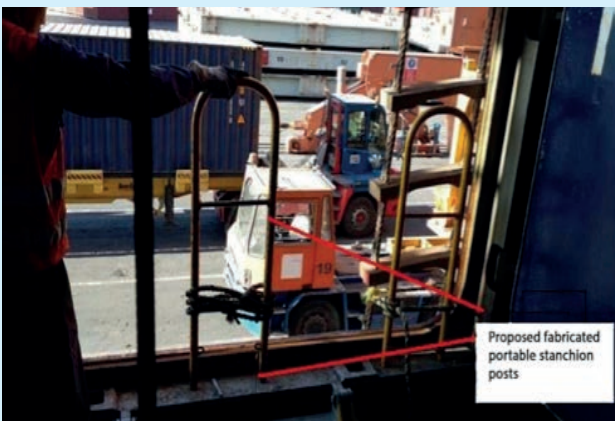
Proposed modification and fabrication by the third party

The Maritime Advisory Board commented upon the quality of the report and the response from the managers, which point to an active learning environment regarding these new builds. The Board agreed that structural modifications were unrealistic (although it was noted that some existing vessels were not constructed in line with the original pilot boarding regulations which included the “mid half length” parallel body requirement), and specifically noted that regarding modifications some quality control would be necessary for the additional handhold stanchion. This should involve the modification being inspected and certified by Class to ensure that it is safe to use.

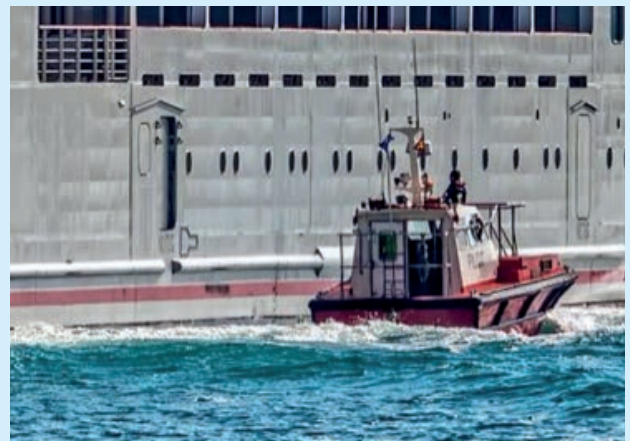
Due to her recent construction (2015) one might think safety features would be carefully addressed, but a raised belt along her side makes the usually hazardous pilot transfer operation even more dangerous. As far as I know "IMPA Required Arrangements for Pilot" demand at least 6 metres of unobstructed ship side at the pilot access point, yet on this ship there is a gap in the belt no longer than 1.5 metres. In cases of swell and/or bad weather the belt can significantly affect the pilot boat performance and increase the risk. This is a design issue.

CHIRP made several attempts to contact the third party ship manager, who declined to respond. The Maritime Advisory Board agreed that the boarding arrangements were non-compliant to the latest SOLAS amendments. They noted that the 6 metres clearance was designed to give a pilot boat sufficient scope to come alongside and drop back. In this case the pilot boat could easily ride up under the "belt" in inclement weather conditions, and since there is no flexibility for movement of the pilot ladder, this creates a very hazardous condition.

A new build passenger vessel with non-compliant SOLAS boarding arrangements

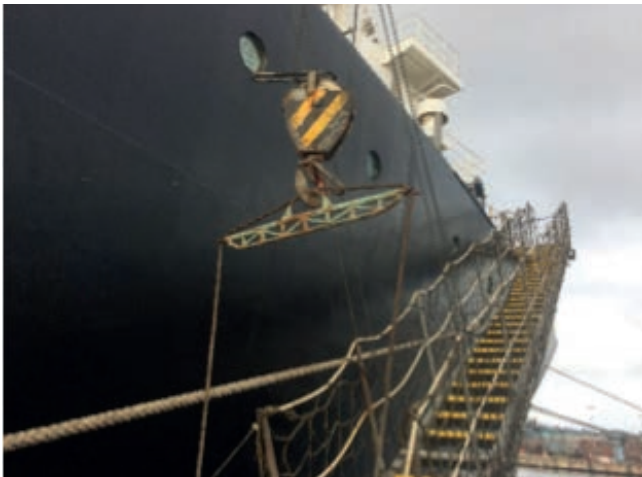
The gangway was suspended by a davit with a spreader that appeared to be a made using an onboard appliance. The shackle attaching the wire to the gangway was not in a straight line during the lift, so I requested the gangway be landed and the load taken off the wire before embarking.

Root Cause – Ships provision crane was using a ‘jury rigged’ lifting spreader in conjunction with the normal accommodation ladder winch arrangement.

As part of the counter-measures, we have similarly cautioned the ship’s crew against using the crew-made spreader which is not type-approved and told them to always ensure the safety of personnel boarding the ship using the ship’s gangway.

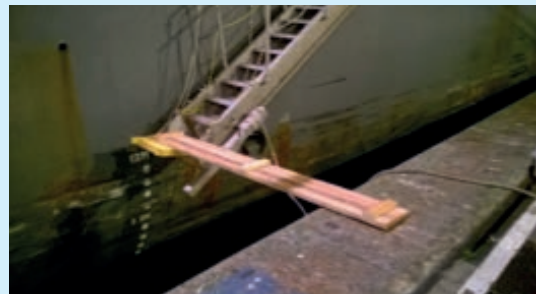
Safe means of access?
