## Editorial

## REPORTS ...

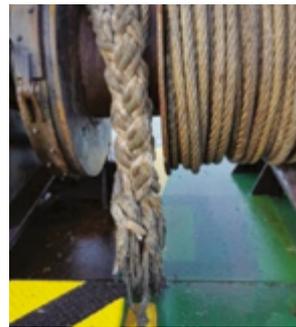
Parted mooring tail following recovery of mooring line

- According to the vessel's report the parted mooring tail had been in service for 12 months with 798 working hours, and was in very good condition. The minimum breaking load (MBL) was 146T.
- All related machinery and equipment was in good operational condition, and tested successfully prior to departure.
- A risk assessment had been completed and the hazards and risk control measures relating to the mooring and unmooring operations had been addressed.
- The pilot instructed the tug to pull without informing the Master or the bridge team.
- The pilot instructed the tug skippers to start pulling although the spring lines had not been slacked or released.
- This action was not noticed by the Master or OOW immediately.
- At the time of the incident the wind was reported as SW Force 2.
- No damage was caused to the vessel or terminal facilities. No injury occurred.

It was concluded that the incident was caused due to improper instructions from the pilot to the tug skippers, inadequate monitoring of pilot orders by the vessel's Master and OOW, and inadequate communication procedures between the pilot and the bridge team.

Having discussed these reports, the Maritime Advisory Board recommends the use of best and now common practice whereby only the use of tugs lines is permitted – a system utilised in the vast majority of ports. The Board emphasised that handling lines with tugs involves risk which can be mitigated with proper planning

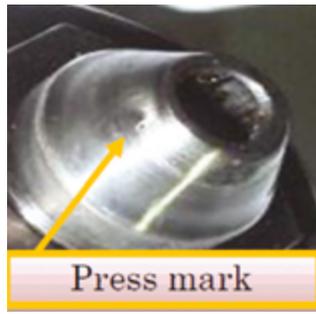
**Case 1:** While the vessel was underway, a slight fuel oil leak was observed at the connection between No.6 cylinder fuel oil pump of the main engine and its high pressure pipe. Immediately, the vessel stopped her main engine and replaced the high pressure pipe. Upon investigation, it was found that the coupling nut had become loose. The cause of this incident was inappropriate torque management of the coupling nut.

**Case 2:** Whilst underway, the crew discovered a fuel oil leak between No.8 unit fuel oil high pressure pipe connection of the main engine and the injection control unit. The vessel stopped her main engine and replaced the fuel oil high pressure pipe. On further investigation, the sealing surface of the removed fuel oil high pressure pipe showed slight press marks.

To help eradicate fuel oil leaks from the main engine fuel oil high pressure pipes, the following key actions for fitting and unfitting the fuel oil high pressure pipes should be followed:

- Close Inspection: seating surface/screw parts of the pipe at both ends and their mating parts should be inspected and cleaned carefully. For close inspection, the fuel oil high pressure pipe should be removed completely when it is dismantled for maintenance, such as during fuel valve replacement, etc.
- Proper reconditioning: if any damage to the seat surface is observed, the relevant seat surface is to be ground by the special tool on board. Also, the lapping special tool must NOT be deformed or damaged.
- Proper tightening: the fuel oil high pressure pipe should be tightened to the proper torque in accordance with the manufacturer's instructions.

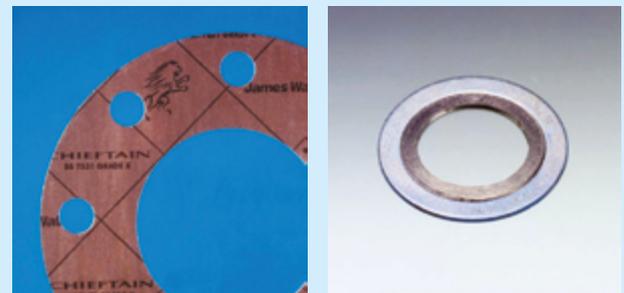
Investigating the cause of the defect, it was found that the leakage occurred due to the poor condition of a gasket, which was replaced with a spare. The damaged gasket was found to be of the ordinary type and not the spiral high temperature gasket which is used for high temperature piping systems. The investigation also noted that the last visual inspection of the system was conducted the evening before, in accordance with the UMS check list, and no problems were identified. Following the incident, a thorough inspection of the piping system was carried out. No defects or leaks were identified and the piping was found in good condition. It was concluded that inadequate inventory management of the vessel's spare parts was a potential factor, and there was improper planning during the fitting of the original gasket. It was highlighted that:

A standard gasket and spiral ring gasket

Having discussed the reports, the Maritime Advisory Board agreed that fuel oil systems are high risk, and that particular attention should be paid during maintenance. The correct identification of gaskets is essential for high pressure/temperature systems. The Board also stressed the need for careful oversight during maintenance or repairs. When a defect regarding an incorrect type of gasket/joint being fitted has been identified at one location in the high temperature pipework, it would be a good risk control measure to open up the remaining similar joints in the pipework, to ensure that correct spiral-wound gaskets/joints have been fitted.

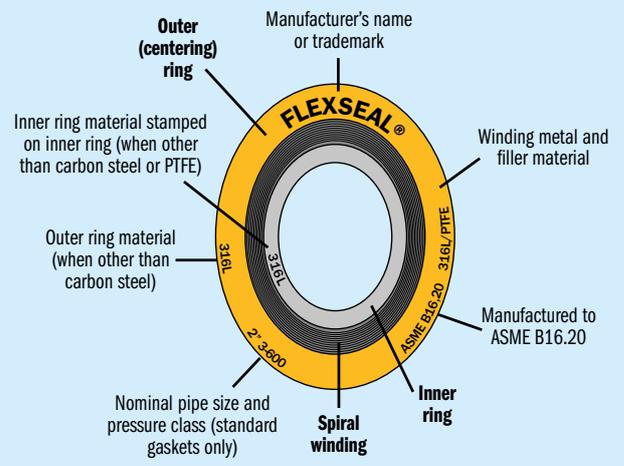
Schematic of a typical spiral wound gasket.

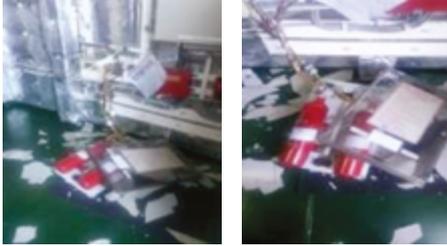
room, the crew observed that the cabinet of the CO2 pilot bottles was lying on the floor damaged, and its wall mounting had completely failed.

Damage to CO2 remote release cabinet

- The vessel reported that inspections and tests of the CO2 fixed system were carried out regularly. Damage to the support brackets for the cabinet had not been noted during inspections.
- The cabinet was constructed of plastic. It was concluded that the incident was caused due to wear and tear of the wall mountings of the CO2 pilot cabinet box.
- All fleet vessels were instructed to thoroughly inspect their remote CO2 cabinets and revert with findings.

This incident could have resulted in multiple casualties if the pilot bottles have been triggered when the control box failed. How secure is your remote release cabinet? Do not let the something like this happen to you. For CO2 system manufacturers – is your cabinet robust enough to withstand the vibrations experienced on a vessel?

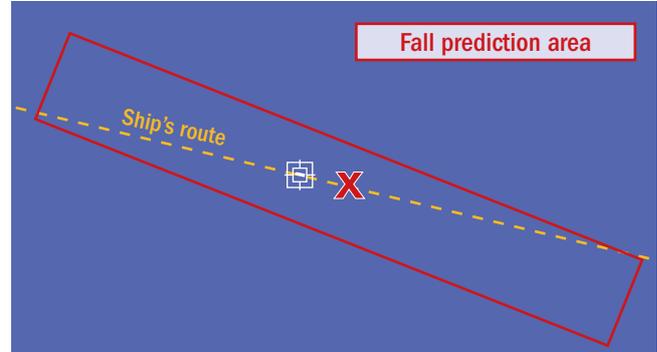
A NAVAREA message about the launching of a rocket, including the area at risk from falling debris, was issued by a national coast guard. However, the Master and duty officer overlooked it and did not plot the risk area on the chart or ECDIS. The vessel entered a hazardous area with considerable risk to the ship's safety, resulting in a serious near miss in which the vessel came close to being hit by falling debris from the booster rocket.

Schematic showing ships track and fall prediction area of rocket debris

Regarding lessons learned, the company advised that in order to avoid any re-occurrence, bridge teams should have the following processes in place for navigation warnings:
