LIFEBOAT INCIDENTS – A REVIEW OF ISSUES

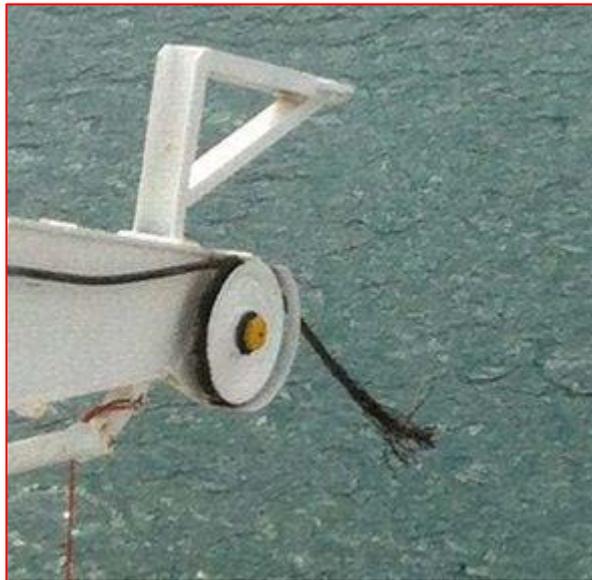
Typical wire failure in way of the davit head / sheave – Picture courtesy BBC News/J. McArthur

Any seafarer who has end-for-ended wire rope falls will be aware that the ropes, when removed from the davits, are usually deformed in way of the sharp turns of the sheaves and do not return to straightened alignment. If a material deforms and does not return to its original shape it has passed its elastic limit and moved into plastic deformation. This is normally taken as the beginning of fatigue and precedes the cracking of surfaces referred to in laboratory reports on samples from failed wire ropes.

- Consider a maximum life span of a galvanised steel wire rope at sea to be limited to two years. Date of fitting, due date of disposal and three month reordering notices are much easier to track and assist in establishing a reliable maintenance regime. Examination of incidents suggests that corrosion failures occur on wire which has been in service longer than two years. Corrosion failures are therefore preventable. Also consider that the actual cost of galvanised steel wire rope is often significantly less than anticipated. This is especially so with an owner's advanced central ordering at known predictable order dates, where access to competitive suppliers and low-cost sea freight to the ship are easily managed.

- Ensure the length of the wire ordered has sufficient spare length so that annual cropping of one metre of length is possible. Lifeboat falls need sufficient length for the lifeboat to be lowered to the water in the ship's lightest condition with adverse heel of 20 degrees and also still retain at least a minimum of three safe turns on the drum - and preferably much more. If there are plenty of spare turns on the drum at the longest lowering position, then there is room to crop.

- By cropping one metre off the end of the wire at the drum end on an annual basis the points of wear and highest corrosion around sheaves and saddles will move. The opened lay (over or around turns where corrosion first starts deep in the lay), closes back up and is then more resistant to the elements. It is these opened lays in difficult to inspect locations where the corrosion is fatal. Periodic inspection of the adjusted wire may not be effective because the lay has then closed and buried the corrosion within. The older the wire, the more this is hidden from view during every inspection.

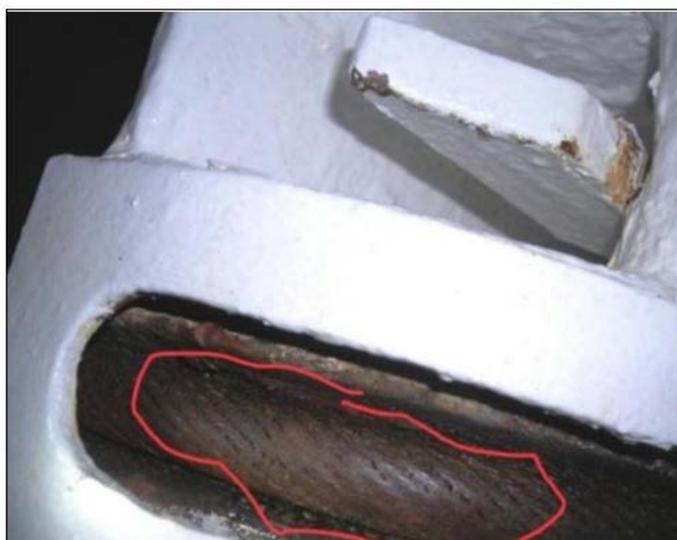
Wires often fail at a position around a sheave. They would have been straightened only on those occasions when the boat was lowered. Bending would cause the strands on the outside of the bend to open and expose the inner surfaces to the elements. Unless effectively coated by grease, these surfaces would have relied on their galvanised coating alone to protect them from the corrosive influences of the marine environment. The galvanised surfaces, if deficient in lubricant, would wear and potentially break down. Furthermore, the position, within the throat of the fall block, could be difficult to reach to apply grease effectively. Sensitivities regarding pollution and cleanliness, combined with a desire to limit exposure of seafarers to dangers when working at height, would serve to discourage regular greasing.

Deformed wire strands opening up around a sheave – (Picture courtesy Malta MSIU Report 05/2014 – Figure 19)

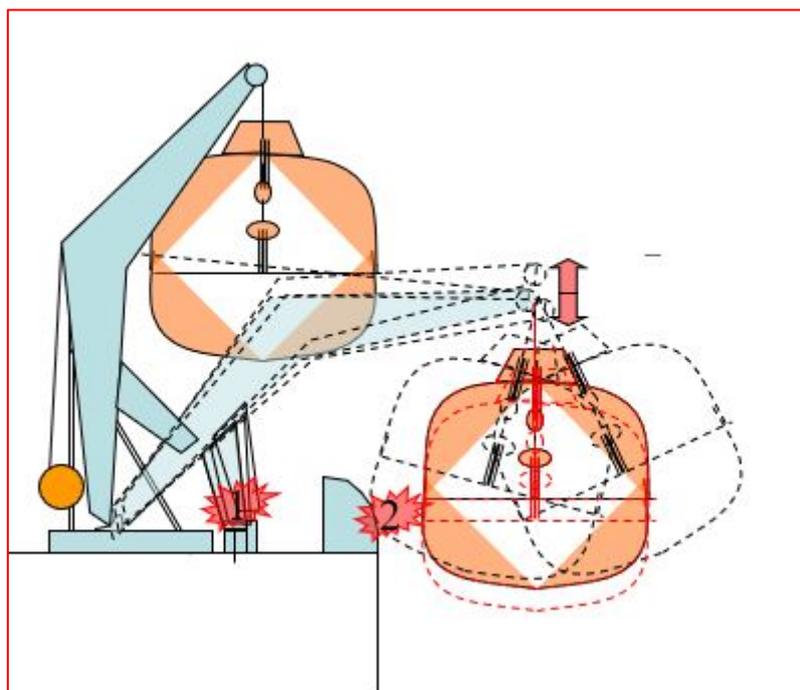
Wire falls failures may also occur when the davits touch the stands on the main deck during lowering. This initial swing-out phase has a tendency to induce extreme oscillations in the boat if the operation is not conducted continuously. Manufacturers often recommend that the brake is lifted completely clear in order to avoid interim braking that causes the oscillation. The only braking that may occur during this phase therefore is applied by the centrifugal brake, which is designed to limit the rate at which the boat descends to the water. On the initial swing-out this brake will not engage until the full descent rate has been achieved, which in turn means that the davits will contact the deck chocks at full lowering descent rate, or a speed close to it. This in turn imposes a sudden impact as the function of the fall wire is transferred from luffing the davit to lowering the boat. One investigation of deformed lifting rings measured the dynamic shock load on a gravity davit and boat system with an accelerometer. It was found that negative acceleration was able to reach in excess of 1.3g at this stage of the lowering operation, i.e. the weight of the boat more than doubled momentarily. Seafarers may instinctively anticipate this impact and try to cushion its effect by applying the brake early. Whilst this action may alleviate the impact it is also likely to intensify oscillation of the boat and, with it, impacts of the boat on the side of the vessel. It has even been known for a fall block to disconnect from the davit horn when this extreme oscillation occurs. Freeing of the fall block in this way can then cause luffing-in of the davit arm from which it has been freed if the latter is not fully located in its outboard position.

Swingout impacts – (Picture courtesy D. Barber)

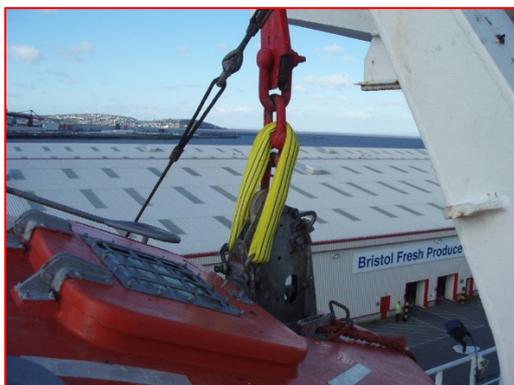
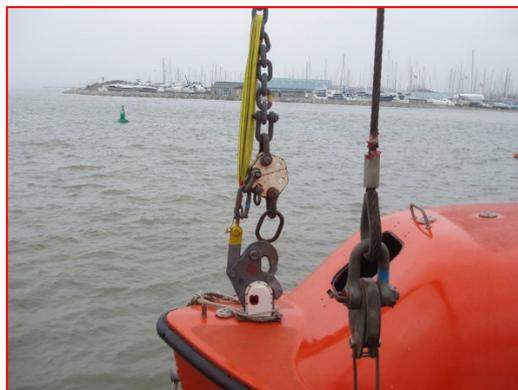
Two examples of Freefall Preventer Devices – (Photo's courtesy D. Barber [MCA/BMA])

It is noted that most failures occur during recovery of boats and it is generally accepted that incorrect re-setting of hooks is a common cause of such failures. Seafarers will know that even in the smallest of dock waves it is difficult and often hazardous to effect such resets and reconnection to the falls. It is therefore imperative that FPDs are attached before the hoist continues from a safe distance just above the water. Once safely stowed all hooks can be checked for correct re-setting. Even if the new pattern of hooks are fitted, masters may feel that it is still safer to incorporate the back-up of the FPDs. It is still possible to re-set even the new designs incorrectly and the in-water position is far from the ideal environment to effect this important operation. It should be remembered that the lifeboat is primarily designed for escape but during drills the recovery is an additional activity that is not covered in detail in SOLAS regulations. It is for the master to operate the system effectively and safely. He/she has the responsibility. He/she also has the authority to enforce any additional measures considered necessary at the scene. Whilst it may be acceptable to reduce the connection of the lifeboat to a single action of disconnection in an emergency, this level of exposure to risk would normally be considered unacceptable, even reckless, in routine operations. Even though the possibility of inadvertent opening is supposedly reduced in the new pattern hooks, why rely on the single connection? The pair of hooks jointly make up a single suspension system; they cannot support the boat in individual isolation. A second level of safety is provided by FPDs, but providing an alternative load path or pins or similar method of securing the release mechanism closed would be a wise precaution during drills, especially for recovery - which is a routine, not emergency, operation.

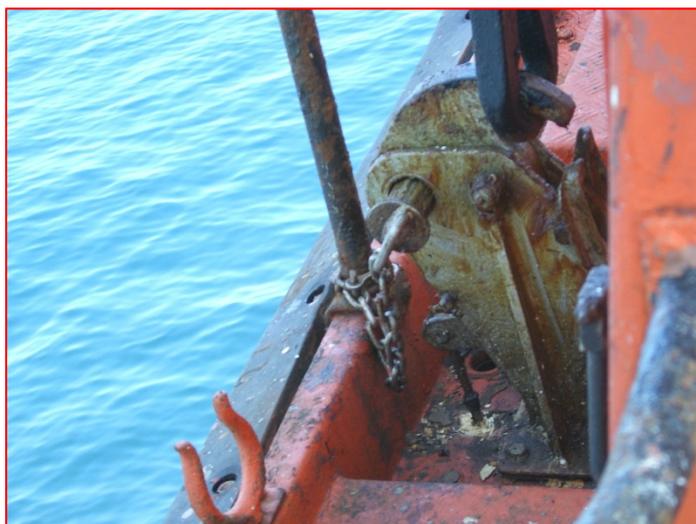
Another type of preventer is the pin type that locks on-load hooks closed – (Photo courtesy D. Barber)
