Editorial

Combination ladder issues

Rudder angle discrepancies

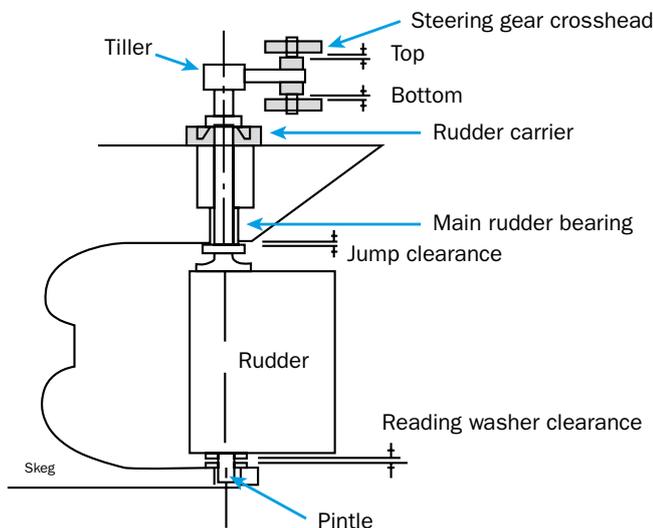
Inspection of the steering gear, rudder stock and the rudder blade were carried out in dry dock. Damage was noted as follows;

- *Securing bolts for the guide bar bearing of the steering gear were found to be broken and the guide bar was found to be 20mm out of alignment.*
- *Cracks were found in the port side hydraulic cylinder ram, several foundation bolts were loose, and the ram was found to be slightly out of alignment.*
- *Several port side steering gear cylinder ram foundation bolts were loose.*
- *The upper rudder stock keyway was found to be slightly deformed, there was an offset of 25mm between the*

upper and lower bearings of the upper rudder stock when compared with the true centre line.

- A twist of the keyway amounting to approximately nine degrees was found between the upper and lower keyway when comparing this with the original centre line.

Typical Ship's Steering Gear, Rudder Stock and Rudder

The Class report additionally gives full details of the repair that was carried out which included a thorough overhaul of the rudder carrier, repairs to the hydraulic rams and the steering gear foundations, heat treatment and straightening of the rudder stock, and machining out the deformations. The tiller keyway and carrier to the rudder stock were renewed. All of the work was carried out as per Class technical specifications.

The repairs were followed by magnetic particle testing, penetrant testing and ultrasonic testing of welding and machined repairs.

Upon completion of the repairs the rudder blade was given a swing test, and the steering gear with associated alarms were fully tested with satisfactory results. In addition, the attending surveyor witnessed sea trials of the steering gear whilst manoeuvring and these also were satisfactory.

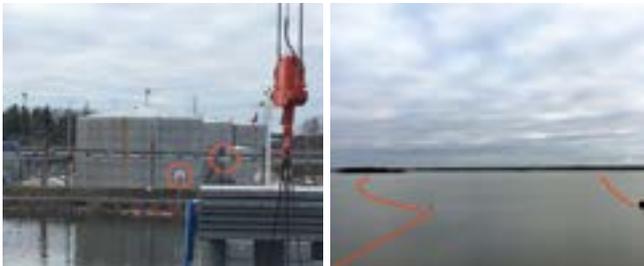
There are two problems with this berth. The main leading line is mostly useless because the upper light is obstructed by a pipeline. According to a pilot, this issue was reported to the authorities six years ago, but it still has not been rectified. Another problem is the position of one of the buoys. The location of this buoy makes for a challenging approach in a strong northerly or southerly wind. I have already experienced several close encounters with this buoy and it is not helped that the buoy is unlit. Re-positioning of the buoy would help a lot. (See pictures below).

Leading lights obscured by a pipeline, and a view of the approach to the berth – looking west.

- Approach to the berth is difficult in some conditions.
- The position of one (unlit) buoy is not logical given the layout of the berth.
- Obstructed navigational aid has not been recognized and corrected, thus making navigation dangerous.

As a general comment, there is always the option of reporting inaccurately charted navigational aids to the Hydrographic Office. In the case of British Admiralty Charts, the process is described in the link below and can be used by all mariners to report any updated information they may have. In addition, further information may be found in *The Mariners Handbook – Chapter 8 (NP100)*

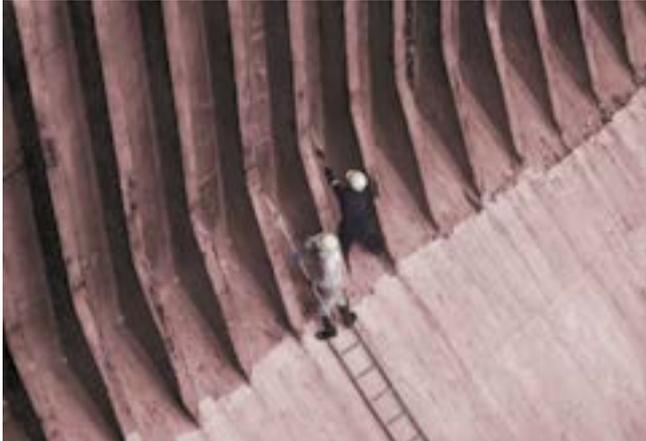
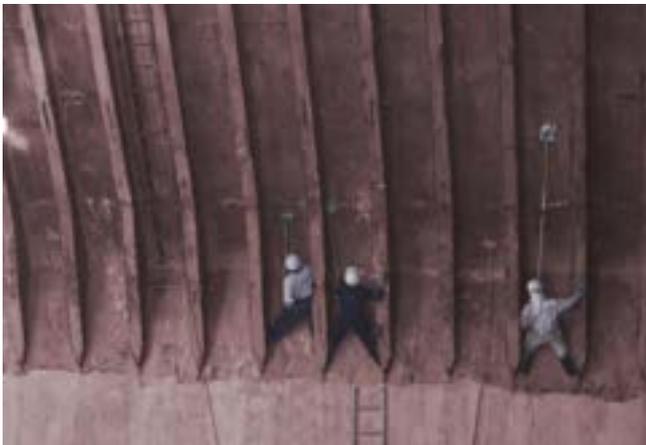
Ladder not secured and crew in a precarious location with a risk of falling

CHIRP highlights that notwithstanding the poor standard of safety employed by the vessel's management and the lack of basic safety protection to do the job, the most common requirement for cleanliness when loading grain in bulk carriers is termed "grain clean". This involves fresh water washing and the removal of all of the previous cargo residues. The hold must be free of any infestation and any loose paint flakes removed, and the hold must be odour free. In this particular case, with these practices being employed, there existed an inherent danger that the holds would not be odour free at all. Holds would generally be inspected prior to loading grain and any failure of the inspection would mean time off hire until any deficiency was rectified.

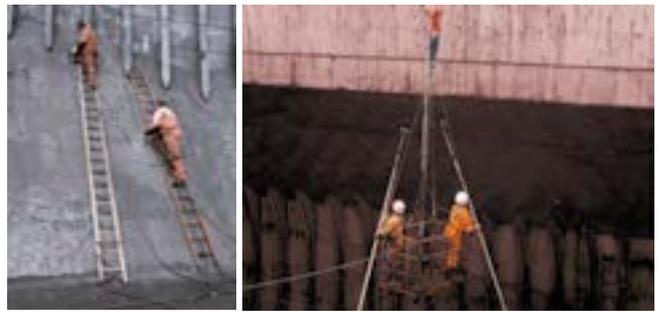
A vessel reported unsafe working conditions whilst engaged in rust removal and painting of the cargo holds from the hatch coaming to the tank top. This involved using the ship's crane with a cage, or sometimes a bosun's chair, suspended from the crane.

Unsafe work practices and crane riding

Whilst some of the work practices regarding unsecured equipment bear remarkable similarities to the previous report, CHIRP highlights the picture where crew members are riding in a cage painting the upper sections of the hold. Any crane and associated equipment used for the transfer of personnel should be designated as "man-riding" for that purpose, and in general this means that a crane must be fitted with a failsafe brake. It should also be Class approved for use in transferring personnel. In the above example, the crane is almost certainly not designated for this purpose.
