Editorial

Pilot door design

OUTLINE: Further to the article in MFB 48 concerning a vessel that was not constructed in compliance with SOLAS V 23, a second similar report has been received.

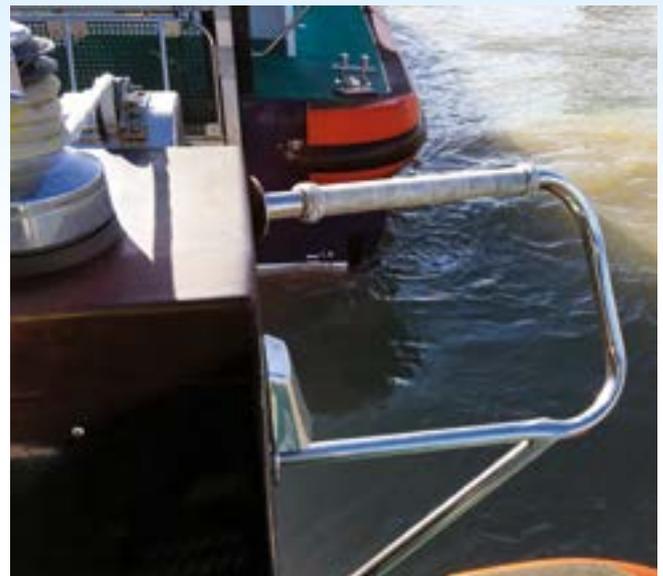
This report concerns a new build vessel on her maiden voyage. The pilot boarded at the agreed pilot boarding area. On this occasion, the pilot access was via a "cat flap" which was positioned within the aft quarter length of the vessel. The stern camber profile started about 5m from the ladder's position making it difficult for the pilot cutter to land properly and risking the cutter being sucked under the counter.

On the outward-bound passage of the same vessel, with a draft of 10.4m, the pilot cutter was damaged whilst trying to disembark two pilots via the cat flap. The cat flap disembarkation option was aborted and the vessel rigged a combination ladder from amidships from which the pilots were able to safely disembark.

Damage to pilot cutter

The actual root cause of this incident and the one previously reported lies both in regulation and the initial approval at the design stage, (whilst noting that the classification society at the design stage may not necessarily be the same one as when the vessel is brought into service).

temptation to use an alternative pilot door requiring less rigging, located in the aft quarter length of a ship in proximity to the propellers should not be an option. The danger to both the pilot cutter and pilot when such a location exists needs to be fully appreciated.

All of the vessel's other ladder equipment was observed to be in good order. The Owner should be informed of the difficulties this design caused, and pilot boarding arrangements reviewed before building any similar vessels.

It is essential that classification societies work in conjunction with shipyards to ensure not only compliance with the letter of regulations, but also within their spirit to avoid hazardous situations and potential loss of life. Flag states have a duty to ensure compliance with regulations either directly or by oversight of designated bodies, i.e. classification societies. Ship owners should also take an active interest in the vessels that they purchase so that they are fit for purpose and do not unnecessarily endanger life.

It is preferable to 'design out' rather than 'design in' a potential hazard resulting from an interpretation of imprecise wording in regulations, especially when the wording is intended for exceptional cases.

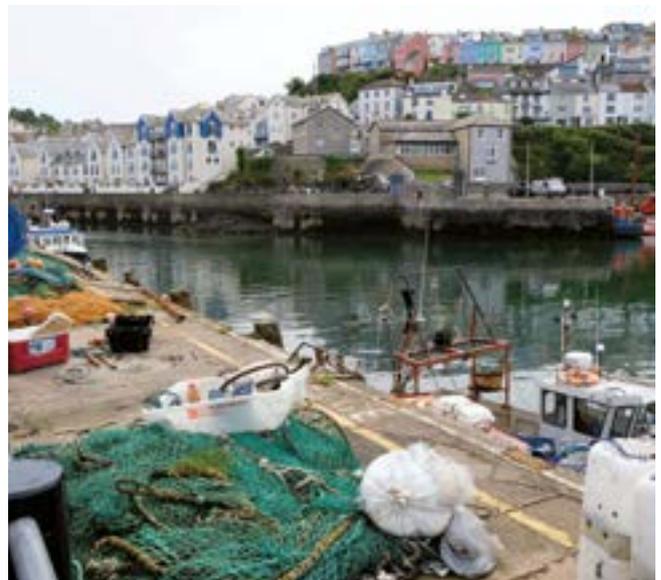
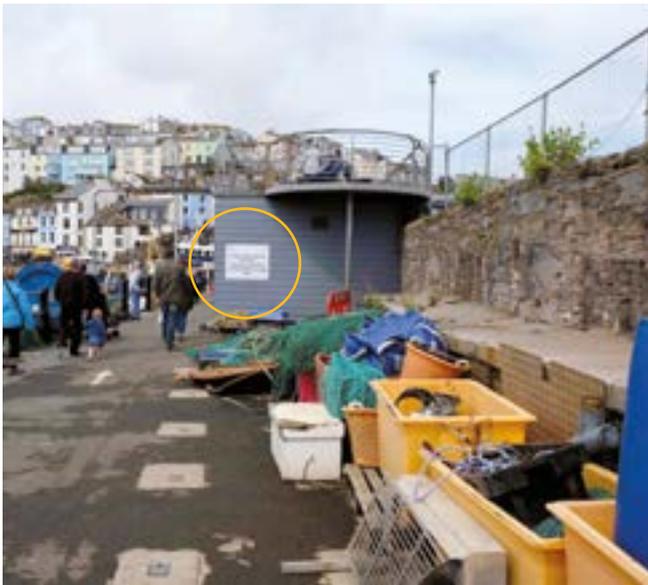
When walking from the ferry landing point, I was aware of the large amount of fishing equipment left discarded around the harbour. I attach photographs showing a mass of fishing equipment on both sides of the access route for passengers using the ferry.

The notice highlighted on the picture above states that fishing gear left here will be removed

The picture on page six shows a large amount of discarded / old equipment close to the dock edge and the access ladder for crew. Fishing gear is permitted to be stowed there but the manner in which it has been done in this case generates plenty of safety hazards. Fishing gear is not permitted to be stowed in the vicinity of the area shown in the the photograph above. The Harbour Authority notice was clearly not obeyed by fishermen or enforced by the Harbour Master.

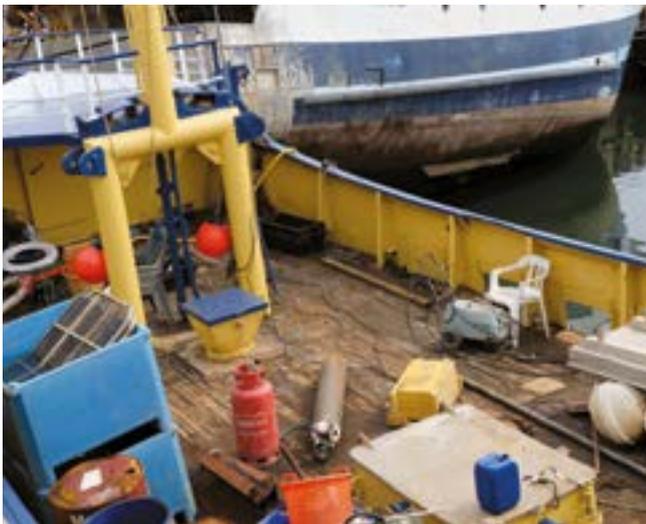
A fishing vessel under repair, shown below, had an LPG canister and what appears to be gas cutting equipment discarded on deck and not stowed safely. There were no crew members onboard.

Plenty of housekeeping hazards here – how many can you spot?

The large number of hazards can clearly be seen. Perhaps with **CHIRP**'s guidance and encouragement the port authority can be encouraged to improve their risk management and reduce the likelihood of injury to third parties using their facilities.
