MARITIME FEEDBACK

Issue 56
September 2019

An independent and confidential reporting system for the maritime industry

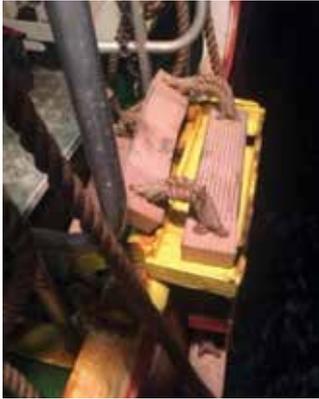
The weight of the pilot ladder was supported by a bracket into which the step fits. This resulted in the weight being taken by the whippings around the chocks directly above the wooden step. I explained the issue to the master and advised him that the weight should be supported by the side ropes. I went to the ladder after berthing and explained to the Chief Mate how ropes should be secured to the side-ropes to take the weight if the pilot boat puts additional weight on the ladder.

This class of vessel has a side door access. The ladder is rigged via slots in an angle bar bracket, thus putting the load on the step lashings rather than on the side ropes. By my reading of the rules and Witherby's Pilot Ladder Manual, this arrangement is not compliant.

Pilot ladder rigged via an illegal angle bar bracket rather than side rope lashings.

Thanks for bringing this to our attention. The observations are fully acknowledged. As per design the weight should be on the ladder ropes and not the whippings. We are working on rectifying actions with particular vessels in this series. Again, thanks for bringing this to our attention.

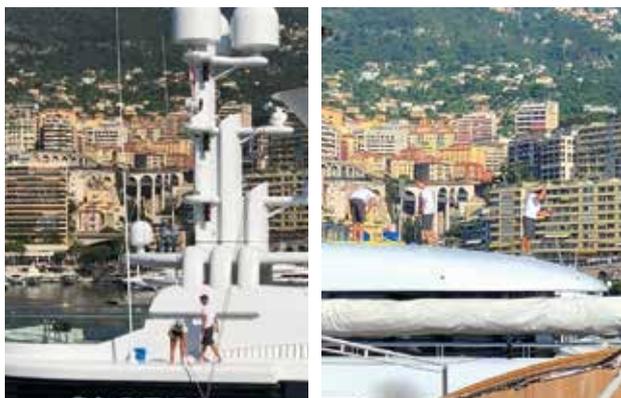
Recently I witnessed several deck personnel on the yacht on our port side working at height without any safety equipment. They were working at a considerable height above the waterline washing down with detergent, which in my opinion increased the risk of slipping and falling over the side. As you can see in the photos attached, certain crew

members were leaning over the side of the vessel trying to clean the superstructure.

The photos clearly demonstrate the lack of crew safety awareness and a poor on board safety culture.

The Maritime Advisory Board noted that this report highlights both human element and technical considerations. Too often naval architects and designers, when designing a vessel – in this case a luxury yacht – give scant consideration to the practicalities of everyday operations such as washing down or routine access for inspection purposes. Rounded or sloping housings and decks may be aesthetically pleasing but without suitable handrails, fishplates or securing points for safety harness carabiners or similar devices, are potentially lethal for crew members carrying out their everyday jobs. Long-handled brushes will only go so far to compensate for thoughtless design.

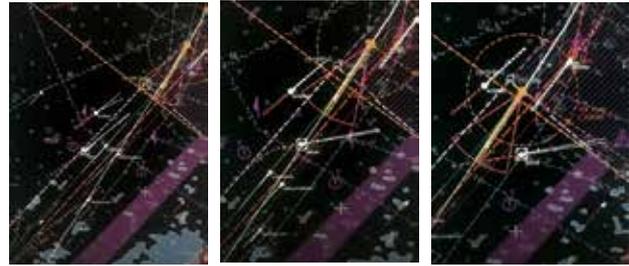
The contravening vessel was a 140m x 22m feeder container vessel and was a frequent trader on the Thames, Rotterdam and Kingston-upon-Hull route. It appeared to be taking a direct line between the Thames estuary and Rotter-

dam approaches. Such a course is contrary to the TSS and recommended routing.

Screen shots of the contravening vessel making no attempt to cross TSS lane at 90°

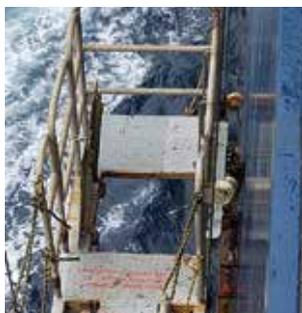
Upon boarding as a pilot, I noted that the man ropes were rigged incorrectly and that the pilot ladder was not attached to the ships side 1.5m above the accommodation ladder platform. The vessel has a trap door arrangement with the pilot ladder shackled under the platform, but this is non-compliant. As this vessel is likely to be regularly calling at this and other ports on the coast, the issue needs to be resolved as soon as possible to avoid future refusal of pilotage services and to remove the risk to pilots. Report dated 05th April.

The pilot ladder not attached to the ships side 1.5m above the accommodation ladder platform. Although I safely boarded the vessel using the starboard side ladder it was noted that the trap door arrangement was non-compliant. Report dated 1st July

Non-compliant combination boarding arrangement with the pilot ladder shackled to the underside of the accommodation ladder platform.
