MARITIME FEEDBACK

Issue 57
November 2019

An independent and confidential reporting system for the maritime industry

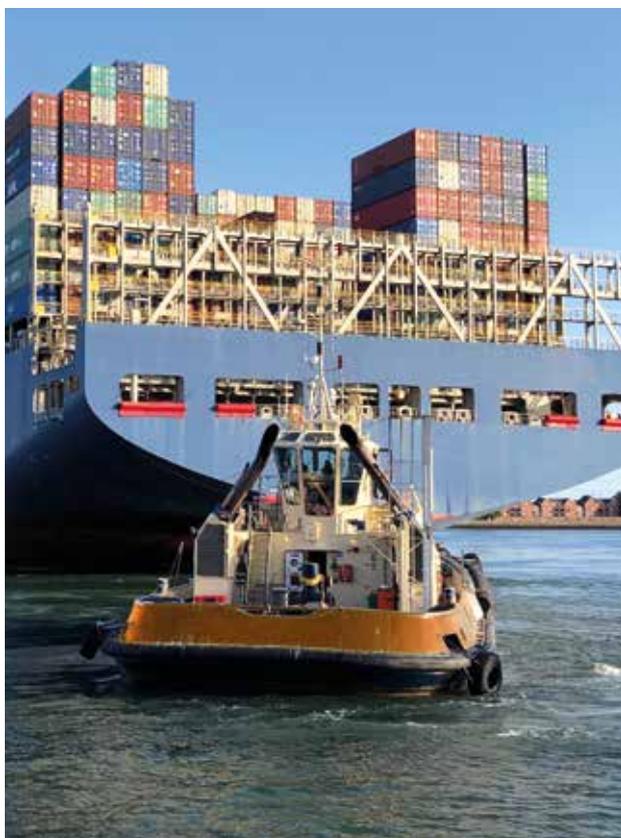
The photograph shows a tug engaged in towing operations assisting a large container vessel during departure. Despite many incidents in the towing industry where watertight integrity has been the cause of numerous accidents and deaths of tug crews, the crew of this tug failed to exercise proper controls to close and secure the watertight door to the accommodation.

A tug towing with an open watertight door – highlighting the risk of flooding.

CHIRP subsequently contacted the DPA who readily engaged with us and confirmed that the photograph did regrettably confirm the report, and that the aft accommodation watertight door may have been open without cause. This was indeed contrary to the company's safety procedures and industry best practice.

Tugs are particularly vulnerable to flooding through any watertight opening that might not properly be secured. This is due, in part, to the external forces being applied when towing. Obviously, anyone working in the engine room or below decks is at maximum risk in the event of flooding. **The inherent reserve buoyancy of a tug is based on all the watertight doors being closed.** Over-familiarity and complacency are insidious and are always waiting to catch the unwary.

The issue was subsequently raised locally for action and a safety flash was promulgated by the company reminding all tug personnel of the importance of maintaining watertight integrity.

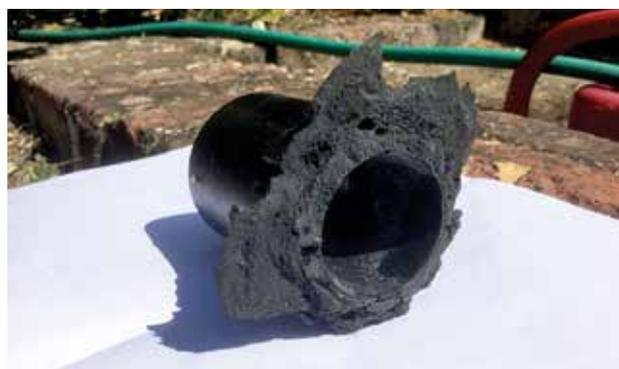
After leaving harbour the mainsail was being hoisted under normal load when the mast halyard winch sheared off its mounting. Closer examination of the winch identified that the centre stem casting had failed.

Photograph of failed casting

- leisure boat construction, including equipment and fittings, cannot be presumed to be as robust as commercial vessel construction. A deep-sea vessel built to Lloyd's classification will have each aspect of the construction inspected and signed off by a Lloyd's surveyor. Equally, all class machinery and equipment installed will be individually inspected and approved. In the case of leisure craft, many are self-certified by the manufacturers themselves. Much of the equipment is bought in, with the components being fabricated on a batch and line QA process – the components are then assembled during final installation of the craft.
- it was noted that the MCA are reviewing the current Leisure and Pleasure Boat Code.

Subsequently the reporter received a further e-mail from the manufacturer stating, "that although they have a very low failure rate of these winches, on this occasion as a gesture of good will they would send the reporter a new replacement centre stem". This was duly done.

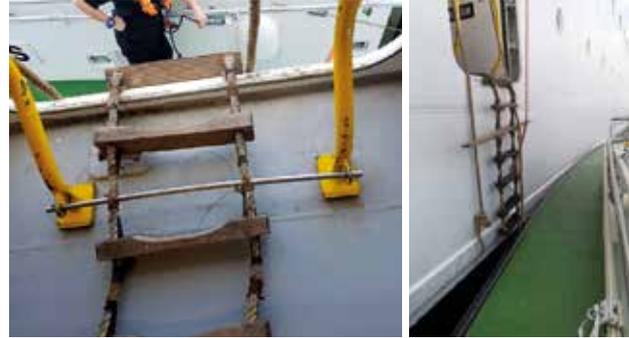
The pilot ladder presented for pilot disembarkation was not rigged in accordance with SOLAS regulations.

A metal bar had been placed between the ladder side ropes which relied solely on the whipping on the chocks to hold the weight of the ladder and the pilot. The side ropes were left on the deck and not secured to anything. I refused to use the arrangement and provided advice to the crew to correctly rig the ladder. There were strong points provided at the head of the side door where the manropes had been secured. In view that there were no other strong points provided, the pilot suggested that this would be a better securing point for the side ropes of the ladder. At first the crew informed me that they always rig the ladder in the presented manner, that it was safe and there were no issues with it. After some discussion the crew eventually re-rigged the ladder so that the weight of the ladder was carried through the side ropes in line with SOLAS regulations. The manropes provided were left with a large knot at termination which would prove a snagging issue to the pilot boat should it roll. There was also a pre-rigged orange line to a lifeboat/tender which impinged over the pilot ladder spreader bar, (photo below from pilot boat shows this). After disembarkation the pilot reported to the vessel via VHF that they should review their pilot ladder arrangements to ensure compliance with SOLAS regulations.

The crew showed no awareness of the SOLAS requirements for correctly rigging a pilot ladder. There was

Completely illegal and highly dangerous method of rigging a pilot ladder

The reporter confirmed he had also reported the matter to the port and national authorities. CHIRP in turn contacted the company who investigated the incident. This resulted in the DPA issuing a Company Circular Letter to the fleet entitled "Pilot Transfer Arrangements – "Safe Rigging of Pilot Ladders".

The Circular Letter also included an annex applicable for certain classes of vessels which illustrated modifications required to be carried out at the next available opportunity to allow those vessels to comply with the requirements of the circular letter and, more importantly, SOLAS and IMO requirements.

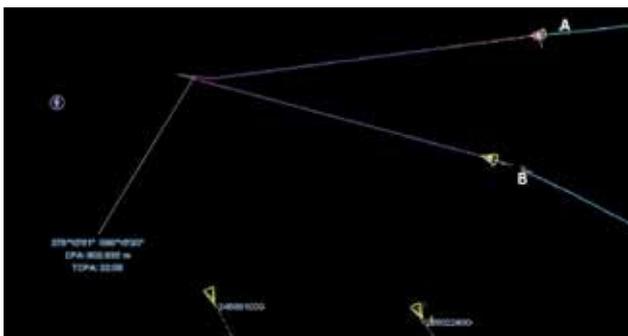
Both vessels had reported to the Vessel Traffic Service stating their intention and were listening on VHF Channel 12. As the TCPA approached ten minutes with a CPA of less than 0.25nm, I contacted vessel (B) on Channel 12 and asked his intention - he suggested that I alter course to port. I told him I would not be doing that and intended to halt the conversation there and abide by the regulations. Vessel (B) then questioned why I wouldn't alter to port and under which Rule, which concerned me slightly.

Screen dump image from the VTS recording – vessel names edited to A + B

- in the above report, vessel A acted under Rule 17(a) (ii) and complied with Rule 17(c)
- whatever the situation Colregs should work, even if a vessel fails to comply with a rule or misinterprets a situation.
