# MARITIME INSIGHT

First published: May 2020

## 2019 Analysis of Pilot Ladder Failings

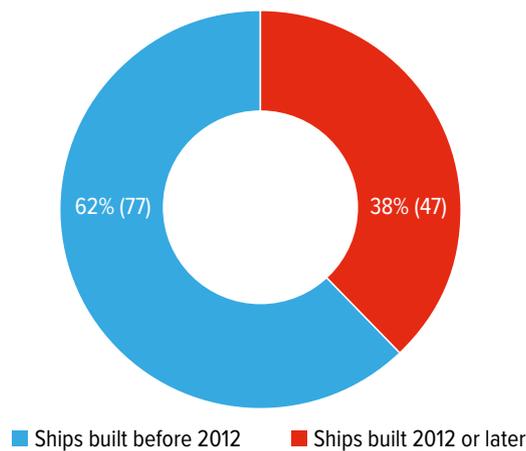
Figure 1 – Non-conforming ships by age.

It is perhaps no surprise that the greater number of non-conforming vessels were constructed prior to the advent of the current Regulations. Neither will there be any raised eyebrows with respect to the second chart – after all the larger sections of the pie chart are the larger ship registries. However, this is not the point. All vessels will have undergone a statutory five-year refit since the 2012 regulations came into force and have had ample opportunity to modify their arrangements in order to comply with SOLAS Chapter V. Yet this has not been done. *CHIRP* would query why this is so and refuses to accept that “We comply with pre-existing older regulations” is a satisfactory answer. The lives of maritime pilots are being endangered day in and day out, so it is incumbent upon shipping companies, classification societies, flag state administrations and indeed vessels’ crews to ensure that the arrangements are one hundred percent compliant.

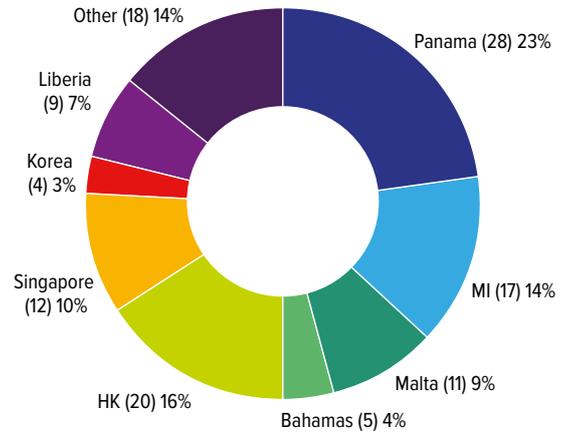
Figure 2 – Non-conforming ships by Flag State.

**Note:** “Other” consists of 12 Flag States with only 1 or 2 non-conformities

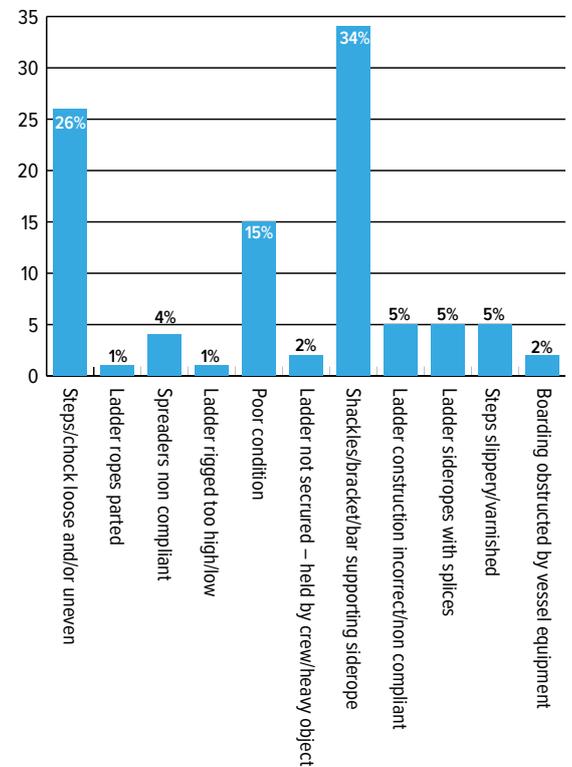
Figure 3 – Reports specific to pilot ladders.

The chart in Figure 3 shows deficiencies of pilot ladders, where a single ladder was utilised for pilot embarkation or disembarkation. *CHIRP* received 66 reports in this category, which detailed 99 specific deficiencies.

It is a damning indictment that 42% of the reports received highlight uneven steps, loose chocks, a ladder in poor condition or, in one case, the side ropes parting completely when weight was placed upon them prior to disembarkation. This

highlights a deficient safety culture and woefully poor quality of seamanship as well as indicating a complete disregard for the safety of the pilot who has to use the ladder. It should be noted that a small percentage of the uneven steps/chocks were in fact ladders that were relatively new and manufactured ashore. CHIRP is aware that in some cases this has been followed up by the port or national administration who have contacted the manufacturer(s) in question. The same applies to some of the pilot ladders which have been manufactured ashore and have arrived varnished.

Regarding the pie chart, one third of the reports highlight that side ropes are supported by shackles, a bar, or a bracket. SOLAS does not state how the side ropes are to be secured, but only mentions that the arrangement must be the same or greater strength than the side rope. Brackets or the equivalent may well be stronger than side ropes, but the load usually impacts upon the steps, seizings, or widgets. Thus, the weight of the ladder is now not supported by the side ropes and the arrangement becomes non-compliant. CHIRP notes that some classification societies and flag administrations have issued notifications that these arrangements are illegal on board their vessels.

A recurring theme in reports received is the lack of understanding as to how to properly rig a pilot ladder. Some pilots have reported to CHIRP that they see the bracket, bar or shackle arrangement as the lesser of two evils compared with the standard of seamanship observed where the pilot ladder side ropes are being “correctly” lashed to the vessels deck. The hitches used have been observed to be completely unsafe and the associated ropework sub-standard (Note that SOLAS 2012 is vague with respect to the actual securing).

Thus, much of the foregoing comes down to safety culture, seamanship, training and supervision, both on board and ashore – there appears to be a long way to go in this respect. CHIRP strongly believes that pilots should not be faced with “the lesser of two evils”, and that one hundred percent compliance with any pilot ladder rig should be the only acceptable expectation.

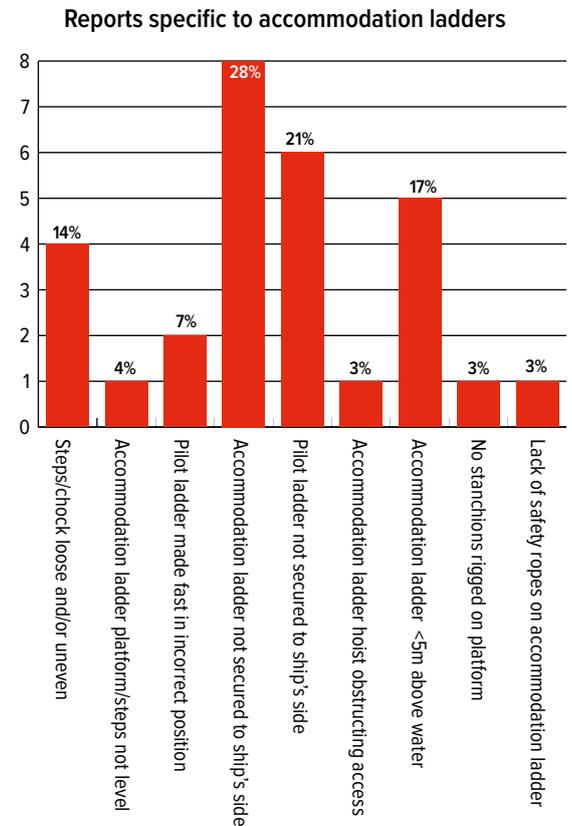
Figure 4 – Reports specific to accommodation ladders.

Figure 4 shows deficiencies related to accommodation ladders with 17 reports received and 29 separate deficiencies highlighted. Almost fifty percent of the reports relate to either the accommodation ladder itself and/or the pilot ladder, not being secured to the ships side as required by the 2012 SOLAS V regulations. Another significant slice of the pie describes the accommodation ladder itself being less than five metres above the waterline. Anything other than a light swell could cause damage to either the attending pilot vessel and/or the accommodation ladder itself.

The apparently repeated report of defective steps and chocks is explained by the fact that the reports

highlighted this issue along with other deficiencies specific to accommodation ladders.

The smaller sections of the diagram deserve a mention since they are extremely dangerous – accommodation ladder steps not being level, a lack of safety ropes on the accommodation ladder and no stanchions rigged at the bottom of the ladder at the pilot access are all extremely dangerous. CHIRP Maritime would argue that there is no excuse for this – in dialogue with the reporters, we discovered the vessels concerned had confirmed that the arrangements were ready in all respects to effect a safe pilot transfer. Clearly this is not the case, and in no situation was the vessel being rushed to prepare the arrangement. This is safety culture and supervision in its poorest form.

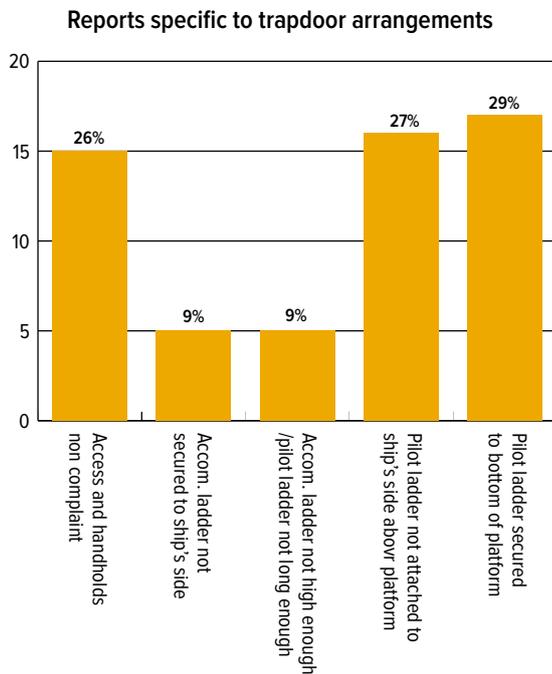
Figure 5 – Reports specific to “trap door” type combination rigs.

Figure 5 shows deficiencies with respect to “trap door” type combination rigs. CHIRP received 25 reports related to these arrangements and the analysis shows a high number of deficiencies, namely 58. The reason for this is not at all surprising. It is almost universally impossible to rig a trapdoor arrangement that is one hundred percent compliant with the 2012 SOLAS V regulations.

The largest areas of failing are the pilot ladder being secured to the bottom of the accommodation ladder, the pilot ladder (often another ladder) not being attached to the ships side 1.5m above the accommodation ladder platform, and access and

handholds being non-compliant – this is causing repeated difficulties for the pilots to make the transition from pilot ladder to accommodation ladder.

CHIRP queries all of the above but specifically the pilot ladder being secured to the bottom of the accommodation ladder. Photographic evidence often shows modifications having been made to accommodation ladders, and that lugs have been welded to the base of the ladder to allow a pilot ladder to be shackled on. Despite the fact that this is non-compliant with the regulations, CHIRP asks the question, “Who authorised these arrangements?”

Fully compliant trap door arrangements such as three-sided trap door rigs are noted to be few and far between. The general view is that the sooner these arrangements are either modified to full compliance or are removed from service and banned altogether the better. CHIRP fully agrees with this sentiment but assesses that such a change will need to be mandated in clear language to avoid misinterpretation.

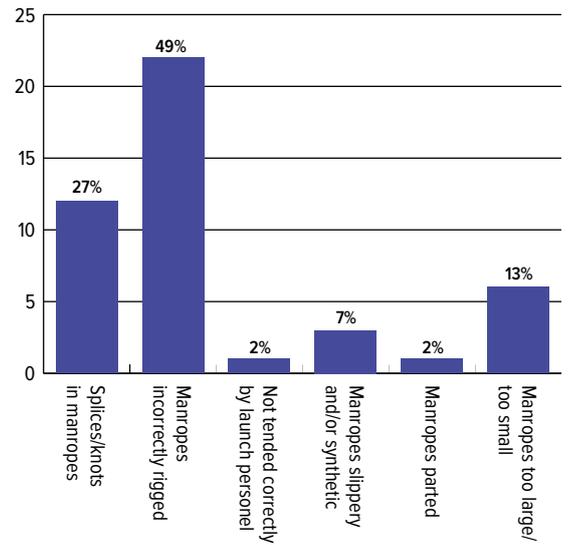
Figure 6 – Reports specific to manropes deficiencies.

CHIRP received 37 reports where manropes were specifically mentioned, and 45 deficiencies were highlighted. Almost half of the deficiencies related to the incorrect rigging of the manropes. Notwithstanding the nature of the other deficiencies reported, all of the failings came down to a basic lack of seamanship, supervision, safety culture and training. This is one area where any change to pilot ladder regulation is unnecessary – all of the deficiencies can be addressed on board to ensure that manropes are rigged correctly.

The whole chart demonstrates a lack of understanding as to what the manropes are used for, and this requires the urgent attention of vessels crews and their managers ashore in order to rectify the problem.

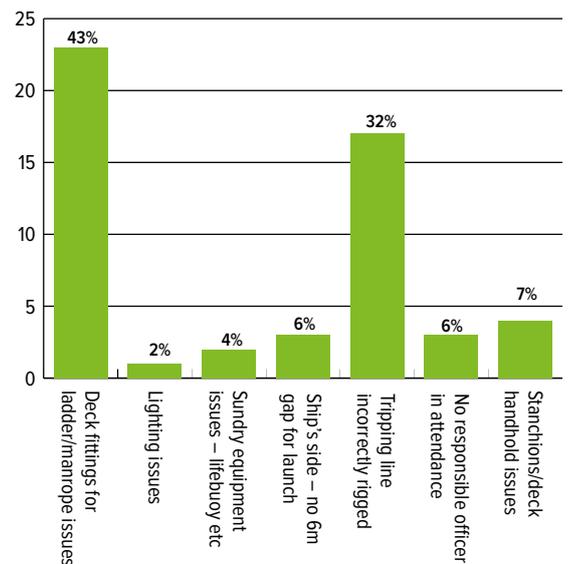
Figure 7 – Sundry equipment deficiencies.

The final chart in Figure 7 describes sundry deficiencies with the equipment. 47 reports were received, and 53 separate deficiencies were noted.

The largest area of failing were the deck fittings (or more correctly lack of) for side ropes and manropes. The deficiencies were noted for both pre 2012 and current SOLAS vessels. As noted earlier, all vessels have had ample time since the introduction of the current regulations to rectify any failings, so the question has to be asked why they have

Incorrect retrieval lines – often called tripping lines – accounted for almost one third of the reports, where the line was rigged in such a manner that it could become fouled upon the attending pilot launch or obstruct the safe access to the ladder for the pilot. The majority of failings were that the line led aft and not forward – also the line was rigged below the bottom spreader. All totally avoidable with a little care and attention.

*CHIRP* also highlights the ship side issue where there was no 6m gap in the rubbing bar to allow for safe access for the pilot boat. The vessels concerned were new – one on her maiden voyage – so who allowed them to be constructed in this non-compliant manner? *CHIRP* often highlights safety culture on board, but this is an example of poor safety culture ashore and a disregard for construction regulations.

Finally, the lighting issues and lifebuoy issues might charitably be attributed to carelessness, or it might be down to a poor safety culture. There is however absolutely no excuse for a responsible officer not being in attendance during the embarkation or disembarkation of a pilot. This highlights a disregard for the safety of any pilot boarding operation and/or exposes deficiencies in crew manning.

not done so? There is much more to be done by flag administrations, their recognised inspection organisations, port state control, and shipping companies in order to rectify this area.
