# MARITIME FEEDBACK

Issue 59  
June 2020

An independent and confidential reporting system for the maritime industry

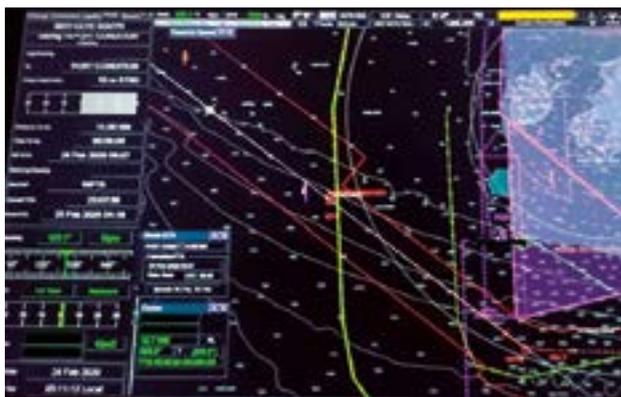
While on watch, I noticed another large cruise ship clearly enter and sail for over an hour through the PSSA we were passing. The other ship's AIS was on and identified the ship and showed her port of destination.

Figure 1 – screen shot of the Radar/AIS showing the reported ship transiting within the adjacent PSSA.

The reporter confirmed that he had not reported the matter to the local maritime authorities due to poor internet access. The reported vessel was nearly 300m long and it is possible that it was cutting a large corner off the transit to make an ETA, or to make up some earlier lost time. At the very least, it is poor attention to passage planning. Contravening the PSSA restrictions for commercial interests would seem particularly cynical. There is a reason for the restrictions on navigating within a PSSA.

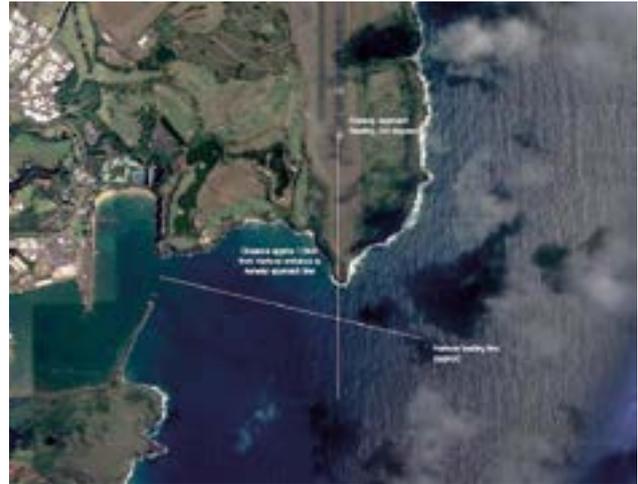
While flying by ILS (instrument landing system) inbound to runway 35 at an island airport, we broke out of low cloud conditions several miles out, on final approach. I saw a very large cruise ship steaming from left to right out of the harbour with a course that would cross the short final in front of Runway 35.

However, in this case, according to the air traffic control tower, the ships do not liaise with the tower and there does not appear to be any restricted area to limit the approach and passing of vessels in the vicinity of the end of the runway.

Figure 2 – Aerial view showing proximity of the runway and port entrance

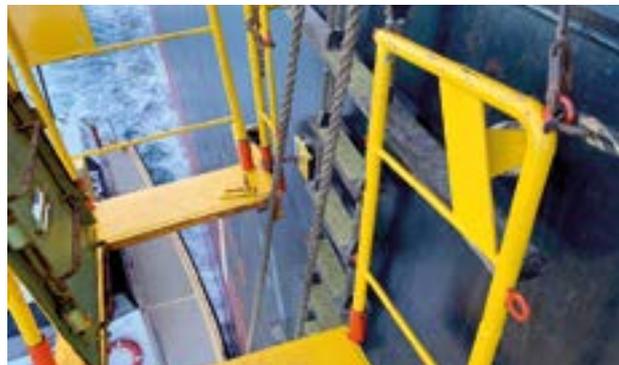
Figure 3 – Example of a compliant combination PBA with trap door.

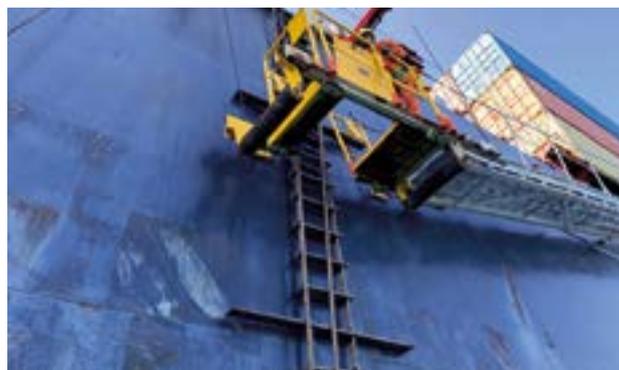
Figure 4 – Compliant combination PBA with trap door – pilot ladder and man ropes extend up to and are made fast on vessel's deck
