MARITIME FEEDBACK

Issue 61
November 2020

An independent and confidential reporting system for the maritime industry

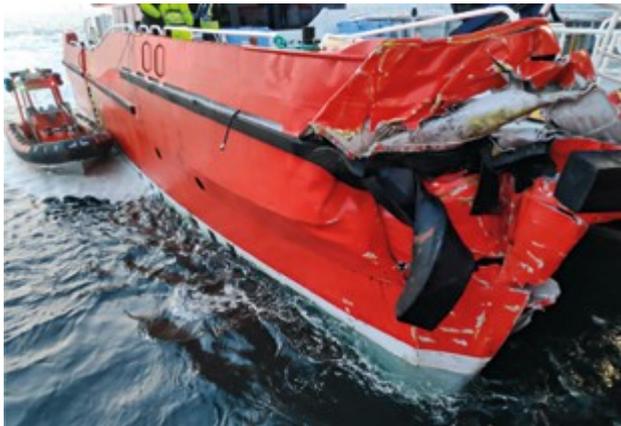
Figure 1 – The Consequence of distraction. (Photograph taken from the Flag State Administration Final Report – vessel name obscured)

The service vessel had finished the day's tasks and was released to return to port for the night; but whilst transiting through the wind farm at a speed of approximately 20 knots, it hit a tower. In the summary of findings, the final report notes "the primary reason why a proper lookout was not being kept was because the Master, who had the conduct of the vessel, was distracted from his primary role".

The report contains images taken from the wheelhouse CCTV that show the captain looking to his right and downwards prior to impact with the rapidly closing tower.

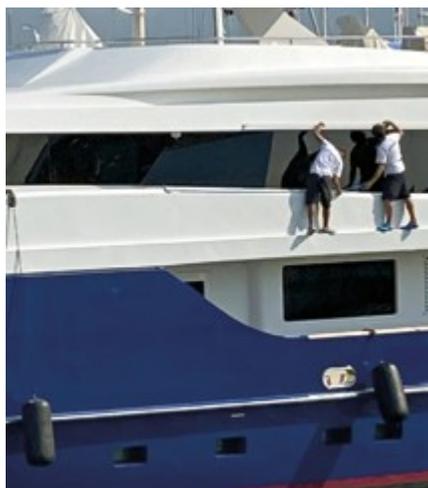
the waterline and without protective or appropriate safety equipment. Whilst one of the two crew members (aft in the picture) might possibly have had a harness attached to the rail above their heads, the other person (fwd. in the picture) certainly did not and was only holding on with his left hand. Neither appeared to be wearing life jackets.

Figure 3 – Another example of poor safety culture in the superyacht sector.

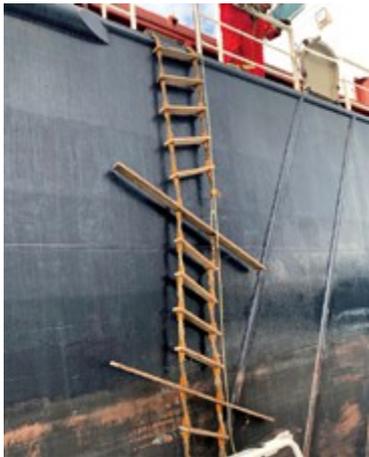
Figure 4 – Parted ladder

While boarding the vessel at the pilot exchange station, one of the side ropes snapped. No other pilot ladders were available.

Luckily, the pilot had only climbed two steps when the side rope parted, and he was able to jump back onto the pilot boat without sustaining any injury.

The company already had maintenance routines dealing with pilot ladders, but immediately following this accident the procedures had been modified and increased to include monthly testing where the weight of several crew was added to the ladder in a safe way, while the ladder was suspended down the wheelhouse front.

In addition, the information about the incident was made available to all company vessels and crew. The company was not satisfied with using manila ropes in pilot ladders due to the quality of rope available and weaknesses being difficult to spot. They had started a replacement programme using better quality rope.

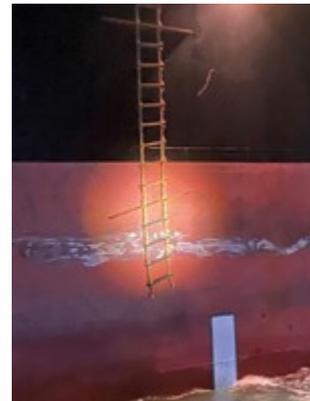
▲ Figure 6 – Second ladder rejected due to very loose whippings

◀ Figure 5 – First ladder rejected due to uneven steps

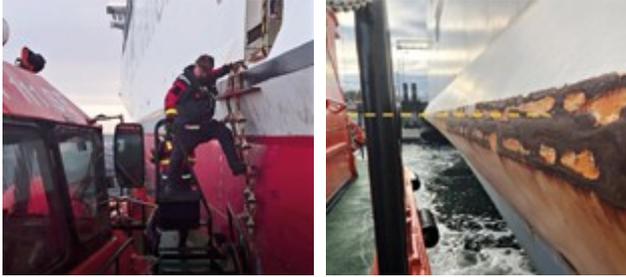
I have read your publication on pilot ladder failings and am seeking your advice. We have several vessels in our area that are constructed in a way unsuitable for boarding by pilot ladder. Most of them have a railing (rubbing strake) without a gap to allow safe access for the pilot boat. The rubbing strake will also press down and damage the pilot boat in the case of rough seas. In some cases, the railing (rubbing strake) is so wide that the pilot ladder swings freely underneath it when rigged above the railing.

SOLAS stipulates that the pilot ladder must lay against the ships side, but we have had a hard time finding rules for railings (rubbing strakes) without gaps. Do you have any useful information on this matter?

Figure 7 – Examples of ship side features that render the vessels non-compliant by design

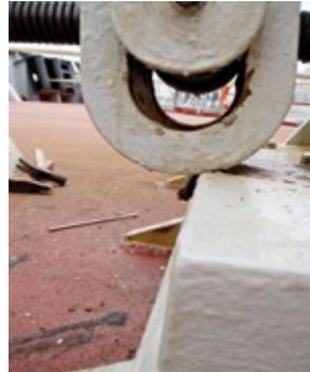
On refitting the fixing plates and bottle screw the adjustment of same was kept to a minimum with only approximately 5 threads entered at both ends of the screw. The brake was then fully applied using the strength of two able seamen. With the drive clutch engaged, the hydraulic motor turned the windlass gypsy wheel with ease and there was absolutely no braking effect.

The reason for the freedom of movement was that the crosshead, located between the brake application shaft and the brake tensioning plates, was in contact with the windlass foundation, as shown in the photograph below:

Figure 8 – Incorrect Brake Adjustment

Corrective Action: With immediate effect, all in the same class are to strip down and clean the internal and external threads of the bottle screw arrangements, insuring that before removal the anchors are fully secured using the lashing wire and compression bar. With the bottle screws refitted the brakes are to be adjusted to give 30 – 35 mm clearance between the foundation and the crosshead plates when the brake is 'Fully On'. To test the holding ability of the brakes, engage the drive shaft clutch, with the brake 'Fully On' and try and rotate the drum in a chain lowering direction using the hydraulic motor, there should be no motion of the gypsy wheel relative to the brake.

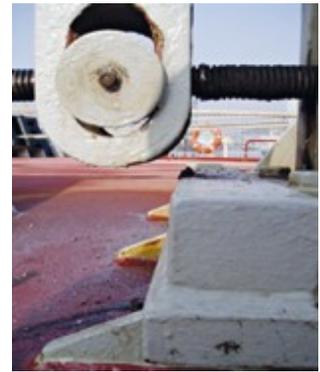
Figure 9 – Correct Brake Adjustment

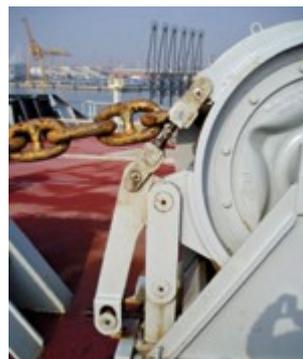
The bottle screw was then tightened to the correct setting, i.e. allowing the gypsy to rotate freely in the brake ‘off’ position, but in the brake ‘fully on’ position the hydraulic motor could not rotate the gypsy. The clearance between the crosshead plates and the foundation with the brake fully applied was in the region of some 30 – 35mm.

Figure 10 – Brake ‘Fully On’

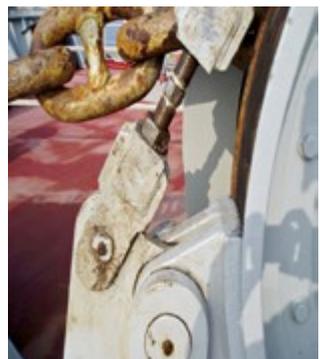
Figure 11 – Bottle Screw Adjustment
