MARITIME FEEDBACK

Issue 63
June 2021

An independent and confidential reporting system for the maritime industry

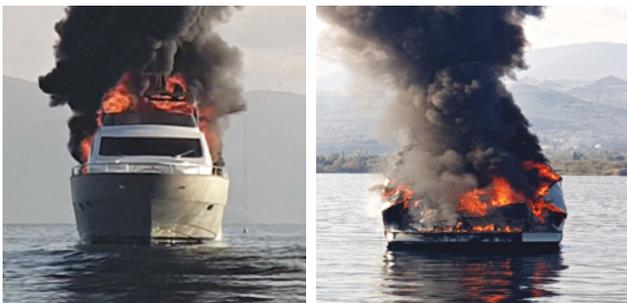
Figures 1 and 2

Shortly after weighing anchor, following an overnight stop, the vessel suffered a catastrophic engine room fire which spread rapidly throughout the vessel.

The vessel subsequently sank in deep water whilst a firefighting vessel was attempting to extinguish the blaze.

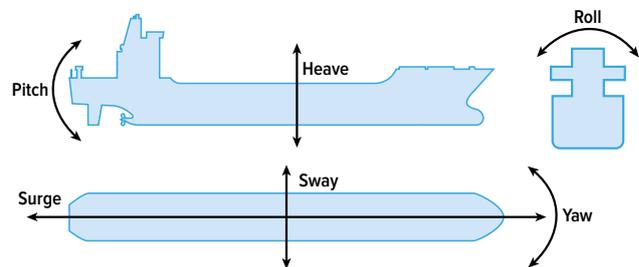
Figure 3 (image courtesy of Witherbys Publishing)

- Two dissimilar vessels will each have their respective pitch, roll, heave, surge, yaw, and sway movement periods, potentially in opposition to each other at any given moment. This can put tremendous snatch loading on the mooring lines.

- This differing movement makes balancing the load on the mooring lines more difficult than conventional mooring operations.
- For this reason, ship to ship transfers should be carried out only under favourable weather conditions with constant monitoring required to ensure that the agreed weather parameters are not exceeded - especially the sea and swell conditions.

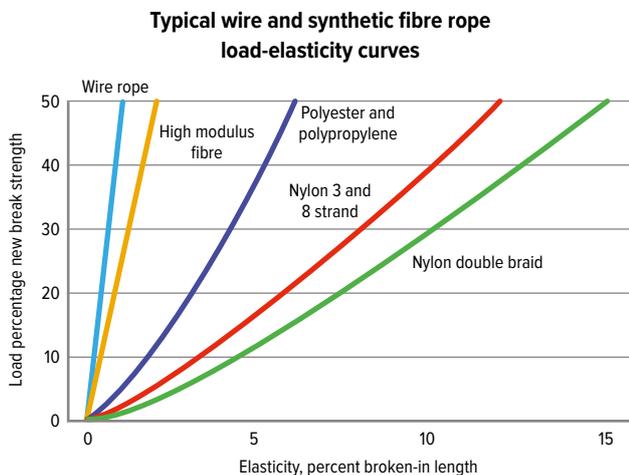
Figure 4 (image courtesy of Witherbys Publishing)

- It is important that all mooring lines in each of the three (3) groups, breast lines, spring lines, and head / stern lines are of the same size, construction, breaking strength and length to ensure equal tension on all lines. Dissimilar characteristics within a group can lead to rapid parting of mooring lines.
