Securing pilot ladders

Improperly secured pilot ladders are putting lives at risk. A culture change is urgently needed

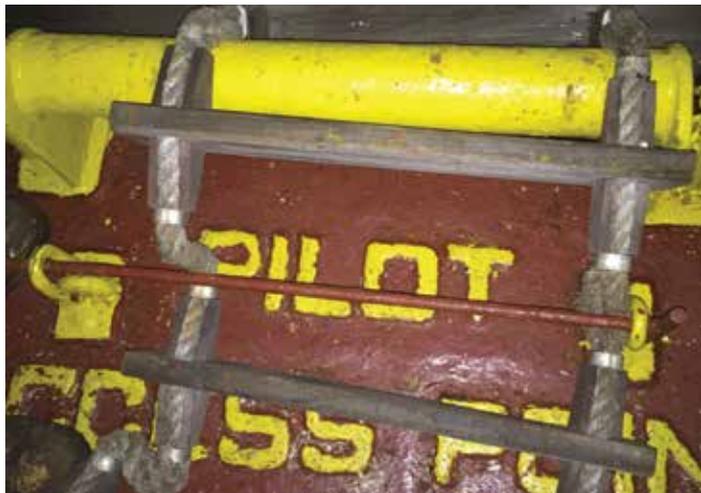
Figure 1 Steel bar used to secure ladder – not SOLAS compliant

- Use the four extended side ropes (at least 3m) beyond the top of the ladder to secure it to adequate deck pads or cleats;
- Shorten and thimble splice two of the four suspension ropes (one on each side). The unshortened ropes are then passed through the thimbles and through the deck pads and secured with half hitches;
- A steel bar that passes through a ring on deck on each side of the ladder (Figure 1). This method must be very carefully installed and used or it will not safely secure the ladder.

This last method is frequently encountered (see photo). However, it does not appear to conform with SOLAS.

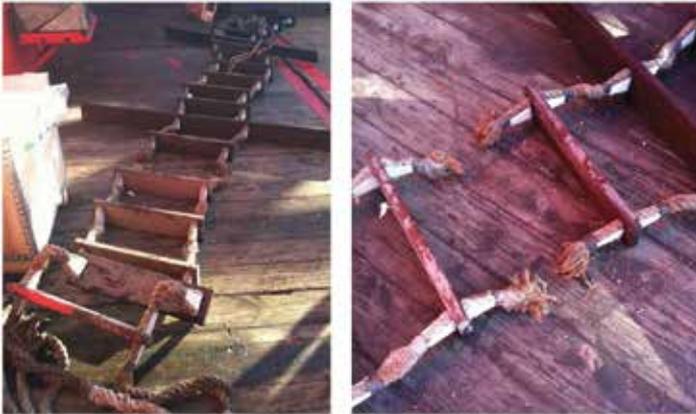
On 4 August 2011, a pilot ladder parted on a Platform Supply Vessel (Figure 3) while the pilot was attempting to board (Marine Safety Forum, Safety Flash 11-29). The pilot fell backwards approximately two metres onto the deck of the pilot boat, suffering whiplash injuries which could have been more serious including fatal. Two shackles secured the sides of the pilot ladder to pad eyes close to the sheerstrake.

The findings of the investigation included, among other things, that the pilot ladder ropes were worn by contact with the sheerstrake, and no measures were in place to reduce the effect of the sharp edge of the

Damaged pilot ladder on Platform Supply Vessel (Marine Safety Forum)
vessel's sheerstrake on the pilot ladder ropes.

Corrective actions included removing any sharp edges with the potential to affect pilot ladders, and the requirements contained within the IMPA 'Required boarding arrangements for pilots' poster to be re-emphasised to all relevant shipboard personnel.
