# CHIRP FEEDBACK

Issue No: 26

Summer 2010

A Maritime Safety Newsletter

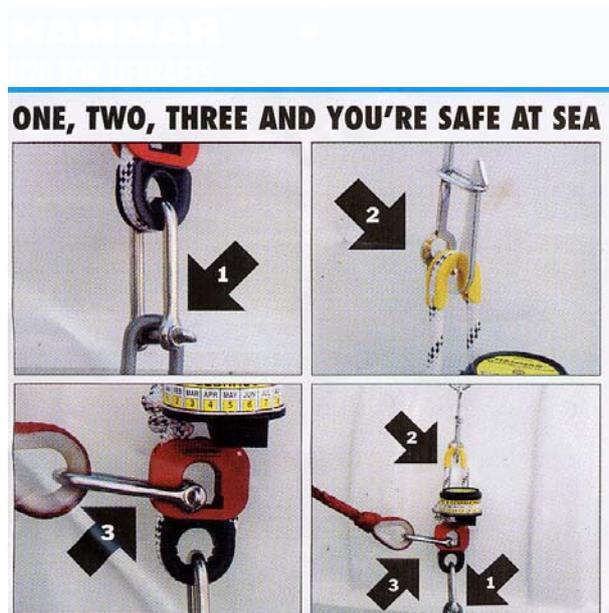
Here is also a useful illustration from the safety training manual of a fishing company.

Diagrams showing the correct installation of various types of HRU can be found in MGN No. 343 on Hydrostatic Release Units - Stowage and Float Free Arrangements for Inflatable Liferafts.
