CHIRP MARITIME FEEDBACK

Issue No: 39

02/2015

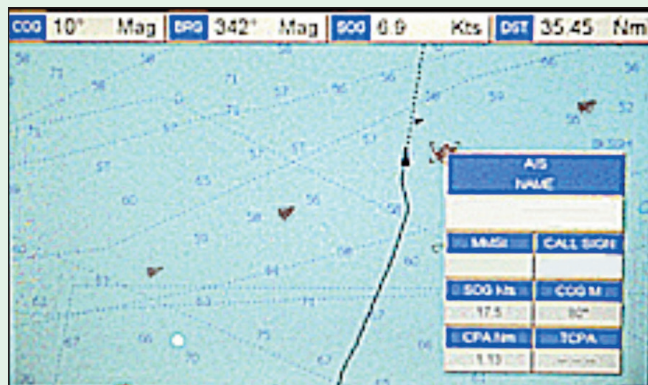
Report Text: We were sailing from Cherbourg to Southampton via the Needles on a 10 metres sailing yacht equipped with an AIS (Automatic Identification System) transponder and active radar reflector. Visibility was about 4 miles, our speed about 8 knots. As we crossed the eastbound shipping lane, several AIS targets were approaching on the port side and eventually became visible. One was of concern because the closest position of approach (CPA) was almost zero. The speed of this ship, the xxxxxx, was about 18 Knots. After monitoring the situation for some time, I called up on VHF radio and informed the crew who answered, that according to our AIS our CPA was near zero. The response was 'I agree'. I then asked if he planned to alter course to avoid risk of collision and he replied in the negative.

I politely pointed out that we were a sailing vessel and the stand on vessel under the Collision Regulations and asked once again if he would alter course. The reply was 'I could do but I'm not going to'. I decided at this point that further discussion was unlikely to be productive, ended the conversation and instructed the helm to turn 20 degrees to port and harden up the sails. This allowed us to pass behind the ship by a safe distance.

Lessons Learned: Do not assume that another vessel will take avoiding action even if it is aware that a risk of collision exists.

CHIRP Comment: The use of AIS is useful for the identification of a ship, but is not recommended for collision avoidance. AIS measures speed and course over the ground and not through the water.
