MARITIME FEEDBACK

Issue 57
November 2019

An independent and confidential reporting system for the maritime industry

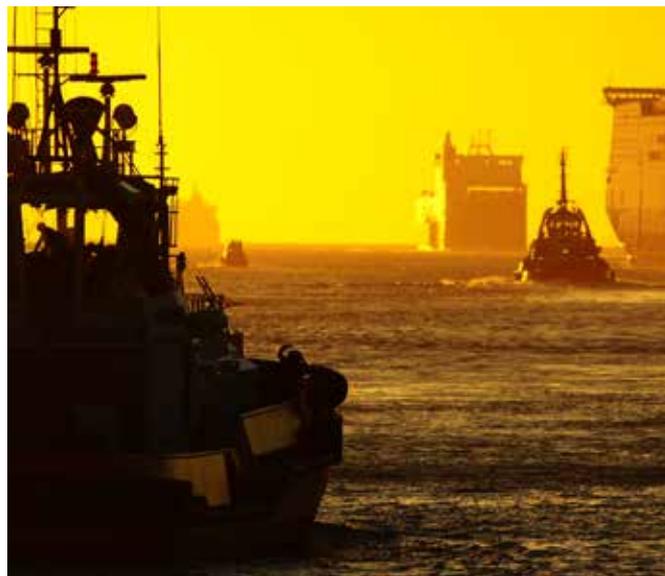
Tug operations can be hazardous for both tugs and vessels. Read more inside. (image: Danny Cornelissen)

The photograph shows a tug engaged in towing operations assisting a large container vessel during departure. Despite many incidents in the towing industry where watertight integrity has been the cause of numerous accidents and deaths of tug crews, the crew of this tug failed to exercise proper controls to close and secure the watertight door to the accommodation.

CHIRP subsequently contacted the DPA who readily engaged with us and confirmed that the photograph did regrettably confirm the report, and that the aft accommodation watertight door may have been open without cause. This was indeed contrary to the company's safety procedures and industry best practice.
