MARITIME FEEDBACK

Issue No: 18

Spring 2008

A Maritime Safety Newsletter

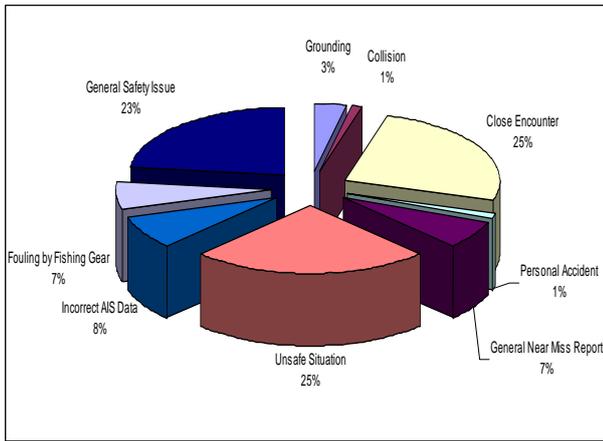
REPORTS RECEIVED IN 2007

The pie chart above shows the various categories of incidents and issues of the reports received by **CHIRP** in 2007. We have differentiated between "unsafe situation" and "near miss", taking into account how close the person or vessel was to risk of injury or damage. For example, in this categorisation we would classify a machinery breakdown in open waters as being an unsafe situation. If the vessel were to drift close to shore before being able to anchor, we would categorise that as a near-miss. If a yachtsman goes to sea without wearing a life-jacket, that is an unsafe situation (also referred to "at-risk behaviour"). If he falls overboard but is subsequently rescued, that would be recorded as a near-miss.
