Safety Alert – Exploding Windlass – Your Experiences?

Britain's [Maritime Accident Investigation Branch](#) has appealed to the industry for information on the catastrophic failure of high pressure hydraulic anchor windlasses in its latest [Safety Bulletin](#) following several incidents since 2007, some of which have caused serious injury.

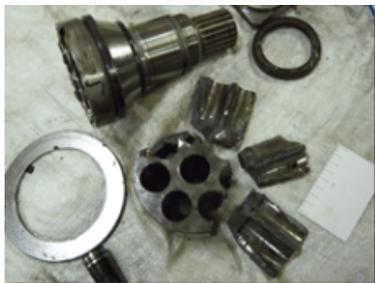
Results of a high pressure that couldn't take it

- Signs that the outer cast iron casing had fractured under extreme internal pressure and on impact with broken components of the hydraulic motor.
- On 19 May 2009, the hydraulic motor of the TTS Kocks high pressure windlass on board a German registered LPG vessel exploded as the vessel was heaving in her anchor off the coast of Florida, USA. The vessel was in ballast and the wind speed was up to 38 knots. The windlass operator was seriously injured by the flying debris. This accident is being investigated by the vessel's owners and her classification society.

The frequency and consequences of the catastrophic failures of high pressure windlass motors highlighted is a serious cause for concern. These and other similar accidents appear to have occurred when heaving in the anchor in adverse sea and weather conditions when the anchor chain has been tensioned beyond the intended safe loading of its windlass. This can be avoided by:

- Closely monitoring the predicted weather and sea conditions and ensuring that the anchor is recovered in good time, before the conditions make this difficult to achieve; and
- Using main engines to manoeuvre a vessel to relieve tension in the anchor chain before 'heaving in'. This also helps to prevent an anchor from 'breaking out' and dragging while weighing.

However, the risk of an anchor chain suddenly tensioning can never be fully eliminated. Therefore, until technical solutions are introduced by all windlass manufacturers that prevent the over-loading of high pressure windlasses resulting in their catastrophic failure, it is imperative that an anchor chain is closely monitored when weighing, and that 'heaving in' is stopped as soon as any significant tensioning is observed or difficulty is experienced.

2009/140S Identify the technical reasons for the catastrophic failures of its windlass motors and determine engineering and design solutions to prevent similar accidents on board vessels fitted with its equipment.
